Subject: Confirmatory Action Letter Response - Root Cause Analysis Report

Root Cause Analysis Report

Significant Degradation of the Reactor Pressure
Vessel Head

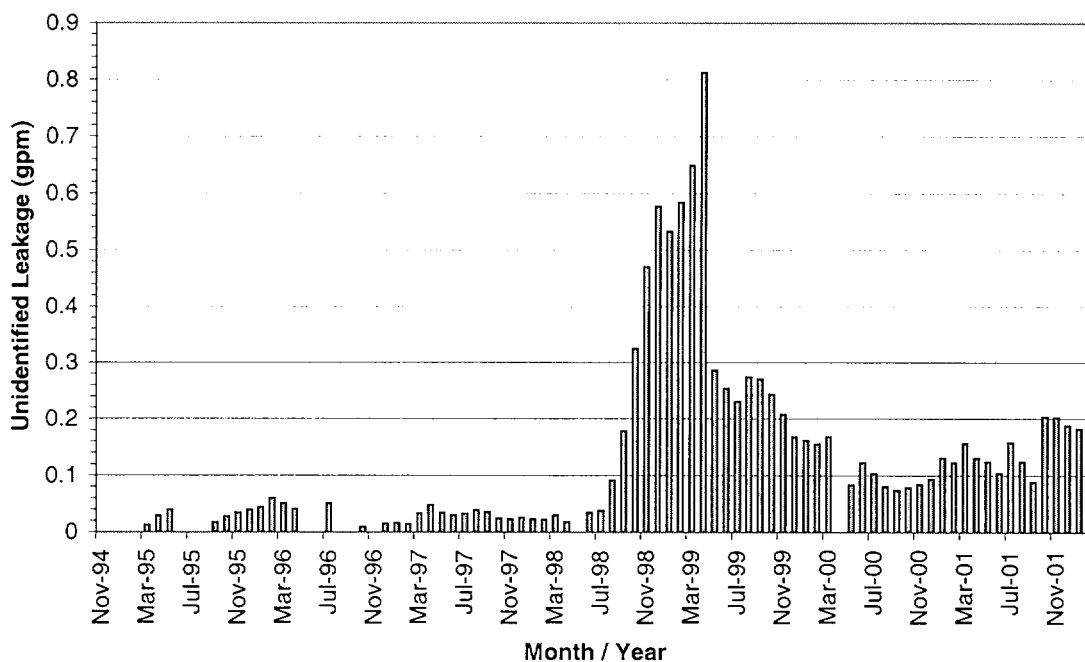
Monthly Average Unidentified Leakage, Cycles 10 through 13 (gpm)

During operating cycles 10 through 13 (November 1994 through February 2002), measured unidentified leakage has ranged from slightly negative to as much as approximately 0.8 gpm in April 1999. From review of data over that time span, it would appear that average unidentified leakage tends to be in the range of 0.0 to 0.03 gpm when the plant is “tight” with no pending maintenance concerns. If unidentified leakage begins to trend upward, efforts are expended to determine the cause, and if necessary, effort is made to repair the source of the leakage. For

example, the high leakage in April 1999 was identified as from the Pressurizer Code Safety Valves and the plant was shutdown to service the valves. Following that shutdown, unidentified leakage remained in the range of 0.15 to 0.25 gpm, some of which was attributable to CRDM flange leakage and some of which may have been attributed to CRDM nozzle leakage.

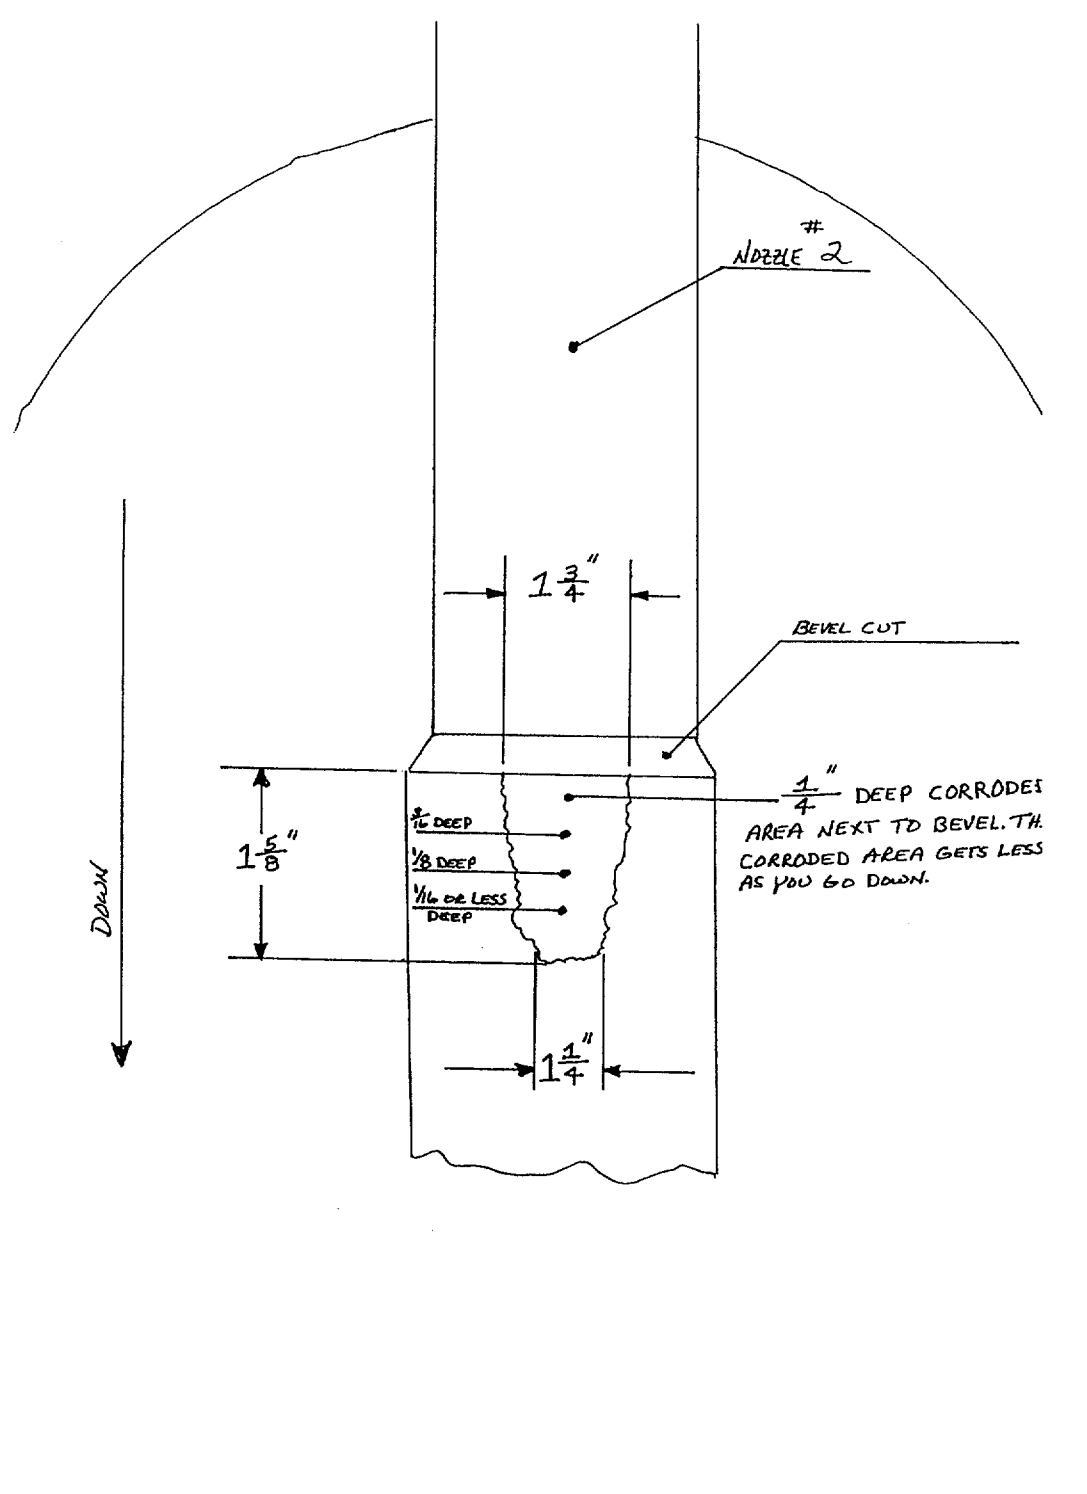
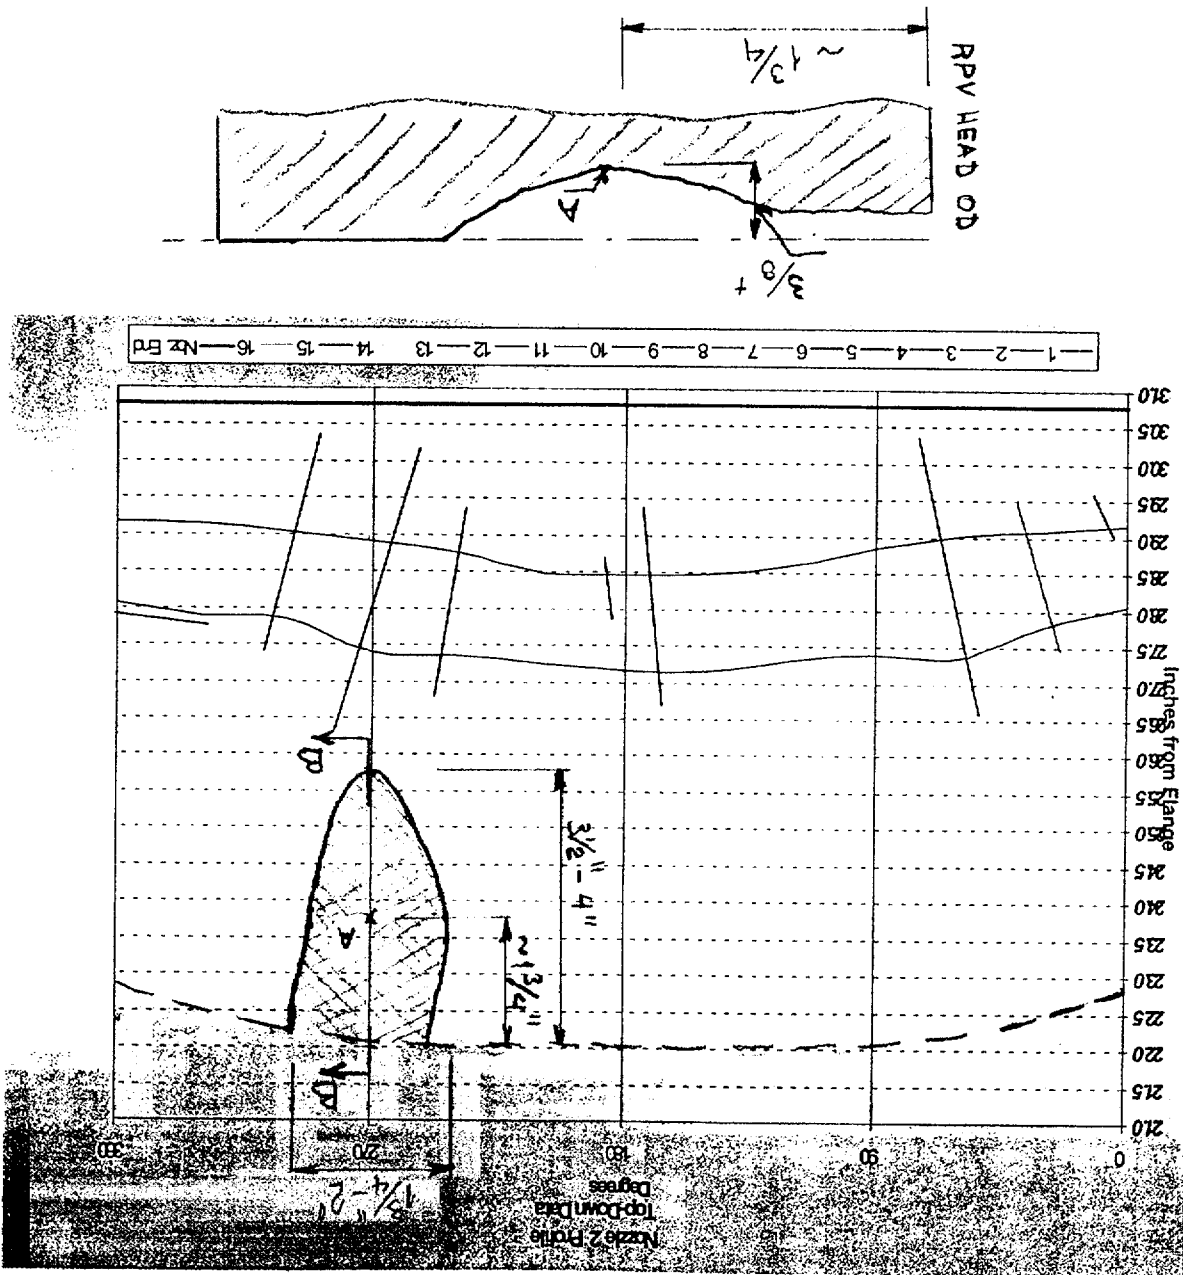
Figure 5. Corrosion at Nozzle 2 Drawing Side View

Degradation at Nozzle 2

Degradation was observed at nozzle 2 following the initiation of repair efforts. Figure 5 and 5a shows the observed area of corrosion. The overall corroded area, based on the video examination and approximate measurements from the impression, is 3-1/2 to 4 inches in length starting from the top of the RPV head, about 3/8 inch deep (at the deepest location approximately 1-3/4 inches from the top of the RPV head), and between 1-1/4 to 2 inches at its widest location. The depth of corrosion decreased as the annulus opening was approached. This type of corrosion profile is similar to testing that has been performed by EPRI (reference 5.3) regarding location of the deepest corrosion and the fact that it could have been identified on the top of the RPV head.

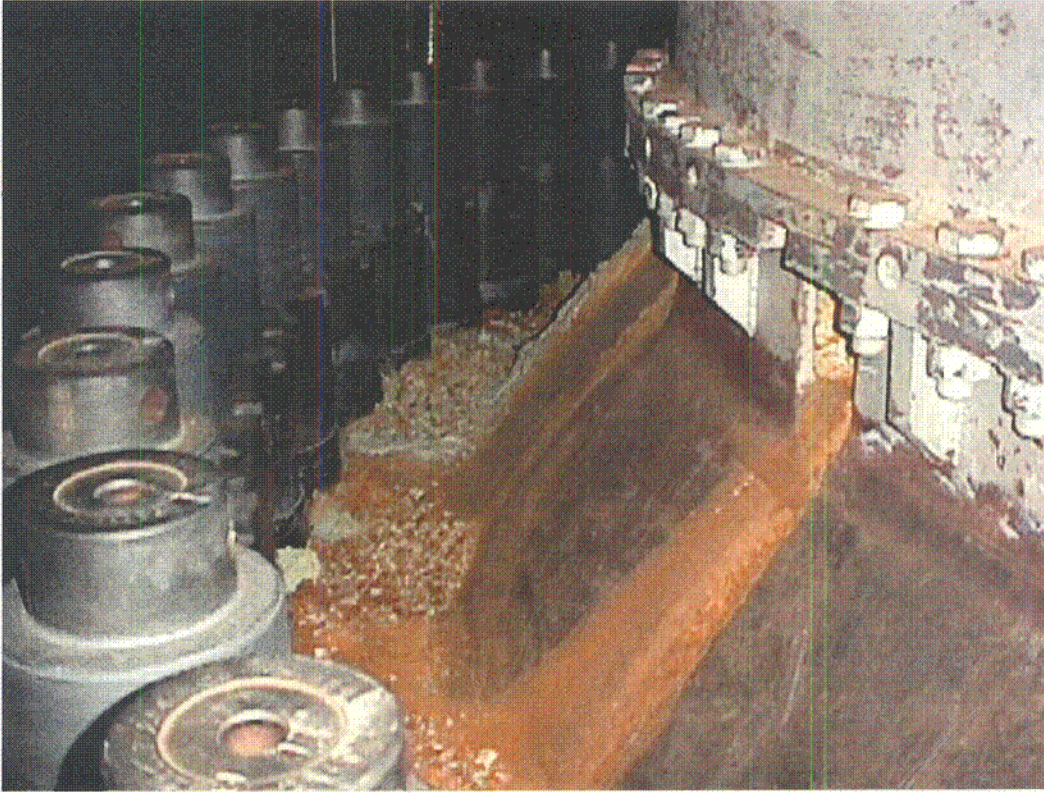
Figure 4. Boric Acid and Iron Oxide on Vessel Flange at 12RFO

The following is a summary of the non-destructive examination effort on the cracked nozzles and degraded RPV head. After removal of insulation from the RPV flange early in 13RFO, boric acid crystal deposits and iron oxide were found to have flowed out from several of the openings (mouse holes) in the lower service structure support skirt (Figure 20). Figure 4 shows deposits on the flange during the inspection in the twelfth refueling outage (12RFO).

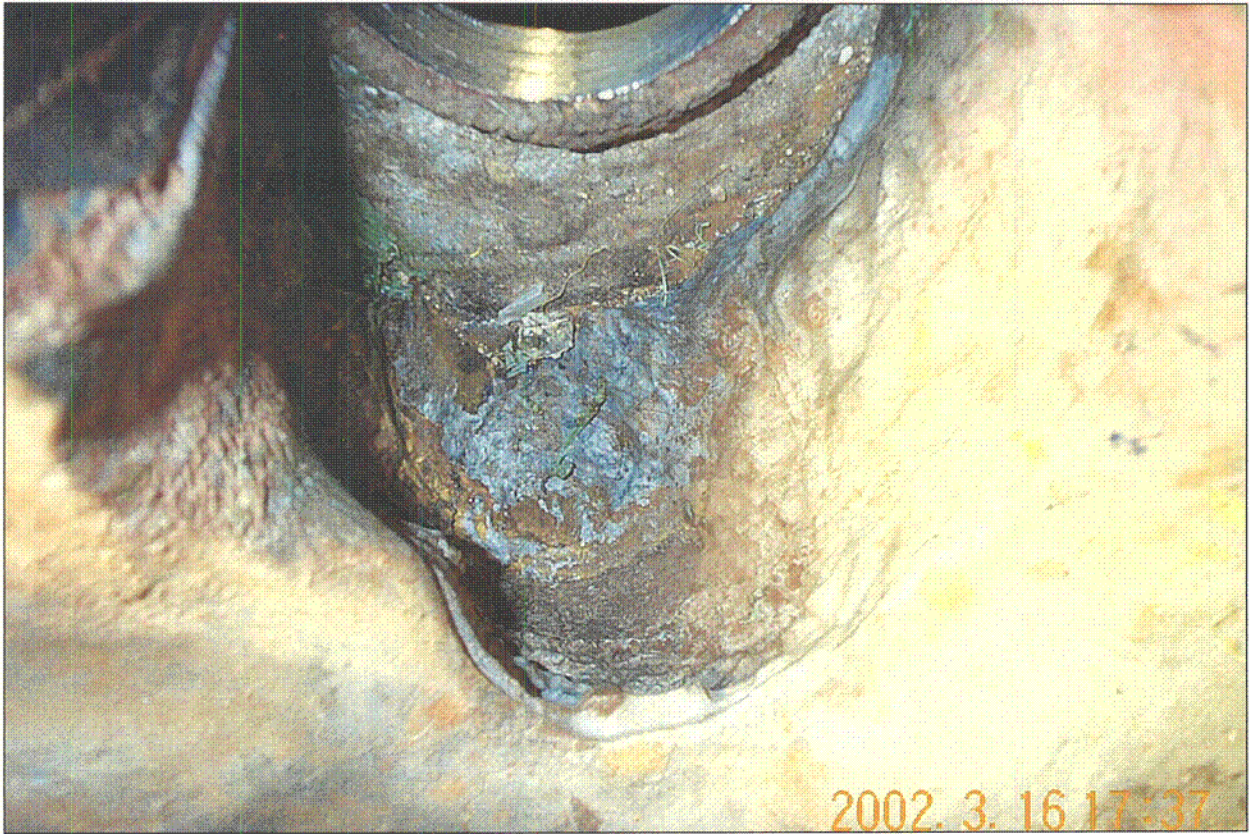
Figure 6. Cavity in Reactor Vessel Head Between Nozzle 3 and 11

After removing the lower part of nozzle 3, a cavity was discovered in the low-alloy steel RPV head material above the J-groove weld on the downhill side. Additionally, after removing the lower part of nozzle 2, a smaller area of corrosion of the low-alloy steel RPV head material was discovered between the bottom of the machined nozzle and the top of the J-groove weld (Figure 5). This area of corrosion was found to extend under the portion of the nozzle left in place after machining.

After pulling nozzle 3 and cleaning by hydrolasing, the top of the RPV head was inspected using a video camera on a long pole through the vacated nozzle 3 penetration. This inspection showed a large cavity in the low-alloy steel RPV head material between nozzles 3 and 11 (Figure 6). The area with missing material was reported as being about 6.6" long and approximately 4-5" at the widest point. Ultrasonic thickness measurements from the underside of the RPV head showed the thickness of the remaining material (cladding) to be an average of approximately 0.3", which is greater than the 3/16" nominal or 1/8" minimum specified clad thickness. The videotape inspections also showed a small area of corrosion where nozzle 2 penetrates the RPV top head surface. The small area of corrosion at the top of nozzle 2 was found to lie directly over the area of corrosion at the bottom of nozzle 2 as seen in Figure 5. The videotape inspection also showed evidence of a small leak path where nozzle 1 penetrates the RPV top head surface.

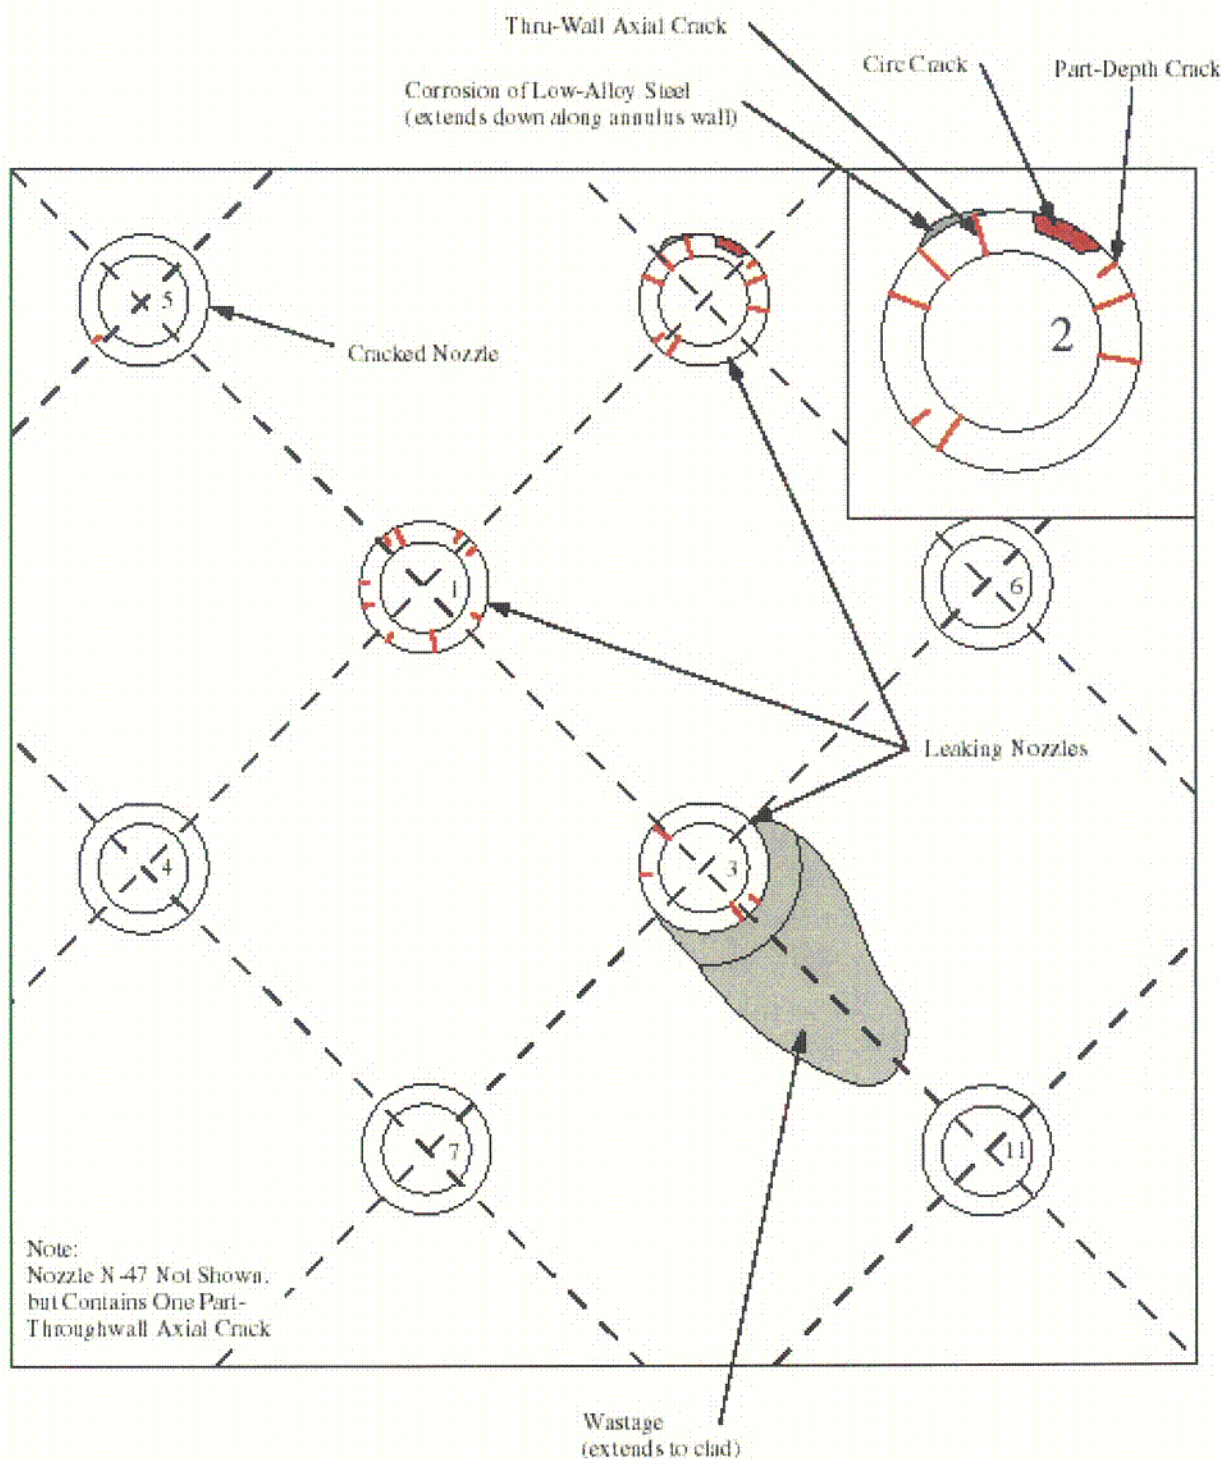
Figure 7. Locations of Cracks and Corrosion on Davis-Besse RPV Head at 13RFO

Figure 7 shows locations of cracks and corrosion on the Davis-Besse RPV top head surface. This figure is included to serve as a reference for the following descriptions of the degraded areas.

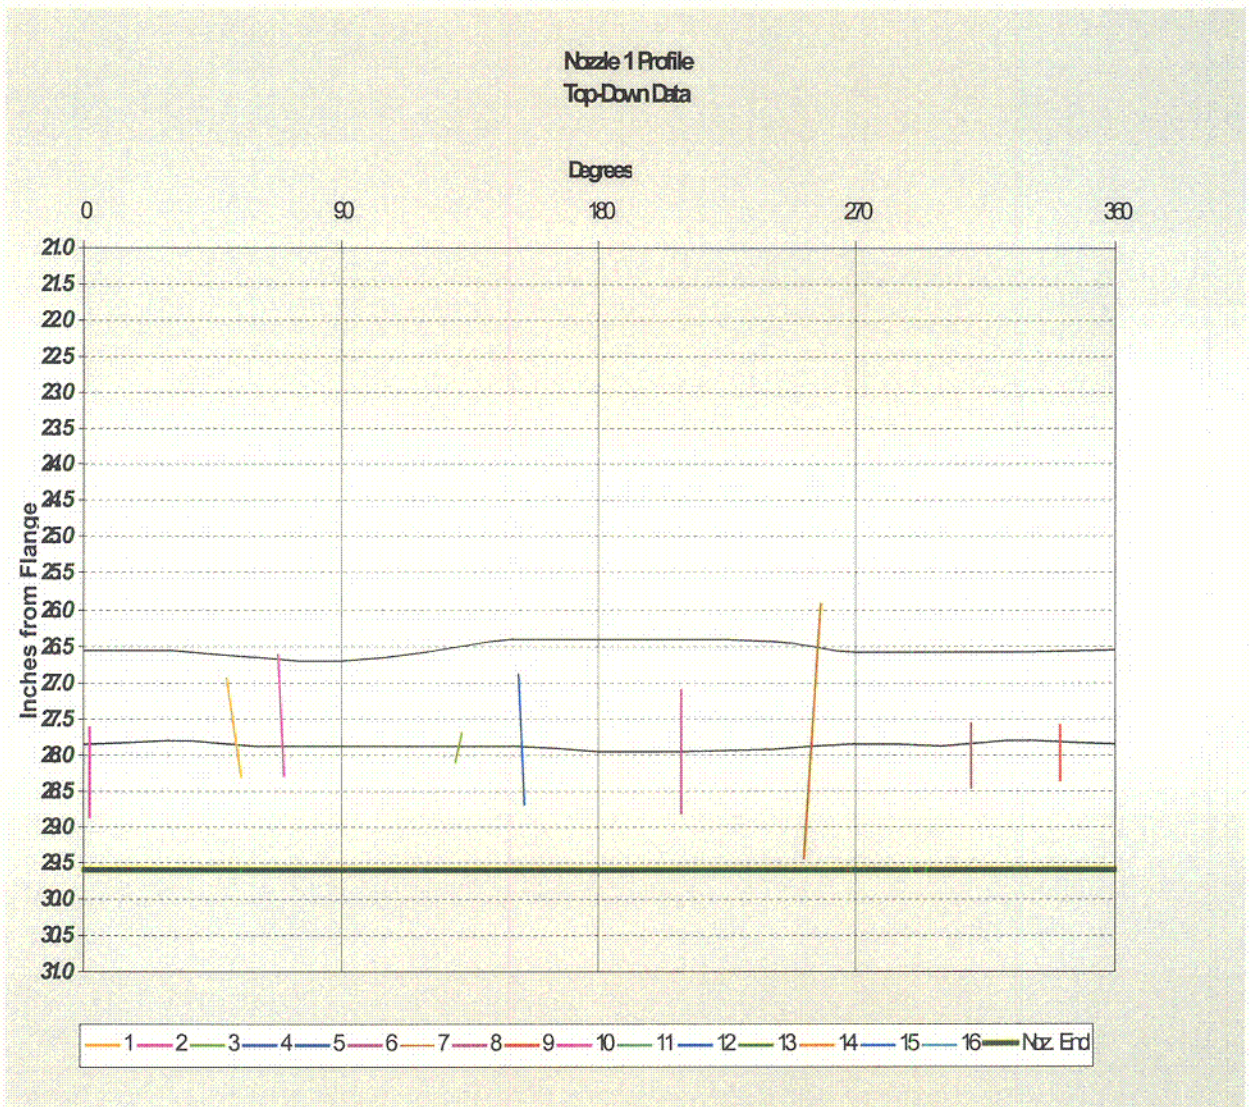
Figure 8. Nozzle 1 Crack Locations and Sizing

Degradation at Nozzle 1

The observed degradation at the nozzle 1 location is minimal. A small, crevice (<1/16 inch wide and about 3/4 inch circumferentially), located at the 270° location (looking down from top of RPV head clockwise with 0° in the West direction), was identified at the surface of the RPV head. The observed degradation at nozzle 1 was within the boundary of the pre-established repair plan.

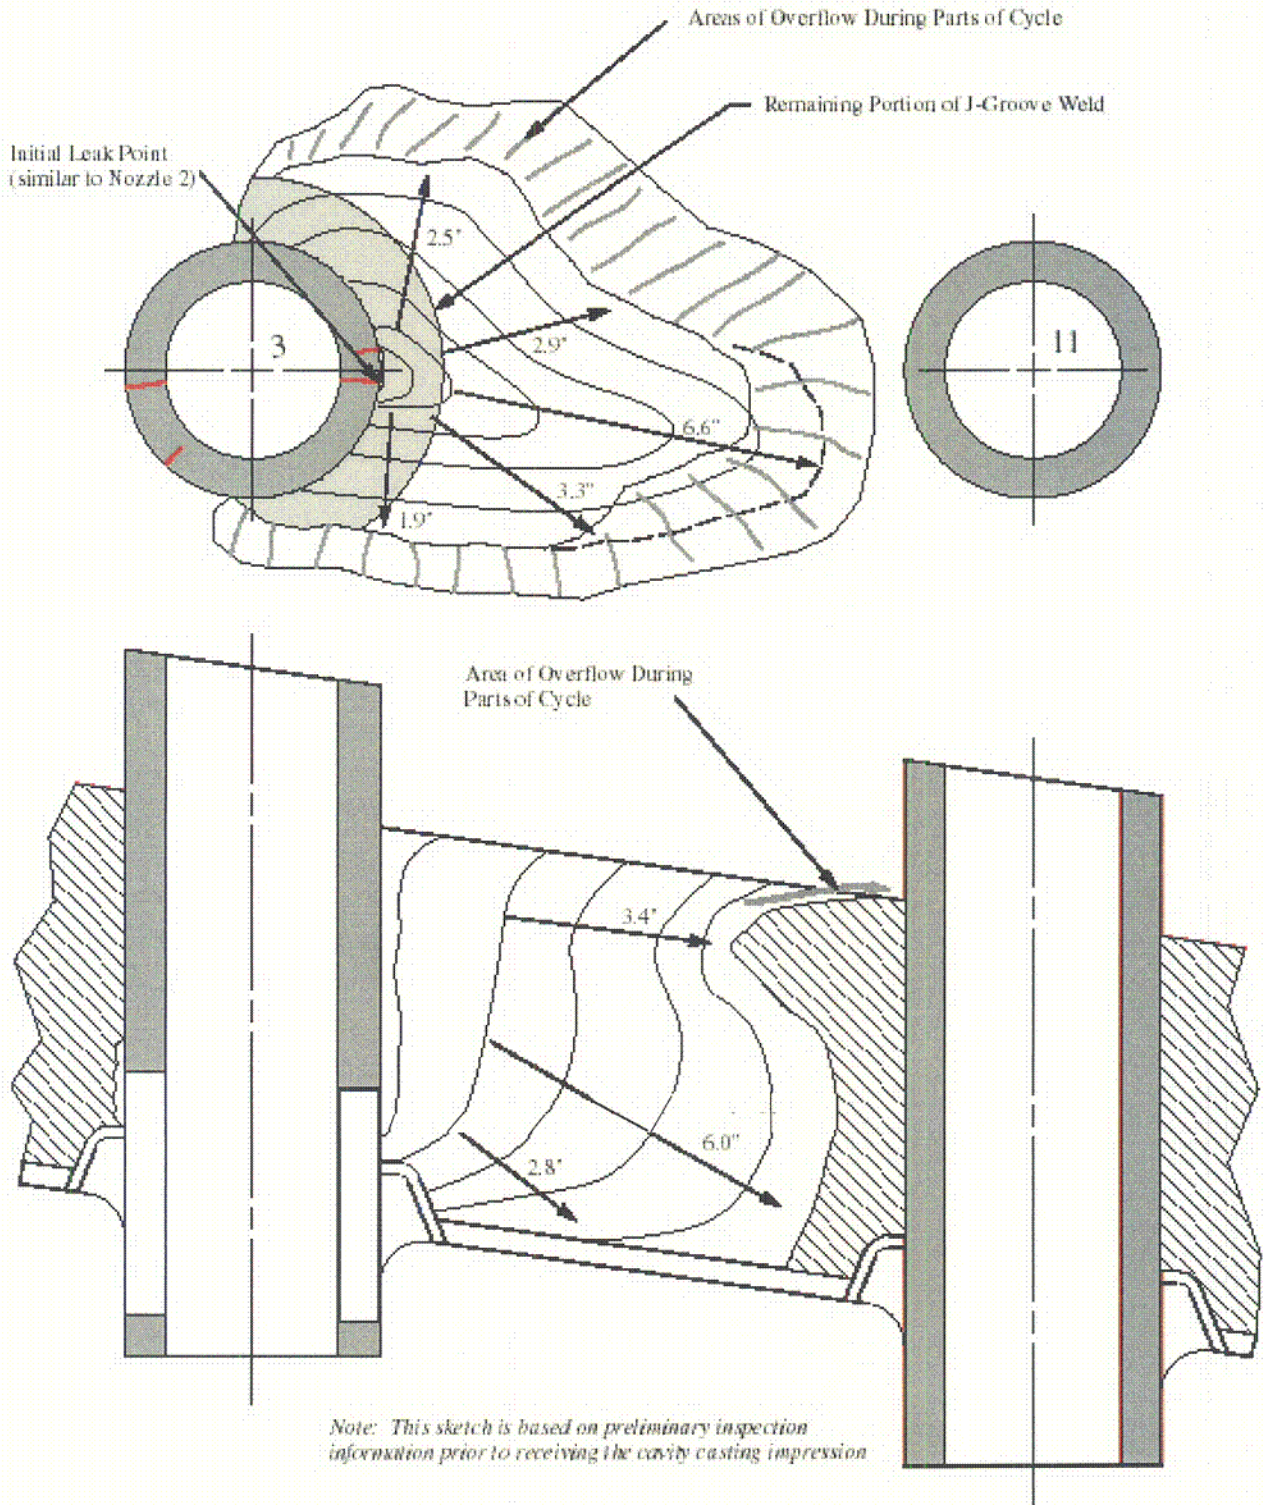
Figure 13. Characterization of Corrosion and Impingement at Nozzle N-3

Degradation at Nozzle 3

Degradation observed at nozzle 3 is pictorially shown in Figure 13. The 180° (uphill toward nozzle 1) location is essentially intact, with little to no degradation. The 0° (downhill toward nozzle 11) location exhibits the worst degradation, with the low-alloy steel material corroded away, down to the stainless steel cladding, for approximately 6.6 inches in length and 4 to 5 inches at the widest part. Figure 14 shows cladding thickness measurements made by UT from the underside of the RPV head. (Note: There are several low readings outside the designated area of damage. These are attributed to inclusions or bad readings. These readings do not correspond with visual observations, and will be further verified following excavation of the damaged area.)

From the 270° location to the 0° location (counterclockwise looking down from the top of the RPV head), there is a large undercut area. From the 0° location to the 90° location (counterclockwise looking down from the top of the RPV head), the corrosion is less. Additional data is forthcoming from profilometry and the failure analysis efforts.

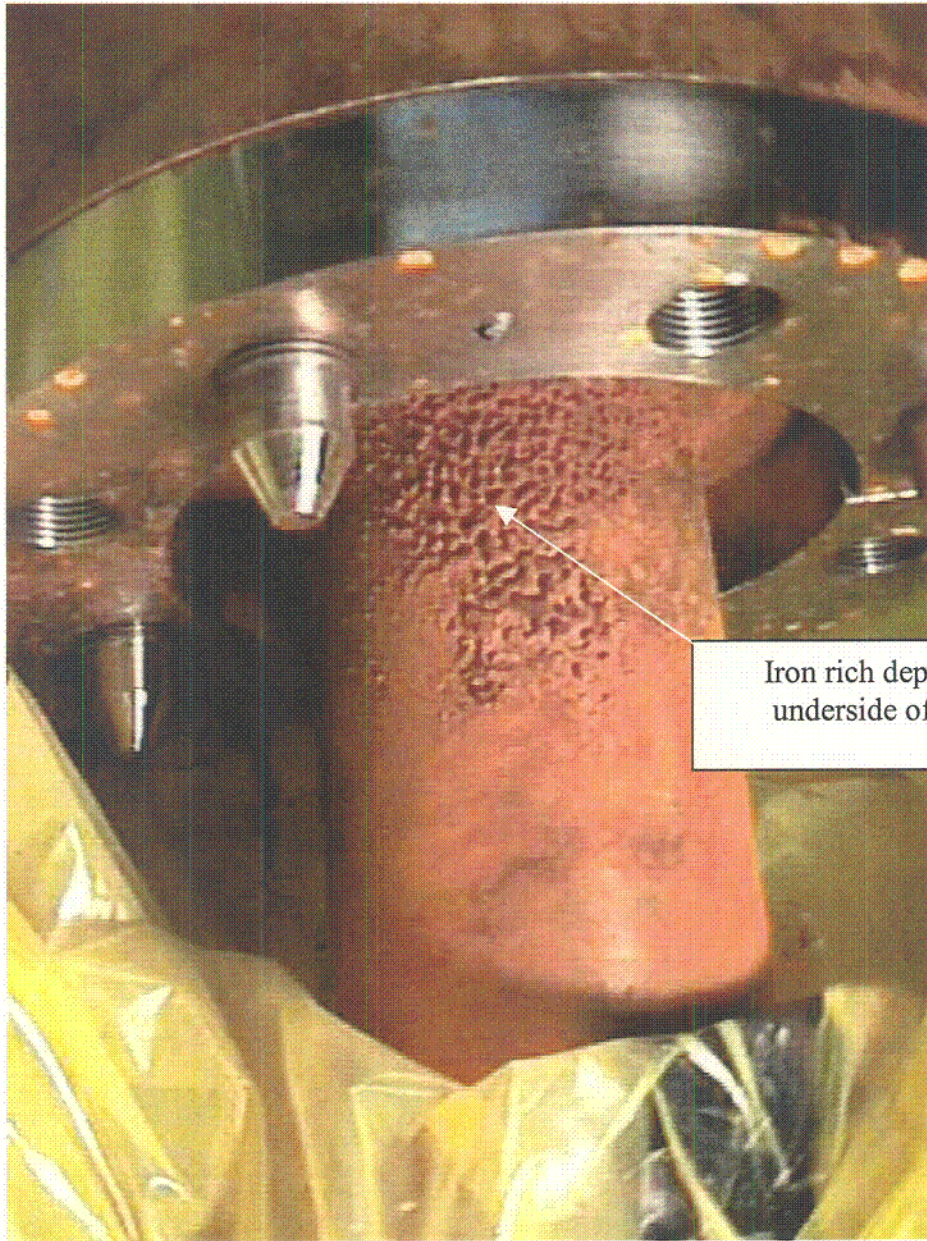
Figure 38. Boric Acid Deposits with Heavy Iron Concentration on Underside of Nozzle 3 (13RFO)

Iron rich deposits on
underside of flange
