Calvert Cliffs
Nuclear Power Plant

SUBJECT: Calvert Cliffs Nuclear Power Plant
Unit Nos. 1 & 2; Docket Nos. 50-317 & 50-318;
License Nos. DPR 53 & DPR 69
Licensee Event Report 2002-02
Potential High Pressure Safety Injection Pump Run-out Failure

LICENSEE EVENT REPORT (LER)

Potential High Pressure Safety Injection Pump Run-out Failure

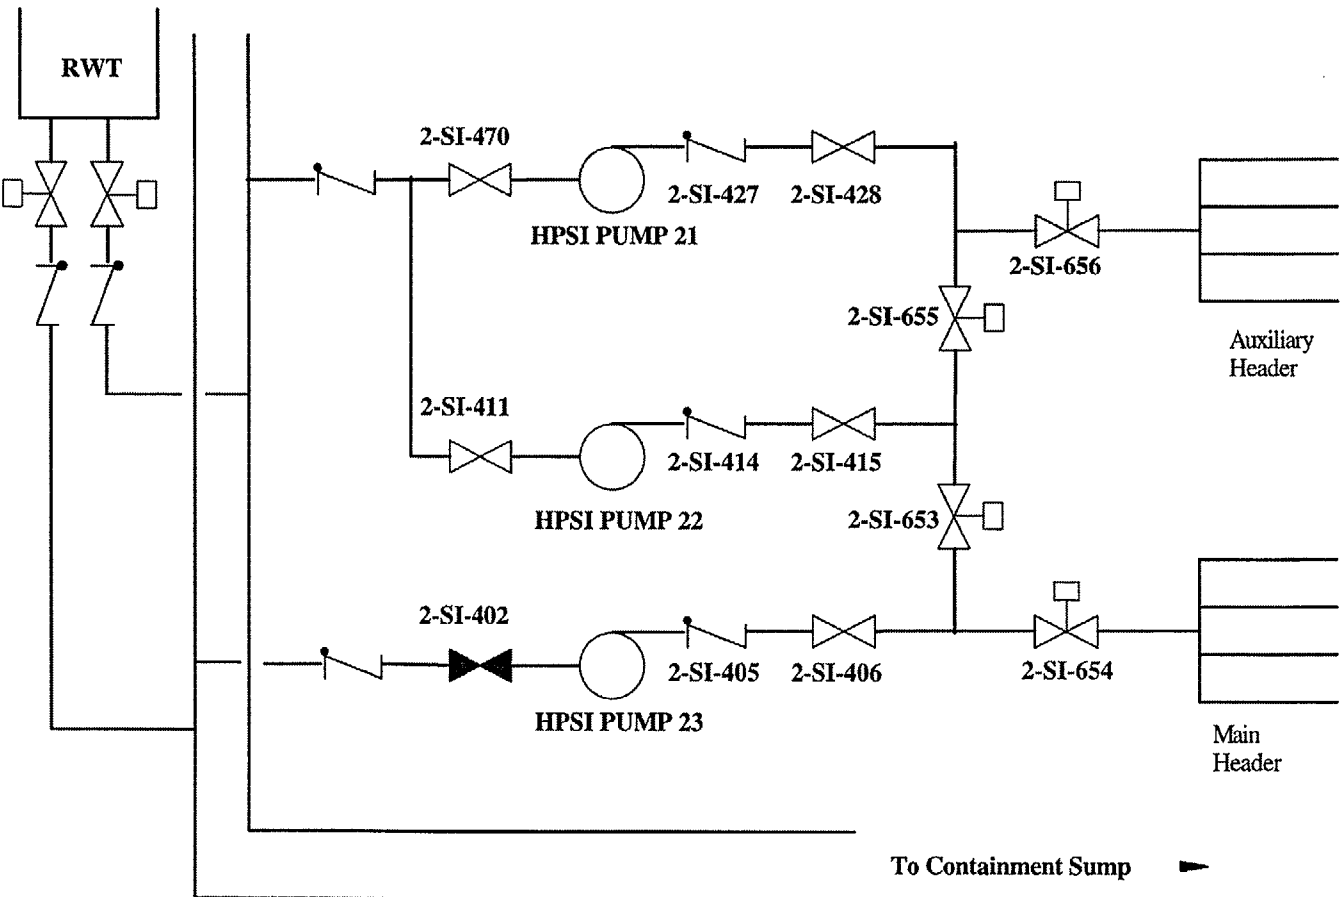
Figure 1
HPSI Pump Alignment for Test

During a review of changes made to Surveillance Test Procedures, STP O-65-1 and 2, HPSI and LPSI Pump Check Valve Closure Test, a question was raised regarding the required HPSI system alignment to perform back flow testing of the discharge check valve for 23 HPSI. When 23 HPSI pump discharge check valve, 2-SI-405, Reverse Flow Test, is performed the following test alignment is required (Figure 1):

1. Technical Specification 3.5.2 Action A, for one HPSI train inoperable is entered.
2. 22 and 23 HPSI pump handswitch are placed in pull-to-lock.
3. 23 HPSI pump suction stop, 2-SI-402 is shut.
4. 2-SI-653-MOV HPSI header cross-connect valve is opened.
5. 21 HPSI pump is started.

If a large break LOCA were to occur during this testing alignment, either with or without a design basis loss-of-offsite power, all eight HPSI loop isolation motor-operated valves (MOVs) would open as designed. The 22 and 23 HPSI pumps would remain secured (handswitches in pull-to-lock) and the remaining 21 HPSI pump would feed all eight HPSI loop isolation MOVs.

If a HPSI pump is powered by a diesel generator operating at the high end of its allowed frequencies, 61.2 Hz, then the predicted HPSI flow-rate would be at its maximum. The HPSI flow-rate would increase from approximately 769 gpm, when injecting through four HPSI loop isolation MOVs, to approximately 825 gpm when injecting through all eight.

High pressure safety injection pumps have been tested at flow-rates up to 771 gpm. However, the increased flow-rate when injecting via eight HPSI loop isolation MOVs, results in a predicted flow-rate above this value. It is not known at what flow-rate run-out failure of the HPSI pump would occur.

The cause for this potential HPSI failure was a procedural deficiency that has been present since initial plant startup in the 1970's. Surveillance Test Procedures O-65-1 and 2, appear to have utilized this testing alignment on both Units since the 1970's.

Both STP's 0-65-1 and 2 have been revised to include a step to shut the HPSI header isolation valve, for the HPSI pump being tested, while a HPSI pump discharge check valve is being reverse flow tested. (1-SI-654 for testing 13 HPSI pump; 1-SI-656 for testing 11 HPSI pump; 2-SI-654 for testing 23 HPSI pump; 2-SI-656 for testing 21 HPSI pump.) These procedural changes will prevent a HPSI pump from being aligned to two HPSI headers during future performance of STP O-65-1 and 2.
