Subject: **Docket No. 50-362**
60-Day Report
Licensee Event Report No. 2002-001
San Onofre Nuclear Generating Station, Unit 3

TITLE (4) Loss of Offsite Power With Consequential RPS/ESF Actuations Due To Maintenance Error								
EVENT DATE (5)			LER NUMBER (6)			REPORT DATE (7)		
MONTH	DAY	YEAR	YEAR	SEQUENTIAL NUMBER	REVISION NUMBER	MONTH	DAY	YEAR
2	27	2002	2002	001	00	4	24	2002
			OTHER FACILITIES INVOLVED (8)					
			FACILITY NAME			DOCKET NUMBER		
			FACILITY NAME			DOCKET NUMBER		
OPERATING MODE (9)		THIS REPORT IS SUBMITTED PURSUANT TO THE REQUIREMENTS OF 10 CFR §: (Check all that apply) (11)						
1		20.2201(b)		20.2203(a)(3)(i)		50.73(a)(2)(i)(C)		50.73(a)(2)(vii)

Plant: San Onofre Nuclear Generation Station (SONGS) Unit 3
 Event Date: February 27, 2002

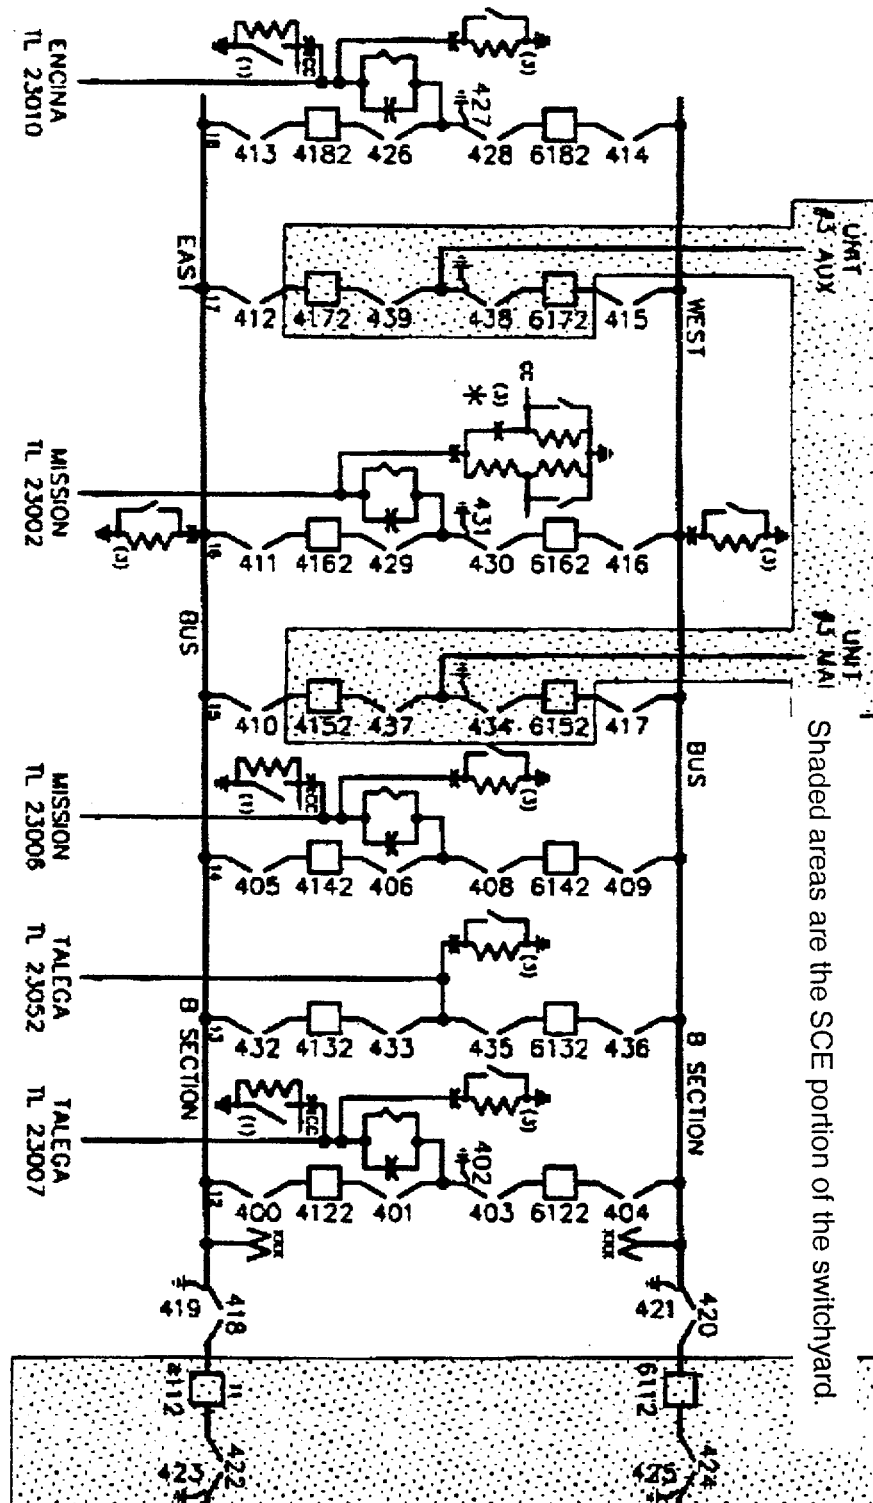
Figure 1 – SONGS Switchyard

Features of the San Onofre (SONGS) Units 2 and 3 electrical distribution system include the following (See Figure 1):

Shaded areas are the SCE portion of the switchyard.
