TENNESSEE VALLEY AUTHORITY - WATTS BAR NUCLEAR PLANT (WBN)
UNIT 1 - DOCKET NO. 50-390 - FACILITY OPERATING LICENSE NPF-90
- LICENSEE EVENT REPORT (LER) 50-390/2002-001 - LOSS OF
RESIDUAL HEAT REMOVAL (RHR) - VOLUNTARY REPORT

1. FACILITY NAME Watts Bar Nuclear Plant (WBN) Unit 1	2. DOCKET NUMBER 05000390	3. PAGE 1 OF 10
---	-------------------------------------	---------------------------

4. TITLE Loss of RHR Flow Path in Mode 6 with Reduced RCS Level

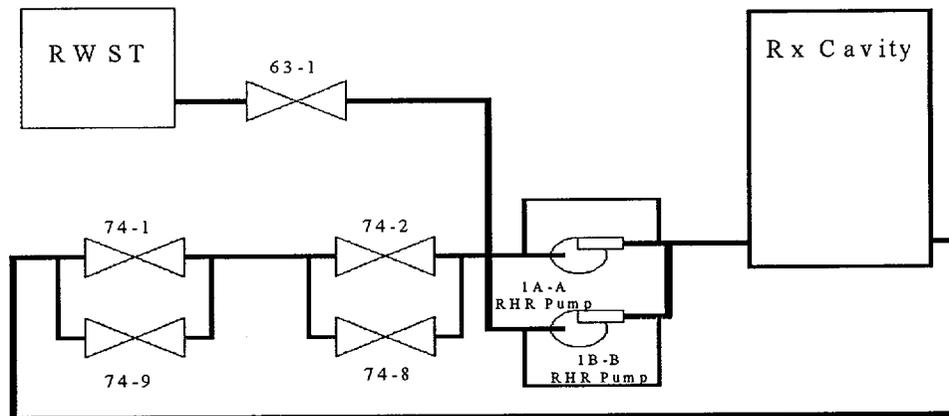
Simplified RHR Flow Path

Background: Both trains of the RHR system (EISS code BP) are supplied by a common suction line that can take suction from the Refueling Water Storage Tank (RWST) through valve 1-FCV-63-1 (EISS code BQ), or from Reactor Coolant System loop 4 hot leg via series valves 1-FCV-74-1 and 1-FCV-74-2. Valve 1-FCV-74-9 is provided as a bypass valve around 1-FCV-74-1, and 1-FCV-74-8 as a bypass around 1-FCV-74-2. Valves 74-1 and 74-2 are interlocked with 63-1 to prevent their being opened if 63-1 is open. However, 63-1 has no interlocks, and can be opened regardless of the position of 74-1 and -2. Additionally, valves 74-1 and 74-8 have a common pressure switch permissive that will prevent either from opening if RCS pressure is too high. Valves 74-2 and 74-9 share a similar common pressure switch permissive.
