Subject: Catawba Nuclear Station, Units 1 and 2  
Docket Nos. 50-413 and 50-414  
Licensee Event Report 413/02-001

Attached is Licensee Event Report 413/02-001 titled "Both Trains of Control Room Area Chilled Water System Were Inoperable Simultaneously as a Result of Inadequate Troubleshooting Follow-Up."

**4. TITLE**  
Both Trains of Control Room Area Chilled Water System Were Inoperable Simultaneously as a Result of Inadequate Troubleshooting Follow-Up

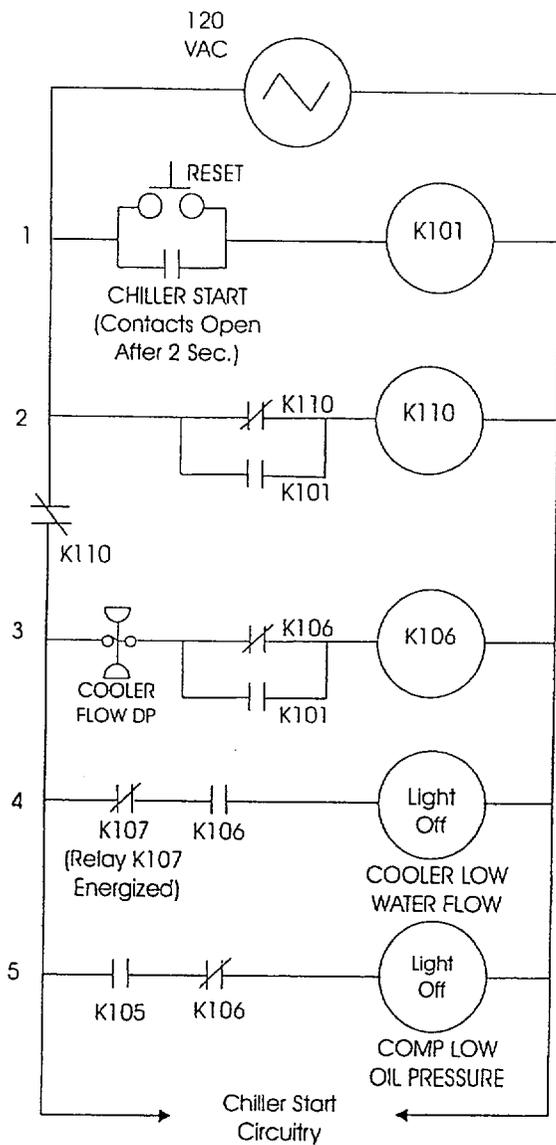
Figure 1a  
CRACWS Chiller Control Circuitry  
(Chiller Running/Normal Operation)

There are two relays [EIIS: RLY] in the control circuitry for the CRACWS chillers [EIIS: CHU] whose function is relevant to this event. They are designated as K101 and K106. The purpose of K101 is to reset certain downstream relays that could become deenergized during events involving a loss of control power to the chillers. The proper

functioning of K101 is required for chiller operability. In the event that power is lost to the chiller control panel, K101 must reenergize when a start is attempted, or the remainder of the control circuit will not receive power and the chiller will not start. One of the relays downstream of and reset by K101 is K106. The purpose of K106 is to provide indication for loss of cooler flow and compressor low oil pressure conditions. K106 affects indication only and proper functioning of this relay is not required for chiller operability. Refer to Figure 1a on Page 8 of this LER for a simplified diagram of the control circuitry for the CRACWS chillers.

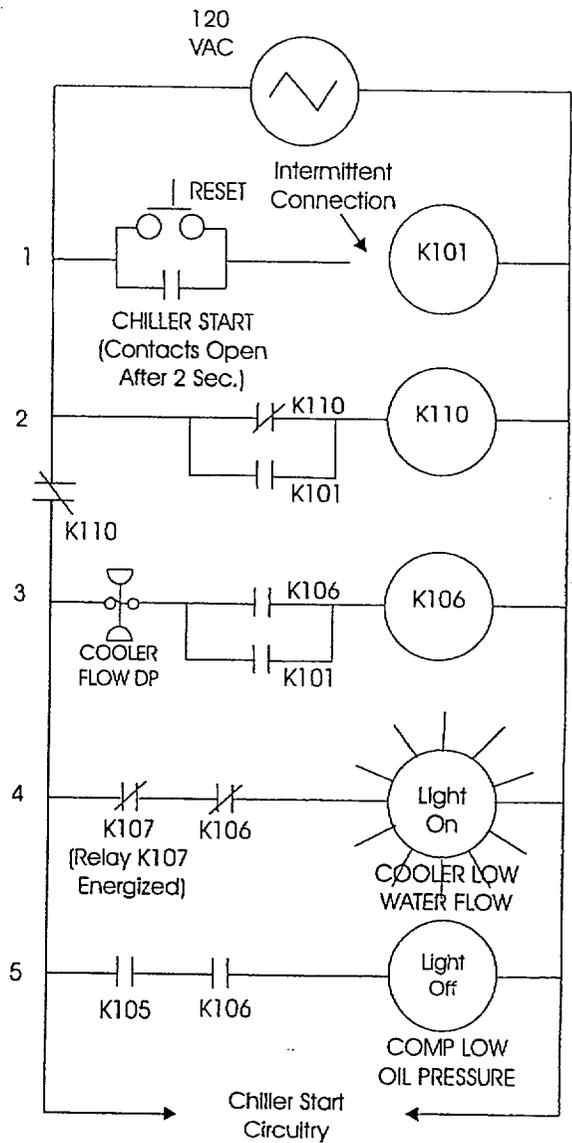
Figure 1b  
CRACWS Chiller Control Circuitry  
(Chiller Running/As-Found 2/21/02)

The root cause of this event was determined to be inadequate troubleshooting follow-up of the anomalous indication concerning the CRACWS Train A chiller prior to taking the CRACWS Train B chiller out of service for preventive maintenance. Had the suspected problem with relay K106 been validated, it would have become apparent that the problem was not with K106, but with K101 instead. K101 had relay leads which had become loose over time and had disconnected. The reason for the relay leads becoming loose could not be determined. No work activities were traced to this relay which could have resulted in the leads becoming loose. When the leads became disconnected, the ability of the chiller to be restarted automatically or manually in response to a loss of power event was lost, thus rendering the chiller inoperable.

During troubleshooting activities associated with the CRACWS Train A chiller on February 21, the problem with the leads was not discovered due to inadequate follow-up and validation/verification of the suspected problem. It is believed that the leads were making intermittent contact for a period of time prior to becoming disconnected. When relay K106 was discovered to be deenergized on February 21, the problem was believed to be limited to K106. If the problem were limited to K106, the design function of the chiller to restart following a loss of power event would not have been lost. As a result, the decision was made to take the CRACWS Train B chiller out of service on February 24 for preventive maintenance activities. Therefore, from February 24 at 1735 hours until February 27 at 2255 hours, both units were unknowingly in TS 3.0.3 and in violation of TS 3.7.11.

1. Following the discovery of the disconnected wiring for relay K101 of CRACWS Train A chiller, other wiring associated with the chiller controls for both chillers was examined and checked for tightness.
