**Operating Experience Assessment
Energetic Faults in 4.16 kV to 13.8 kV Switchgear and Bus Ducts That
Caused Fires in Nuclear Power Plants 1986–2001**

February 2002

**Prepared by:
William S. Raughley
George F. Lanik**

U.S. Nuclear Regulatory Commission

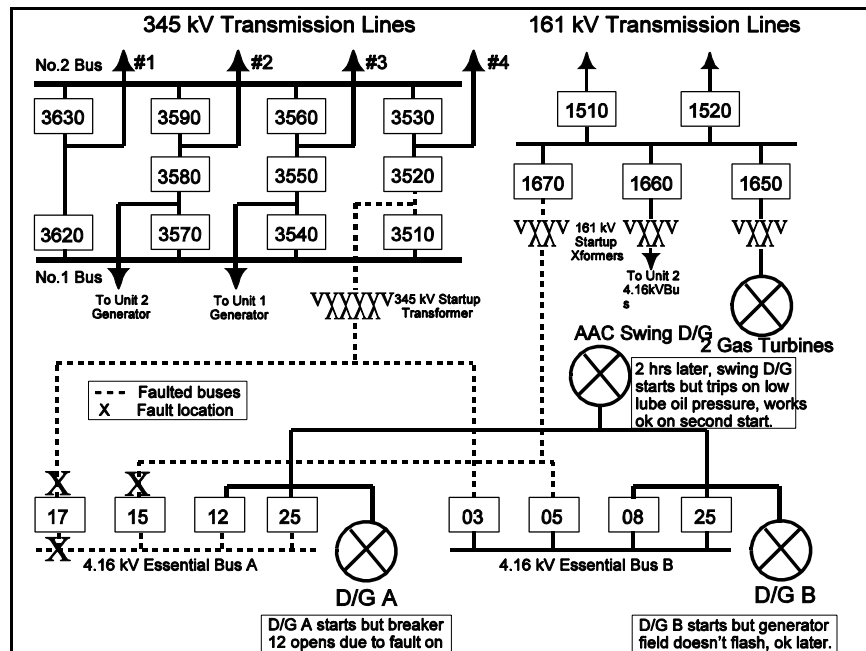
Figure 2 - Maanshan Simplified Electrical Switchgear Diagram

Taiwan Power indicated that breaker 17 may have been momentarily closed while breaker 15 was closed. The arcing, smoke, ionized gases, and fire released by the energetic electrical fault inside breaker compartment 17 propagated and caused collateral damage to other switchgear compartments, including a fault on

essential bus A, and a fault on the input side of feeder breaker 15, which was separated from breaker 17 by one cubicle. Breakers upstream of both 345 kV and 161 kV STs opened to isolate the faults. The fault locations on breakers 17 and 15 are marked by "X." This resulted in a LOOP to both the safety and non safety electrical buses. Maanshan Unit 2 has separate STs and was unaffected by the problems on Unit 1.

The damage to essential bus A was extensive. Maanshan reported ground faults on the power side of the 4.16 kV bus and circuit breakers 17 and 15. Photographs and drawings were shown

at a meeting with Taiwan Power that indicated that breaker 17 and 15 were separated by one switchgear cubicle. Five cubicles adjacent to breaker 17 were damaged; two cubicles were damaged in one direction and three in the other direction.

Maanshan believed the root cause to be insulation failure in breaker 17. Although not certain, Maanshan identified several possible causes of the insulation failure: overvoltage due to switching or ferromagnetic resonance, overvoltage from residual rotational momentum of RCPs, or faulty protective relay coordination. To date, the information reviewed indicates that there was no protective relaying (bus differential relays) that would quickly detect some of the faults and lockout the circuit breakers. A University of Texas consultant working for Taiwan Power noted that extensive damage, including vaporizing of metal indicated a very high electrical current. His review of the Maanshan station logs found that frequent negative phase sequence current alarms (from frequent unbalanced transmission line voltages since 1985) may have resulted in premature aging of the switchgear insulation. Taiwan Power recently concluded that ferromagnetic resonance was the cause of the event. Taiwan Power also concluded there was insufficient electrical separation between safety bus A and B, and subsequently added an interlock between bus A and B. Taiwan Power also added emergency startup of the EDGs to its regular test schedule.

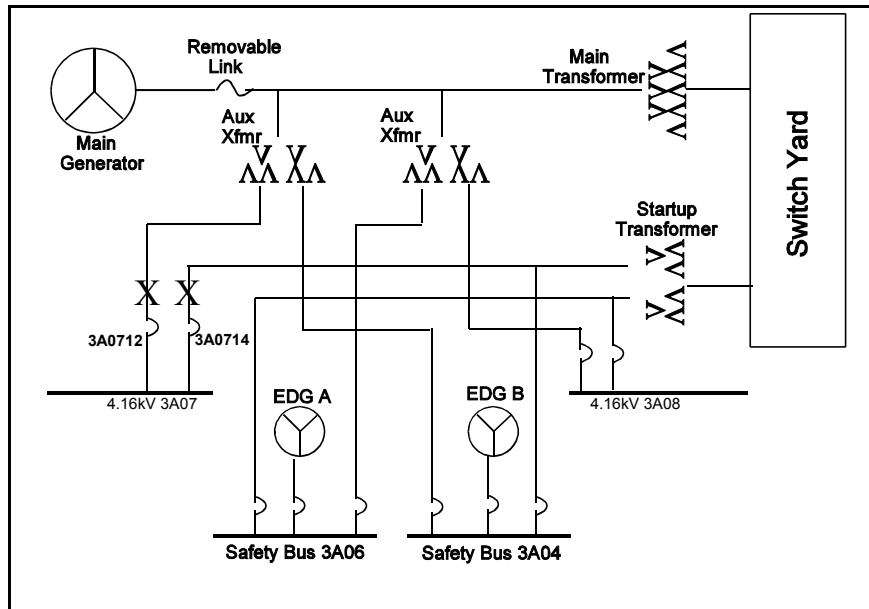
Figure 3 - San Onofre 3 Electrical Single Line Diagram

Refer to Figure 3, "San Onofre 3 Electrical Single Line Diagram." At 1513 the operator closed 4.16 kV AT supply circuit breaker 3A0712 onto bus 3A07, and the ST supply circuit breaker 3A0714 that was feeding bus 3A07 opened as designed. Just after this transfer, the AT protective relays detected a fault and tripped the main generator, the generator output circuit breakers in the switchyard, and AT supply circuit breaker 3A0712. Even though AT supply circuit breaker 3A0712 tripped, the fault was not isolated, and the main generator continued to supply energy to the fault. The fault was energetic and resulted in the burning and failure of the AT current limiting grounding resistor and started the fire in circuit breaker 3A0712. The faults are shown in Figure 3 as "X's." In addition, arcing, fire, smoke, and ionized gases diffused from the switchgear compartment housing circuit breaker 3A0712 through the passageways between adjacent cubicles and caused a ground fault on the ST side of circuit breaker 3A0714, which was separated from circuit breaker 3A0712 by one cubicle. The ST protective relays sensed a

fault and tripped the 230 kV switchyard circuit breaker that feeds the ST and the Unit 3 STs. This resulted in a loss of power to the Unit 3 safety and non safety buses, the automatic transfer of the Unit 3 safety buses 3A04 and 3A06 to Unit 2, and the automatic start of the Unit 3 EDGs. The Unit 3 reactor tripped after the RCP speed decreased as bus voltage decayed following the slow transfer of the RCP buses to Unit 2.

Station firefighters arrived at the scene at 1522 and reported the fire out 18 minutes later. At 1720, the station firefighters opened the door to circuit breaker cubicle 3A012 and observed flames. The fire was permanently extinguished with water 147 minutes into the event after attempts to extinguish the fire with dry chemicals failed. The delay in using water was caused by the reluctance of the shift manager to grant permission to use water on the electrical fire. After the event the licensee observed that dry chemicals temporarily removed air from the fire but did not reduce the heat, and reflash occurred once the air was reintroduced.

The damage was so extensive that the exact cause of the fault could not be determined. The licensee found the circuit breaker 3A012 phase C arcing contact completely melted and concluded that circuit breaker 3A012 phase C failed to open completely during the bus transfer. The licensee also indicated that arcing, fire, smoke, and ionized gases in circuit breaker 3A0712 caused multiple faults on bus 3A07, and collateral damage to 4 other switchgear compartments and the offsite power circuit connection at circuit breaker 3A0714. However, the condition of other equipment also contributed to the failures during the event. For example, the dc turbine lube oil pump did not start because its circuit breaker tripped prematurely; the as found trip point was 510 amps which is below the motor starting current of 650 amps. The trip device was damaged and would not respond to adjustments. In addition, the annunciator was lost due to the lack of circuit breaker coordination in the dc system.

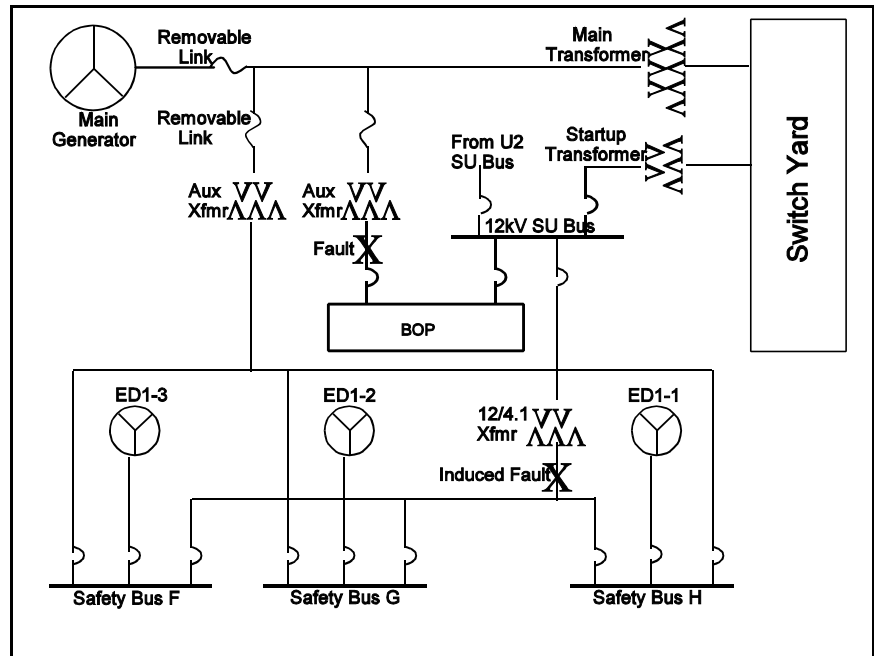
Figure 4 - Diablo Canyon 1 Electrical Single Line Diagram

On May 15, 2000, Diablo Canyon Unit 1 was at 100 percent power with the station loads powered from the AT. At 0025, a fault occurred on the 12 kV bus duct between the AT and two 12 kV buses. Protective relays immediately sensed the fault and opened the switchyard circuit breakers, the generator field breaker, and the 12 kV AT supply circuit breaker. Since there are no circuit breakers between the main generator and the AT, the main generator continued to feed the fault for 4–8 seconds until the

main generator field collapsed. The sustained fault resulted in arcing in the 12 kV bus duct that jumped to and damaged the 4.16 kV bus duct from ST 1-2. The 4.16 kV bus duct was approximately 4 inches above the 12 kV duct. ST 1-2 tripped, causing the loss of 4.16 kV to the three vital buses, and the start and loading of all three EDGs. ST 1-1 remained energized, supplying power to some 12 kV and 4.16 kV non-vital loads. Figure 4, "Diablo Canyon 1 Electrical Single Line Diagram," shows the 12 kV fault and 4kV induced fault locations.

An NRC inspection found that approximately 3 feet of the center 12 kV bus bar and 6–9 inches of the other two 12 kV bus bars had vaporized, several feet of the 12 kV bus duct had melted, and a one-square-foot hole was burned into the 4 kV bus duct. The licensee concluded that the cause of the fault was the thermal failure of the bolted connection of the center conductor of the 12 kV bus. A polyvinyl chloride boot over the connection overheated and created smoke. The smoke and the radiant heat from the center conductor provided an conducive environment for a phase to phase arc. The connection was believed to have been silvered and the nut torqued to less tight than that recommended by the manufacturer when it was replaced after a 1995 AT transformer fault and fire on the 12 kV bus, as reported in LER 275/95-014, "Diesel Generators Started and Loaded as Designed Upon Failure of Auxiliary Transformer 1-1 Due to Inadequate/Ineffective Procedures Related to the Control of Grounding Devices." The licensee

also believed the aluminum bus duct load-carrying capability was marginal and replaced some sections with higher amperage copper bus. The NRC inspectors found that the licensee included the 12 kV system under the Maintenance Rule; however, the NRC inspectors found that the licensee did not perform preventive maintenance on the bus duct. The licensee responded by saying that the vendor did not recommend any preventive maintenance.

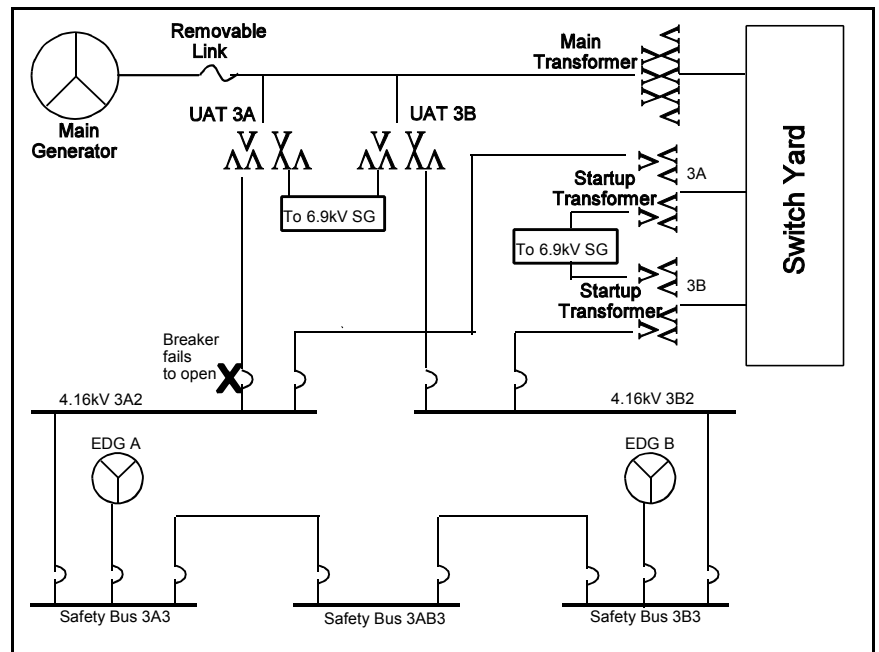
Figure 5 - Waterford 3 Electrical Single Line Diagram

On June 10, 1995, Waterford 3 was operating at 100 percent power with the plant loads fed from ATs 3A and 3B. At 0858, a remote substation transformer lightning arrester failed. This resulted in a transient that caused inadvertent operation of the Waterford main transformer sudden pressure relay, tripping the main generator and turbine and initiating a fast bus transfer of the station loads from the ATs to STs 3A and 3B. Refer to Figure 5 "Waterford 3 Electrical Single Line Diagram." The buses transferred as designed with the exception of 4.16kV non-safety bus 3A2. The AT supply circuit breaker to bus 3A2 failed to open in 5 cycles while the ST supply circuit breaker to bus 3A2 closed within 7 cycles. Since there are no circuit breakers between the AT and the main generator at Waterford 3, the electrical current from the generator continued to supply power to the grid through the AT, the 4.16 kV non-safety bus 3A2, and the ST. The excess current caused an energetic electrical fault with an explosion and fire in the 4.16 kV AT supply circuit breaker to bus 3A2. A fault recorder in the switchyard indicated that the generator supply was 180 degrees out of phase with the offsite power supply. The RCPs A and C which were fed through the ST and 6.9 kV bus slowed in response to low voltage caused by the fault and out of phase condition. The reactor tripped on low departure from nucleate boiling ratio from channels A and C. Both the AT and ST circuit breakers received overcurrent trip signals.

Since there are no circuit breakers between the AT and the main generator at Waterford 3, the electrical current from the generator continued to supply power to the grid through the AT, the 4.16 kV non-safety bus 3A2, and the ST. The excess current caused an energetic electrical fault with an explosion and fire in the 4.16 kV AT supply circuit breaker to bus 3A2. A fault recorder in the switchyard indicated that the generator supply was 180 degrees out of phase with the offsite power supply. The RCPs A and C which were fed through the ST and 6.9 kV bus slowed in response to low voltage caused by the fault and out of phase condition. The reactor tripped on low departure from nucleate boiling ratio from channels A and C. Both the AT and ST circuit breakers received overcurrent trip signals.

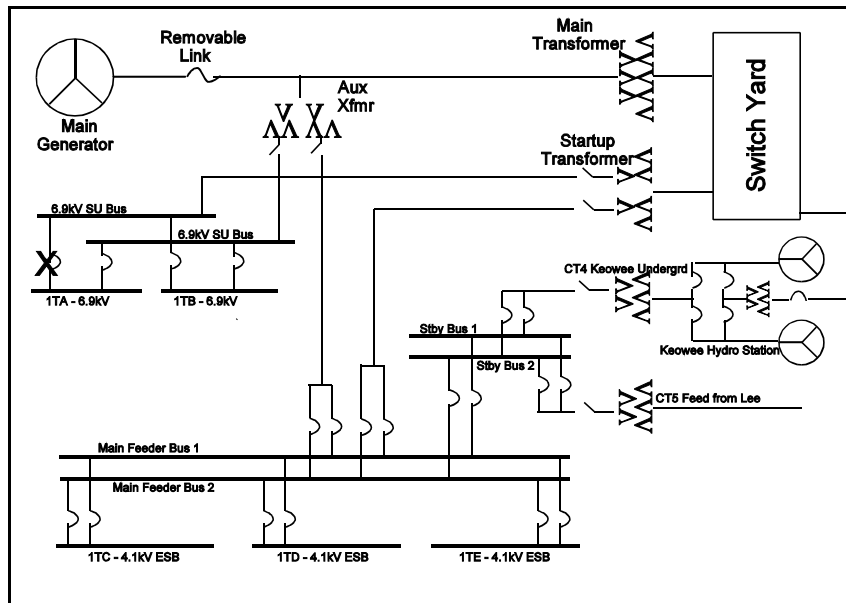
Figure 6 - Oconee 1 Electrical Single Line Diagram

At 1916 on January 3, 1989, Oconee 1 was at 26 percent power and in the process of manually transferring non-safety 6.9 kV bus 1TA from the ST to the AT. Refer to Figure 6, "Oconee 1 Electrical Single Line Diagram." Immediately after the transfer, an energetic electrical fault occurred resulting in a fire and explosion in the AT supply circuit breaker that feeds non-safety bus 1TA. The AT protective relays detected an electrical fault and tripped the turbine generator, the switchgear 1TA 6.9 kV supply circuit breaker for the AT (which failed to completely open), and the two RCPs fed from switchgear 1TA. The main generator continued to supply energy to the fault through the stuck 1TA 6.9 kV supply circuit breaker from the AT until the generator field decayed.

The fire was detected promptly. Switchgear 1TA dc control power was isolated at 1929. At 1933 and 1949, attempts to use carbon dioxide and dry chemical extinguishers failed. The reactor was manually tripped at 1956. Nearby switchgear 1TB was de-energized at 2002 in preparation for using water. The fire was extinguished with water 59 minutes after it started.

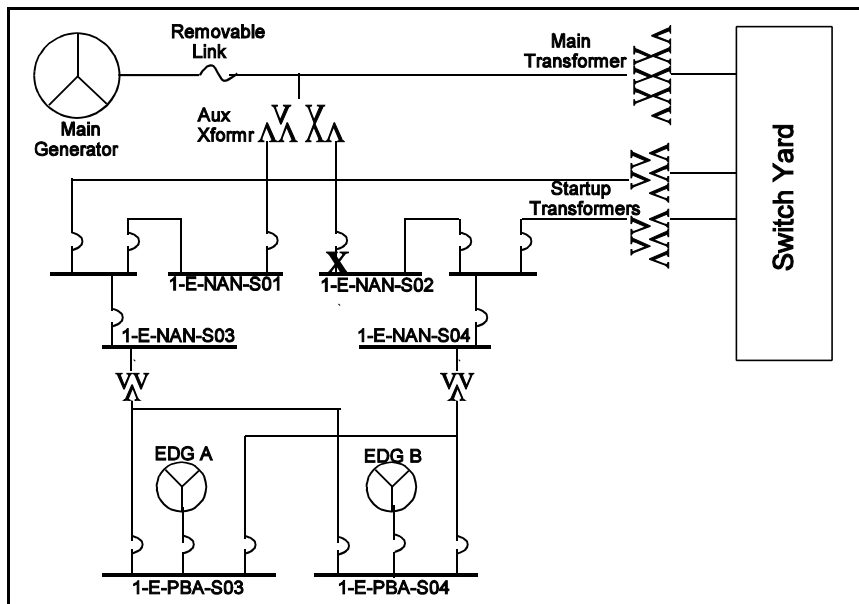
Figure 7 - Palo Verde 1 Electrical Single Line Diagram

At 1208 on July 6, 1988, Palo Verde Unit 1 was at 100 percent power with the plant's loads powered from the AT. A three-phase-to-ground fault occurred in non safety 13.8 kV bus 1E-NAN-S02. The generator continued to feed the bus fault since the 13.8 kV circuit breakers that connect the AT to the bus did not open immediately due to the design of the bus relay protection. Figure 7 "Palo Verde 1 Electrical Single Line Diagram" shows the equipment involved in the event. The bus

overcurrent protection was designed to operate and isolate the bus fault in 42 cycles for a 24000 amp fault; however, the fault was energetic enough to fail the AT electrically, rupture its tank, and start it on fire within 20 cycles. The AT sudden overpressure relay tripped the generator output circuit breakers in the switchyard, opened the 13.8 kV AT supply circuit breakers to buses 1E-NAN-S01 and 1E-NAN-S02, and blocked the automatic transfer of the 13.8 kV buses to the STs, resulting in a loss of power to the RCPs and a reactor trip.

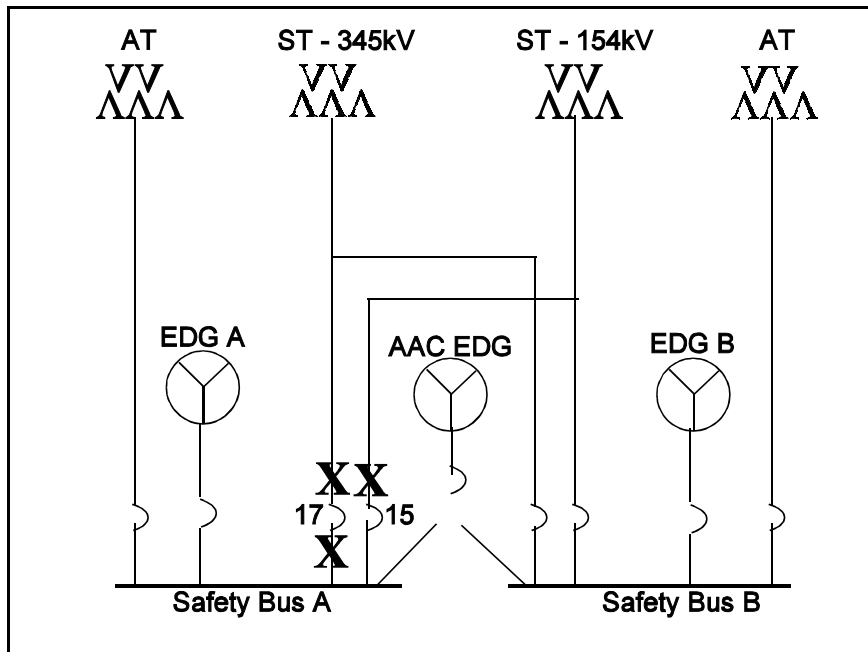
Figure 8 - Maanshan Simplified Safety Bus Diagram

At Maanshan, the offsite power circuits from both STs that feed the two safety buses are connected in parallel as shown in Figure 8, “Maanshan Simplified Safety Bus Diagram” – the electrical feed from the ST to both safety bus supply circuit breakers is common. A fault anywhere on that portion of the circuit faults the supply to both safety buses. At Maanshan, the two offsite power supply circuits are terminated in switchgear compartments 15 and 17, which are separated from each other by one other switchgear compartment. Nonetheless, the energetic electrical fault resulted in arcing and fire, generating ionized gases and smoke that diffused through bus and cable passages between five adjacent switchgear cubicles and caused multiple faults in the bus and the line side of both supply circuit breakers as indicated by the “Xs” in Figure 8. The initiating event resulted in a LOOP, the loss of one EDG, and damaged the offsite power circuit in compartments 15 and 17. In addition, the energetic electrical fault damaged the power cable feeding a load three compartments away from circuit breaker 17.

Nonetheless, the energetic electrical fault resulted in arcing and fire, generating ionized gases and smoke that diffused through bus and cable passages between five adjacent switchgear cubicles and caused multiple faults in the bus and the line side of both supply circuit breakers as indicated by the “Xs” in Figure 8. The initiating event resulted in a LOOP, the loss of one EDG, and damaged the offsite power circuit in compartments 15 and 17. In addition, the energetic electrical fault damaged the power cable feeding a load three compartments away from circuit breaker 17.
