### SUBJECT: SUMMARY OF THREE APRIL 2002 CONFERENCE CALLS WITH THE LICENSEE ON THE REACTOR PRESSURE VESSEL HEAD INSPECTION PLANS AND RESULTS AT ARKANSAS UNIT ONE, UNITS 1 AND 2 (ANO-1&2) (TAC MB4525)

## ANO-2 RV Head Inspection Summary for 2R15

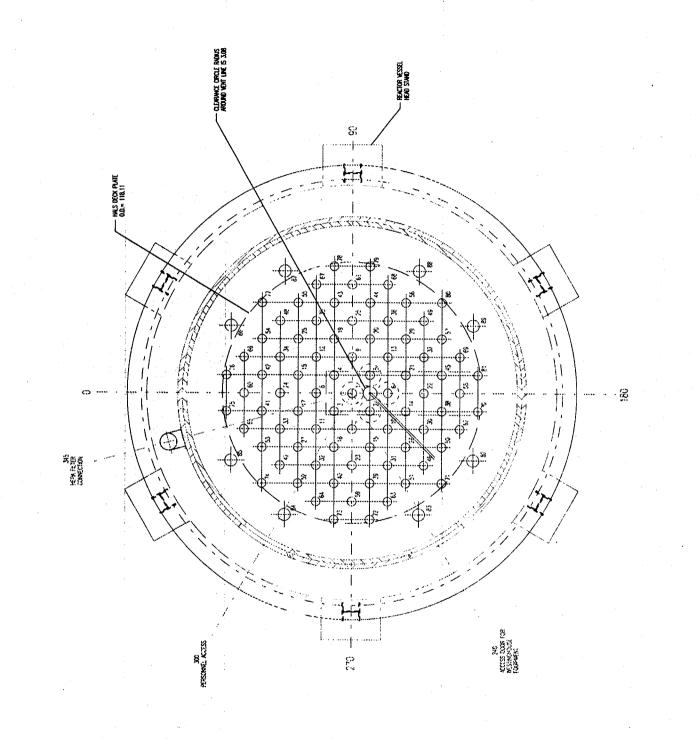
## ANO-2 PV Head Plan View

- All 90 head penetrations were confirmed to have pressure boundary integrity with no indications of PWSCC cracking and no through wall leaks that could cause head wastage.
- Additional NDE was performed on three CEDMs from under the head (see diagrams)
  - Nozzle 43 and 59 had J- weld reflections at the low side of the nozzles (~0°) that were further inspected by PT and found to have no surface indications found.
  - Nozzle 30 had indications in the nozzle just above the threading for the CEDM guide cone. An ECT was performed on the OD of the nozzle with no surface indications found.
- No signs of leakage were detected above the head on the insulation. Only very minor occasional boric acid staining observed (likely from historical venting).
