From: "BENNETT, STEVE A" <SBENNE2@entergy.com>
To: "Tom Alexion" <twalex@nrc.gov>, "Linda Smith" <ljs@nrc.gov>, "BYWATER, RUSSELL" <RBYWA90@entergy.com>, "HAMILTON, JOHN R" <JHAMIL2@entergy.com>, "LEWIS, RAYMOND S" <RLEWIS1@entergy.com>, "MILLER, D BRYAN" <dmill14@entergy.com>, "KRUPA, MICHAEL A" <MKRUPA@entergy.com>
Date: 4/25/02 12:50PM
Subject: Information for NRC Call on ANO-2 Head Inspection

ANO-2 RV Head Inspection Summary for 2R15

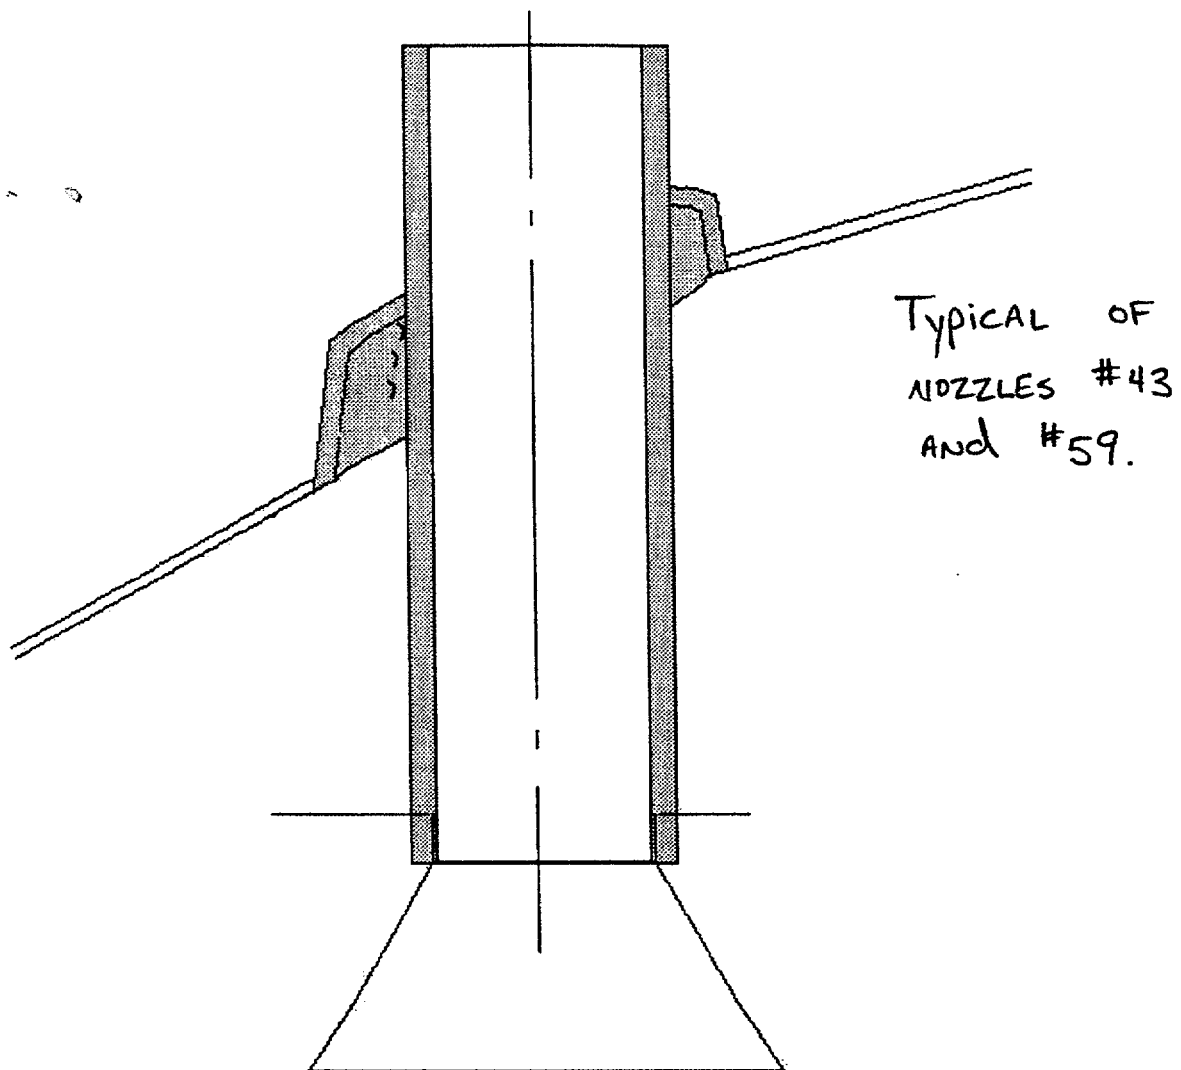
Elevation View of UT Reflectors on ANO-2 Nozzles 43 and 59

- All 90 head penetrations were confirmed to have pressure boundary integrity with no indications of PWSCC cracking and no through wall leaks that could cause head wastage.
- Additional NDE was performed on three CEDMs from under the head (see diagrams)
 - Nozzle 43 and 59 had J- weld reflections at the low side of the nozzles (~0°) that were further inspected by PT and found to have no surface indications found.
 - Nozzle 30 had indications in the nozzle just above the threading for the CEDM guide cone. An ECT was performed on the OD of the nozzle with no surface indications found.
- No signs of leakage were detected above the head on the insulation. Only very minor occasional boric acid staining observed (likely from historical venting).
