# St. Lucie Unit 2

## NRC Update SL2-13 November 2001 Steam Generator Inspection Plans

STEAM GENERATOR TUBE INSPECTION DISCUSSION POINTS  
 PREPARED BY THE OFFICE OF NUCLEAR REACTOR REGULATION  
 FLORIDA POWER AND LIGHT COMPANY  
 ST. LUCIE PLANT, UNIT 2  
 DOCKET NO. 50-389

FPL has participated in three phone conferences with NRC to discuss on-going inspection results for St. Lucie 2 steam generators. During our 1<sup>st</sup> phone call on Thursday, portions of the inspection program were only 65% complete. In our discussions on Friday the inspection was about 90% complete, but there were several hundred outstanding diagnostic Plus Point inspections that were required to finalize tube repair listing. Over the weekend, the inspection was essentially completed and most diagnostic tests were completed which increased the total tubes to be plugged. NRC identified several issues and requested further explanation in our phone call scheduled for today. The following discussion and attachments provide our response to these issues. For reference, the information provided to NRC for our discussion yesterday is provided as Attachment 3.

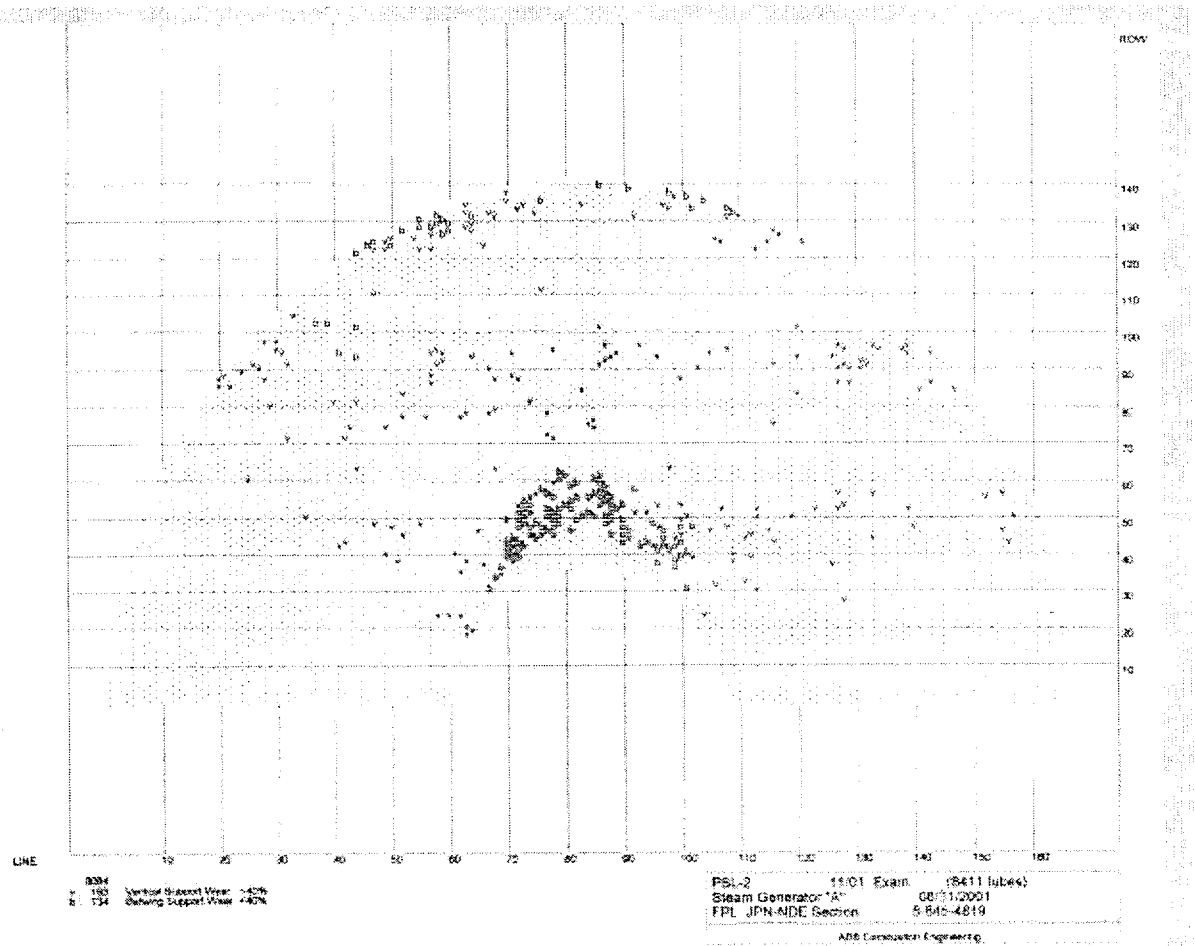
Wear at Diagonal Supports occurs near center stay cylinder.

Wear at Vertical Supports occurs randomly.

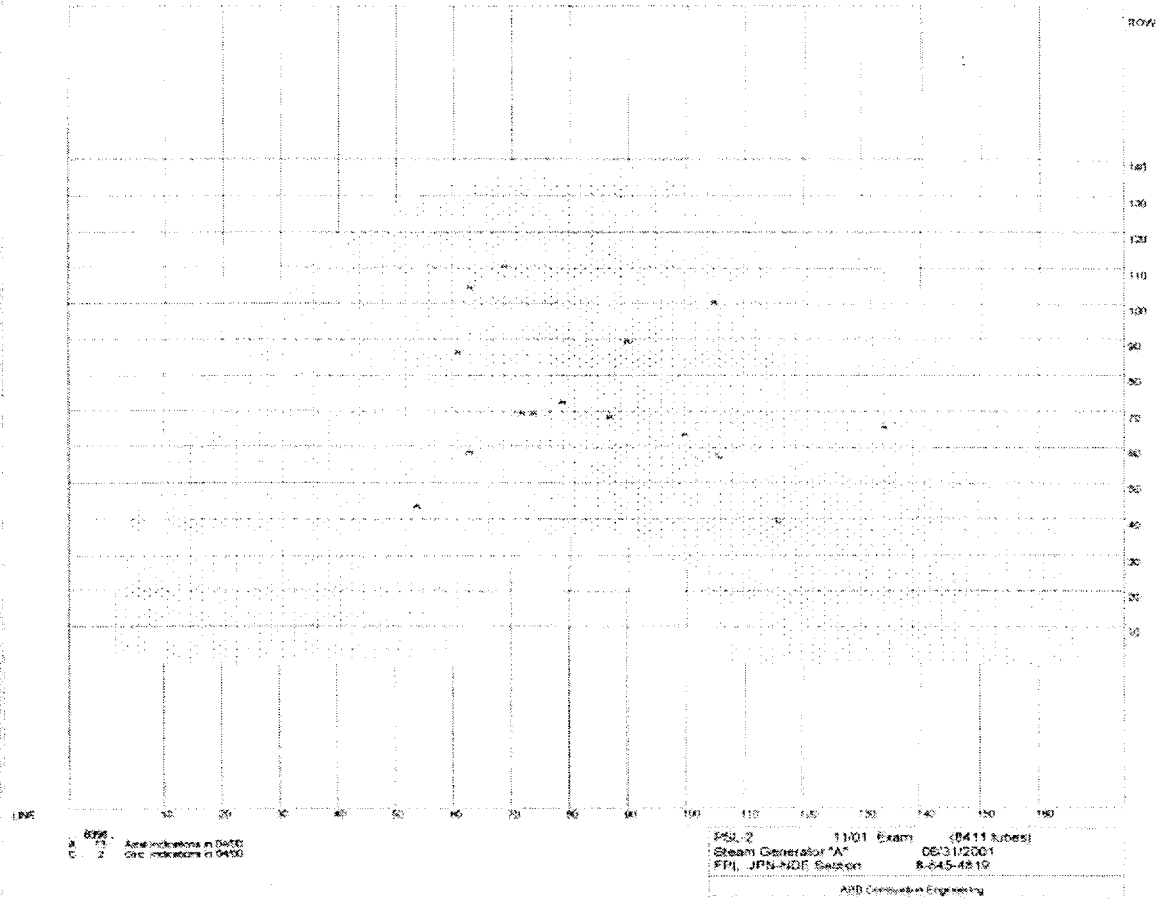
Axial Indications occur at the top of tubesheet and eggcrate supports.

Circumferential Indications occur at the tube Expansion Transition.

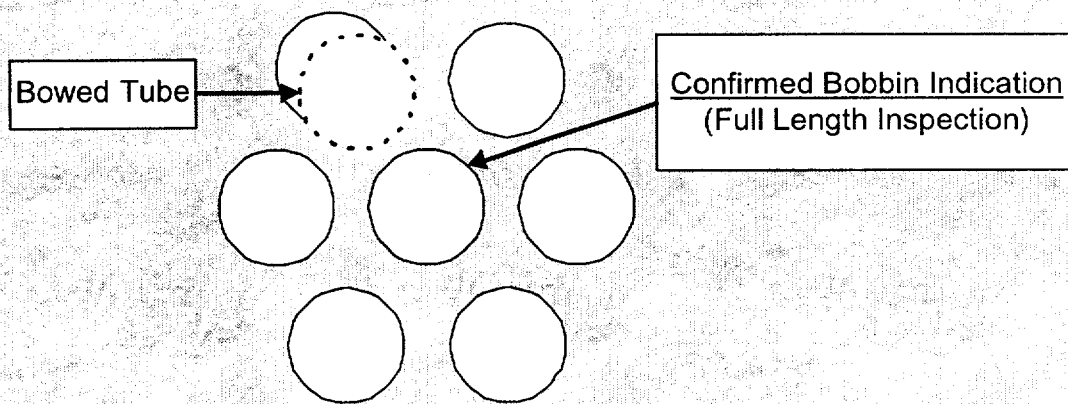
If Cracking is Confirmed:

Inspect Remainder Of Tube On Side With Crack

Inspect 6 Neighbor Tubes At Same Span with Confirmed Cracks

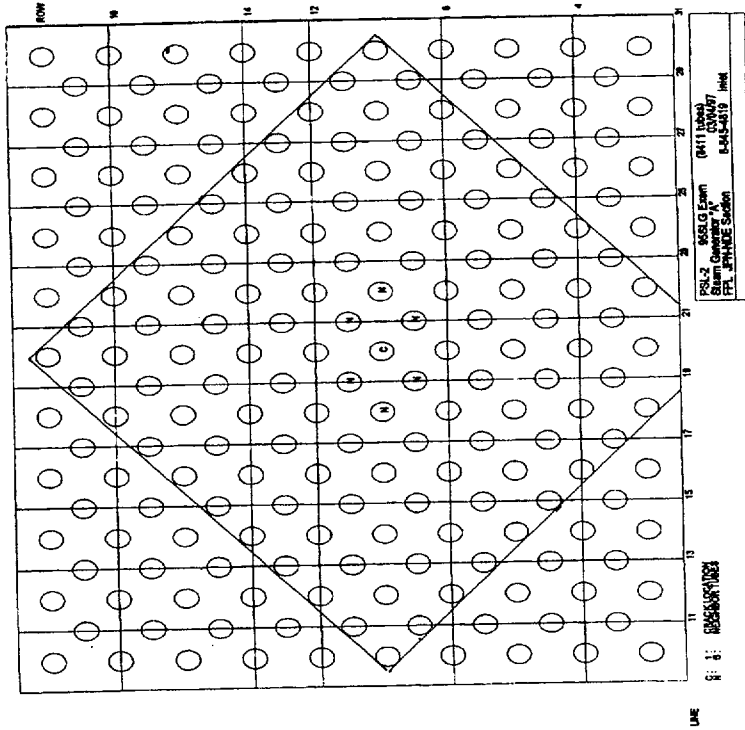
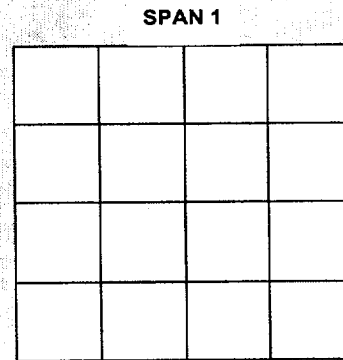
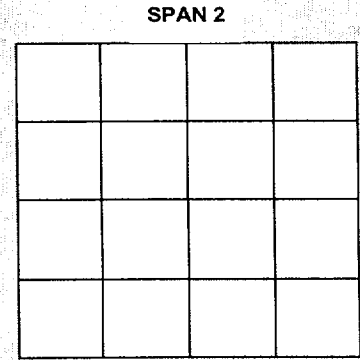
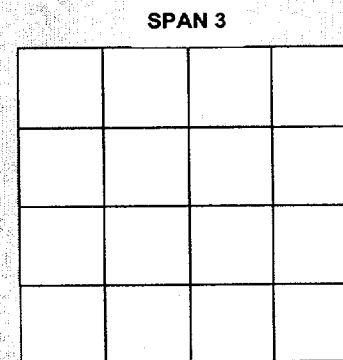
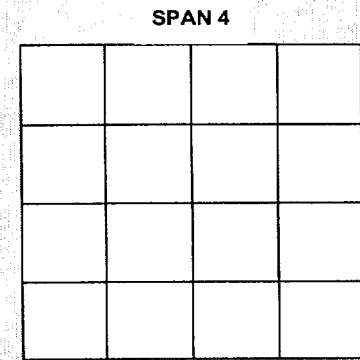
**LHS Example:** Generate 11 X 11 Tube Box Around Tubes w/Crack  
Sample Affected Region to Cover All Possibilities

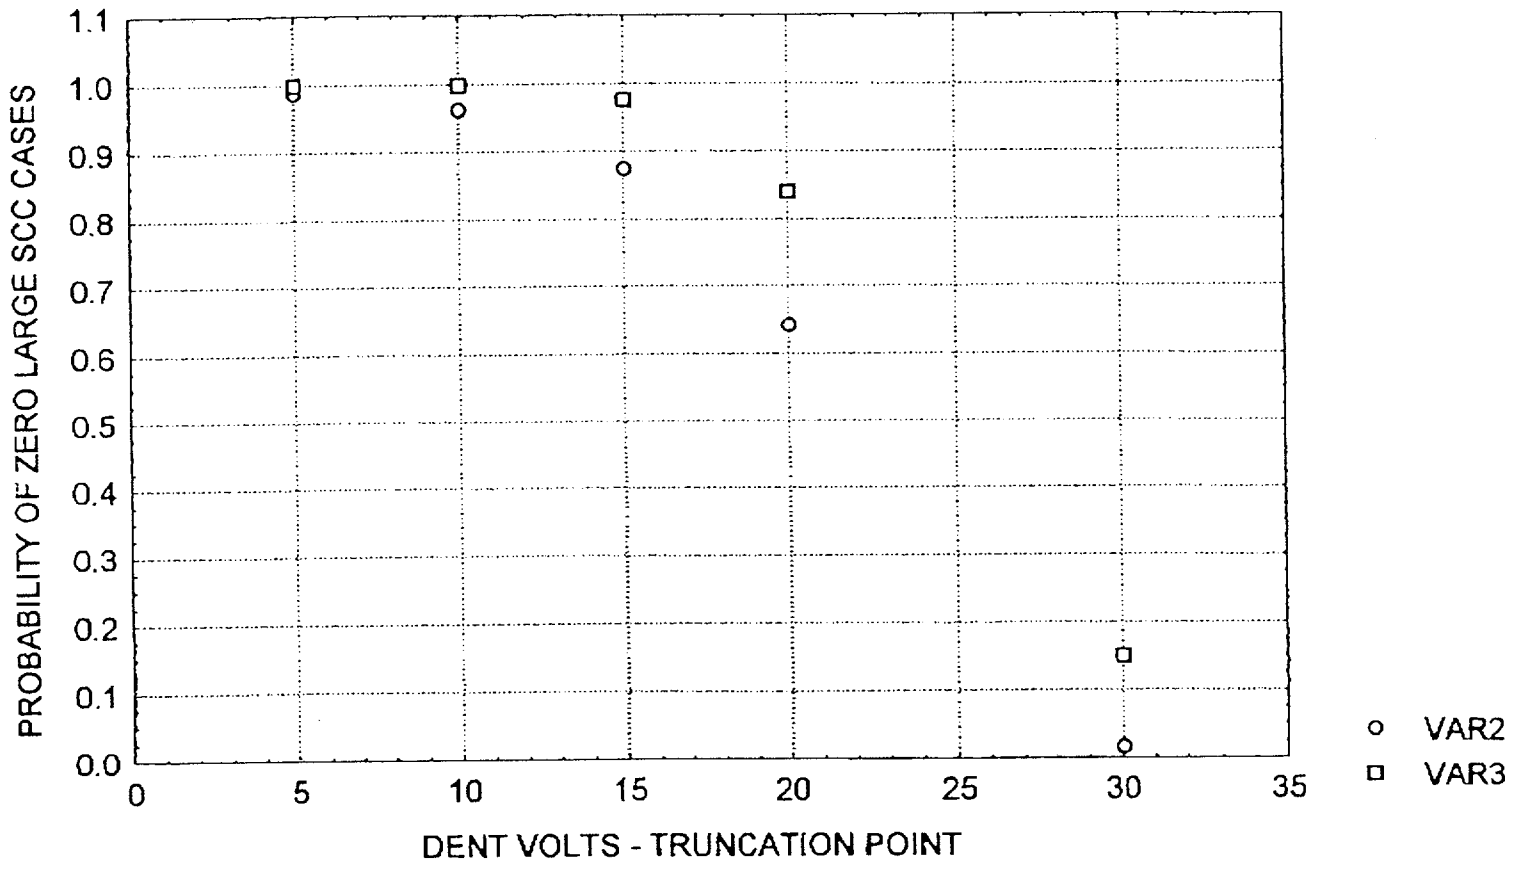
TUBESHEET RISK VS REPAIR LIMIT  
[HOT LEG TUBESHEET]

- BASED ON SG-A DATA [4 SCC INDICATIONS]
- HIGHEST RISK
- LOGISTIC REGRESSION MODEL
  - CONDITIONAL PROBABILITY OF SCC GIVEN DENT VOLTAGE
  - APPLIED TO INDIVIDUAL TUBES
  - COMBINED OVER VOLTAGE SPECTRUM
- RISK VS REPAIR LIMIT FOR TUBESHEET AREA
