WOLF CREEK

CT 02-0029

Subject: Docket No. 50-482: 30-Day Response for NRC Bulletin 2002-01,
"Reactor Pressure Vessel Head Degradation and Reactor Coolant
Pressure Boundary Integrity"

**30-Day Response to NRC Bulletin 2002-01
Reactor Pressure Vessel Head Degradation and
Reactor Coolant Pressure Boundary Integrity**

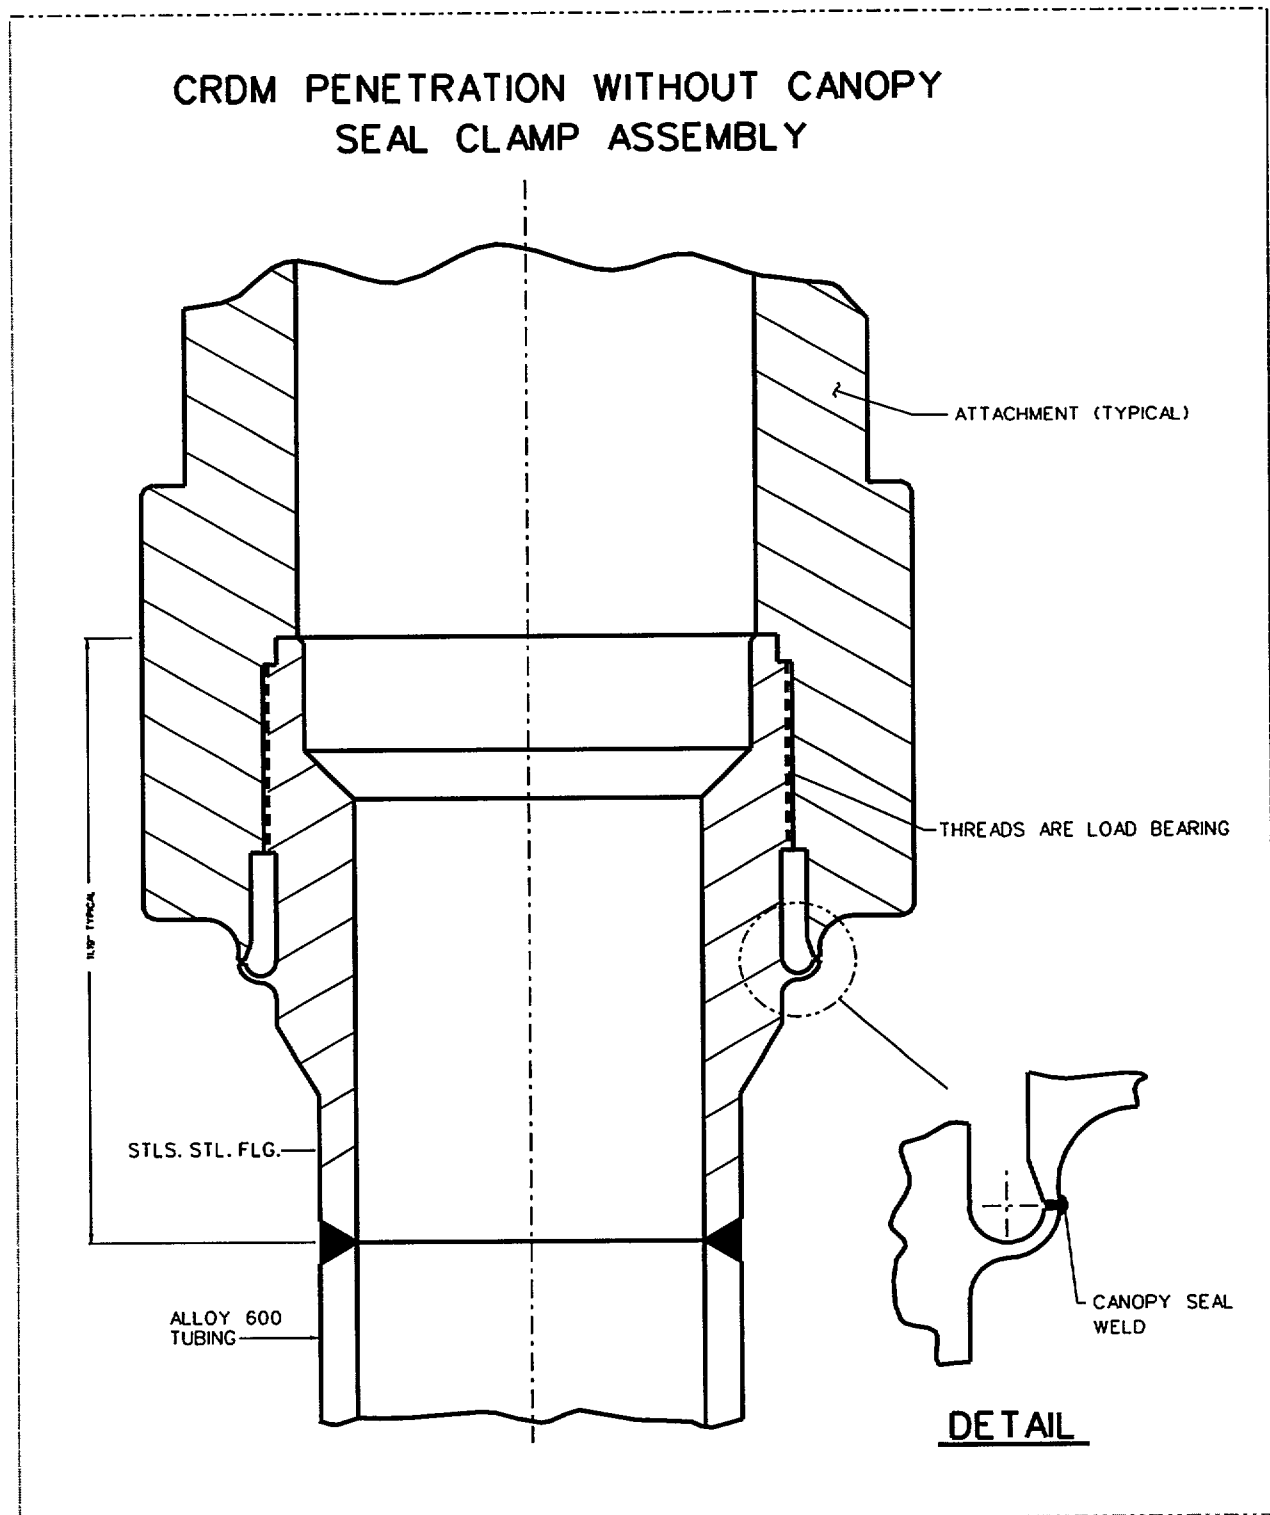
The reactor vessel head penetration assemblies at Wolf Creek Generating Station (WCGS) consist of two-piece construction -- an inconel tube section welded to a stainless steel (Type 304) flange, referred to as the head adapter flange. The inconel tube section is inserted into the penetration opening of the reactor vessel head and held in place by a partial penetration weld. Every head adapter flange attached to the inconel tube is designed and fabricated the same. Each is fabricated with a canopy lip and a threaded end for installation of attachments. There are a number of different attachments that can be installed on the head adapter flange. These attachments include control rod drive mechanisms (CRDMs), head adapter plugs, and core exit thermocouple (CET) attachments. Figure 1 shows the upper end of a typical WCGS reactor vessel head penetration.

During fabrication, the top attachment (the CRDM, head adapter plug, or CET attachment) is threaded into the head adapter flange. A gas tungsten arc weld process is used to form a seal weld. This seal weld is referred to as the lower canopy seal weld at WCGS. Figure 1 shows the configuration details for a typical lower canopy seal weld.

The canopy seal welds are thin welds of about 0.070" thickness that serve to seal the threaded pressure boundary connection. The canopy seal weld configuration forms a "dead end" in which impurities in water that works its way past the threads can accumulate (Figure 1). It is suspected that the water used during cold hydrostatic testing and hot functional testing remains in the canopy seal area for the life of the joint (unless a leak develops). Additionally, each time the head is removed from the vessel and reinstalled, and the vessel is repressurized, the trapped water in the seal area is oxygenated. This environment establishes conditions that appear to increase the probability of stress corrosion cracking. Annealed stainless steels are known to be susceptible to transgranular stress corrosion cracking (TGSCC) in this type of high temperature, stagnant chloride/oxygen environment.

Figure 1. Typical Reactor Pressure Vessel Head Penetration Construction Illustrating Flange, Tube, and Attachment Relationship

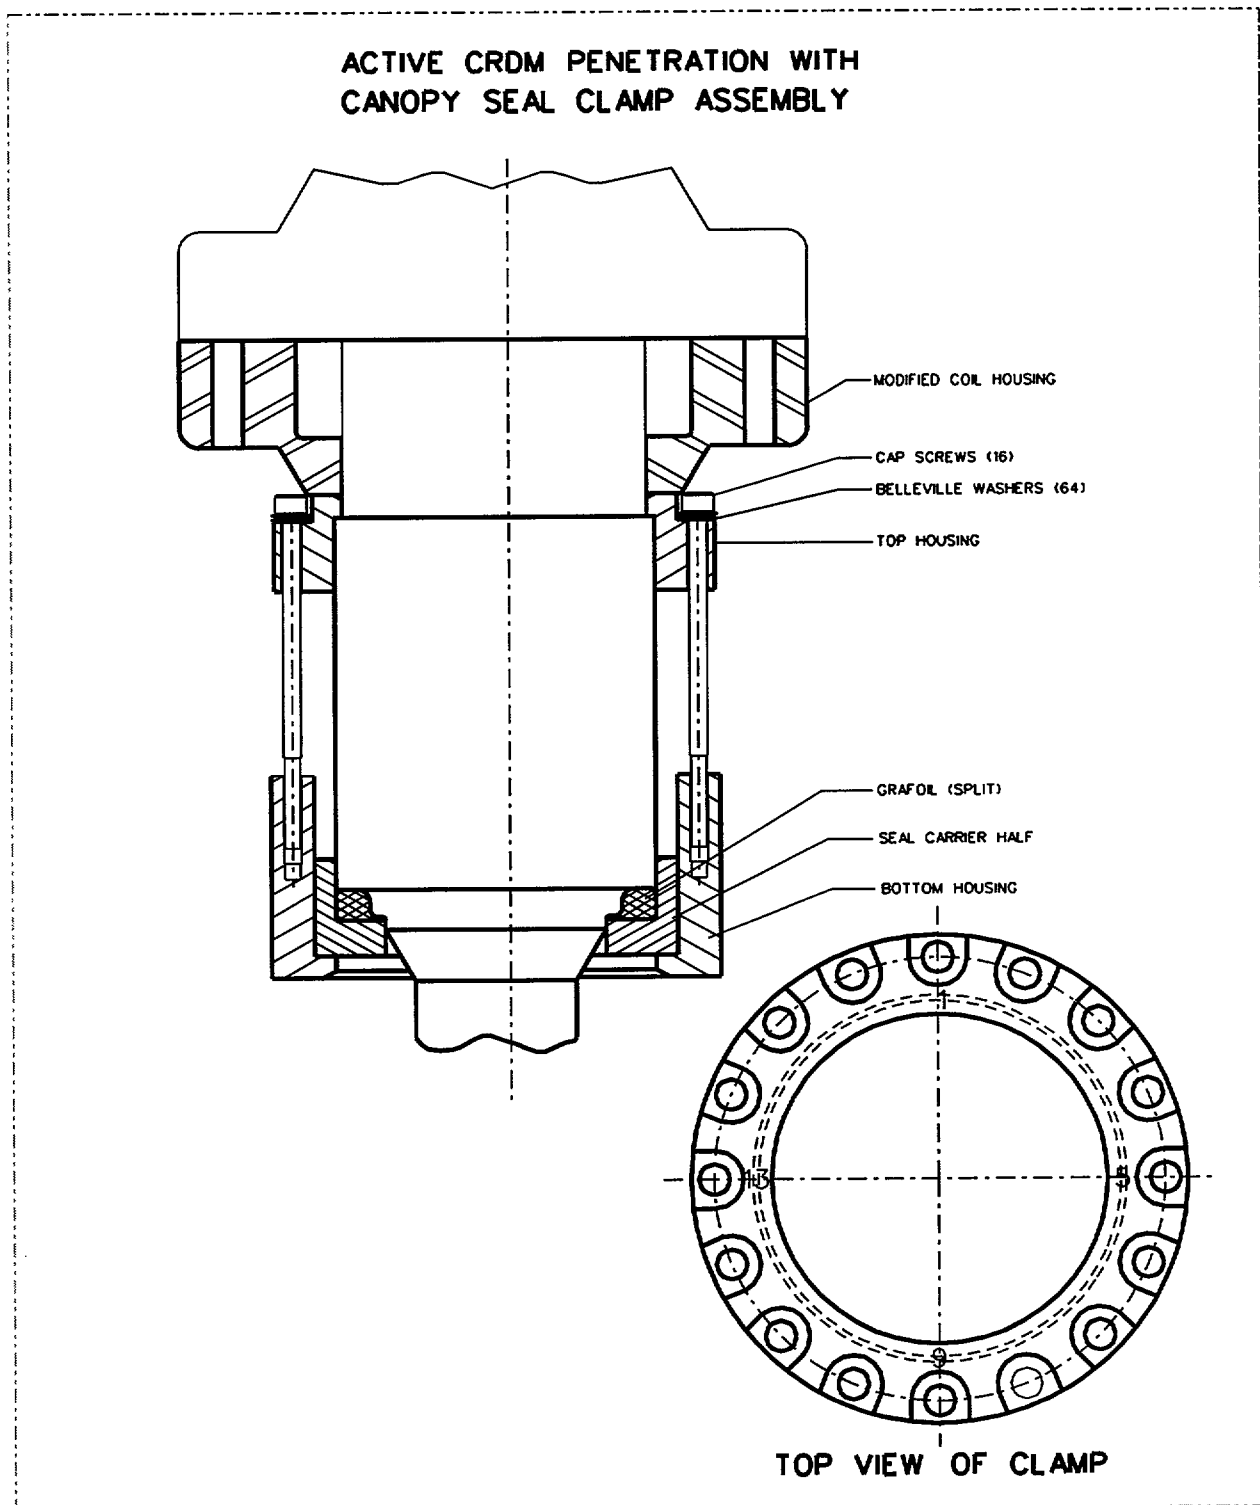
Figure 4. Typical Canopy Seal Clamp Assembly Cutaway

When a suspected leaking lower canopy seal weld is identified following the supplemental visual examination, WCGS installs a Canopy Seal Clamp Assembly (CSCA) (References 6 and 7). Figure 4 is a sketch of the CSCA design utilized at WCGS. The CSCAs are designed and fabricated as Class 1 components to the 1986 Edition of the ASME B&PV Code, Section III (Reference 8). Construction Code date reconciliation has been performed to document the acceptability of using a later edition of the Construction Code for the CSCAs (Reference 9)

In the CSCA design, a large ring of Grafoil™ (graphite) sealant that is compressed against the canopy seal weld region provides the barrier against fluid leakage. The Grafoil™ is held in place by the seal carrier halves, top and bottom housings, and attachment cap screws.
