U.S. NUCLEAR REGULATORY COMMISSION  
OFFICE OF NUCLEAR MATERIAL SAFETY AND SAFEGUARDS  
INSPECTION REPORT

Report No. 40-2259/2002-201

Facility: Former Lucky Mc Uranium Mill

Site of Former Lucky Mc Uranium Mill  
NRC Inspection Report 40-2259/2002-201

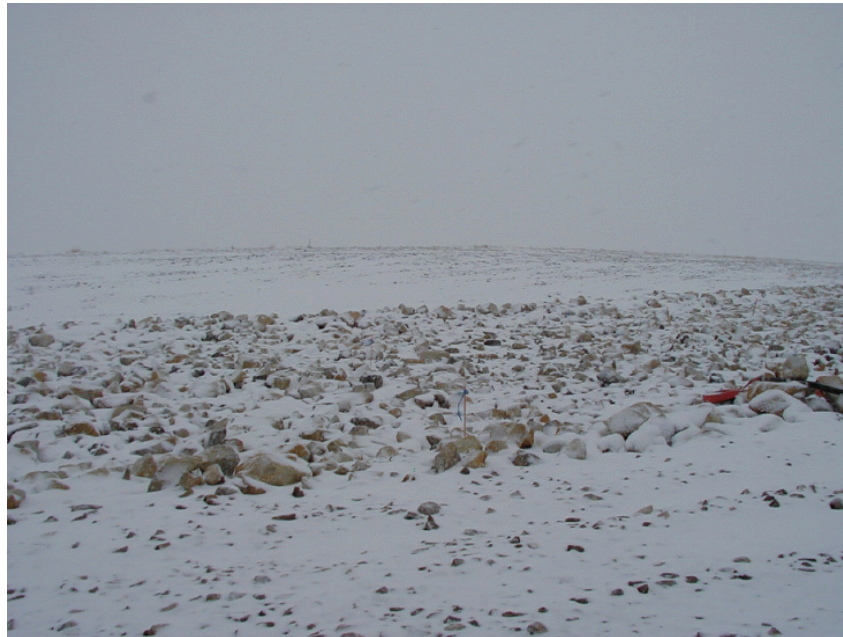
Drainage  
Rap

Based on visual observations of the riprap in the channels the inspectors indicated that the rock placement should be more uniform, with less segregation of fine materials.
