SUBJECT: CRDM THIMBLE RUPTURE SENSITIVITY STUDY

SUBJECT: DAVIS-BESSE NUCLEAR POWER STATION
NRC AUGMENTED INSPECTION TEAM - DEGRADATION OF THE
REACTOR PRESSURE VESSEL HEAD - REPORT NO. 50-346/02-03(DRS)

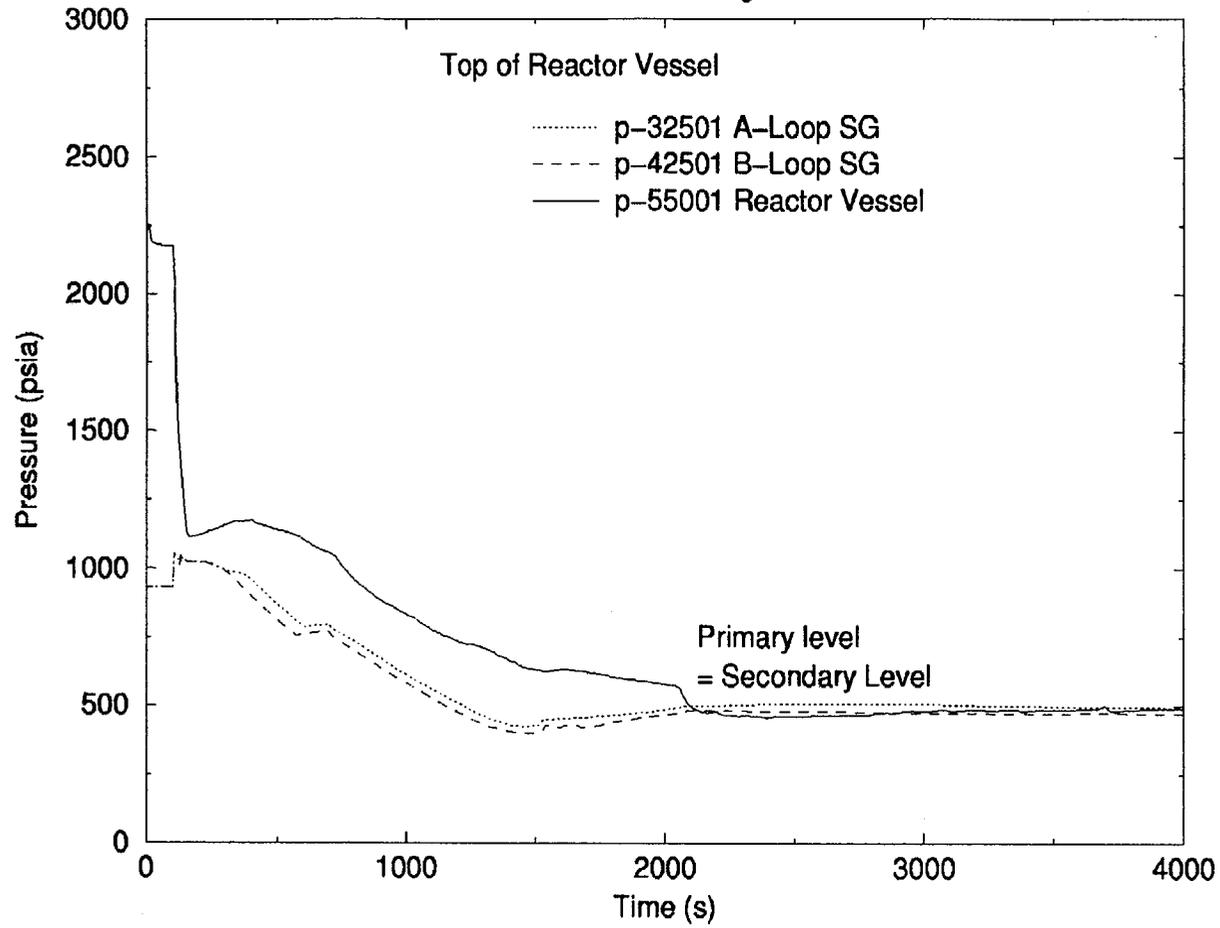
Figure 3

Case 1: The rupture of a single CRDM thimble with AFW and minimum HPI flow. See Figures 3 and 4.

Control Rod Housing Break

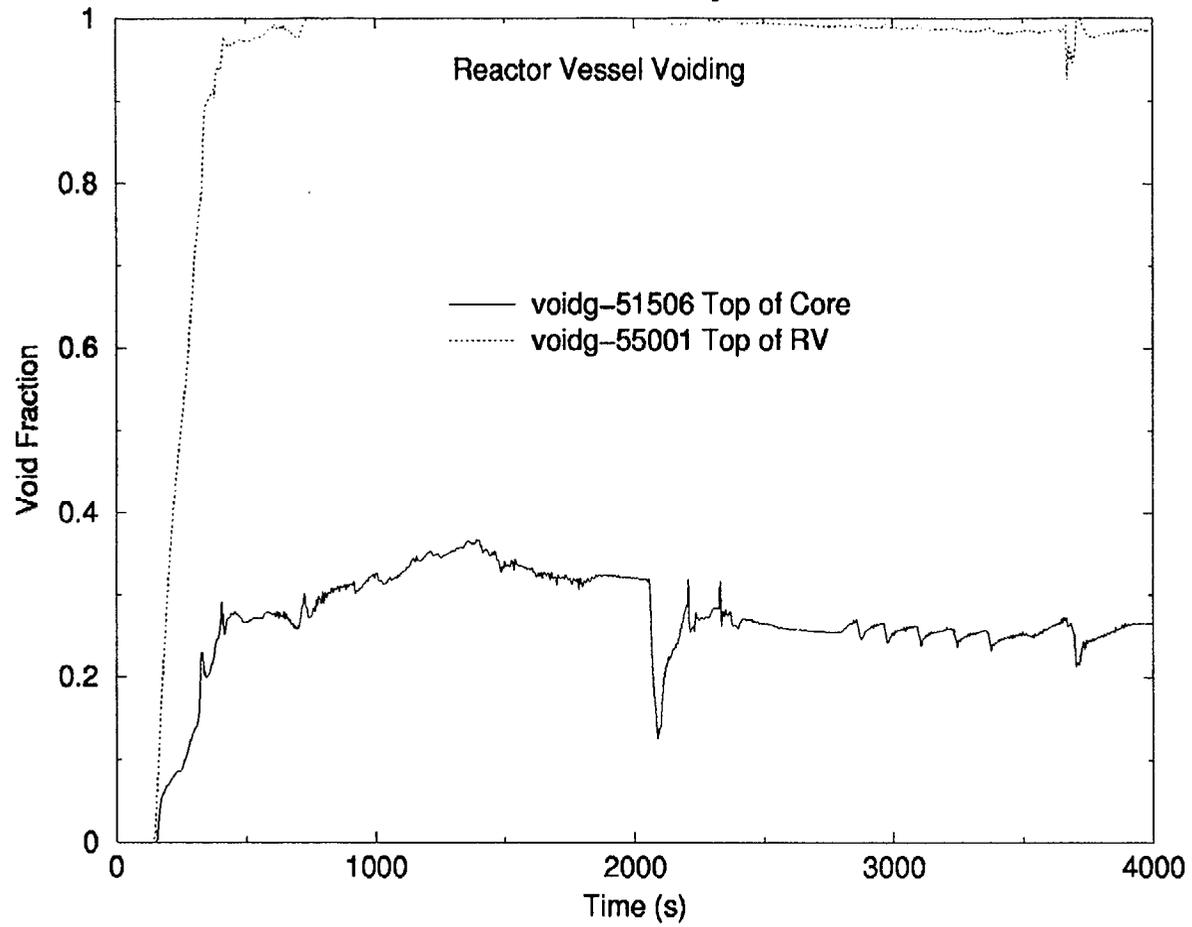
Figure 4

Control Rod Housing Break

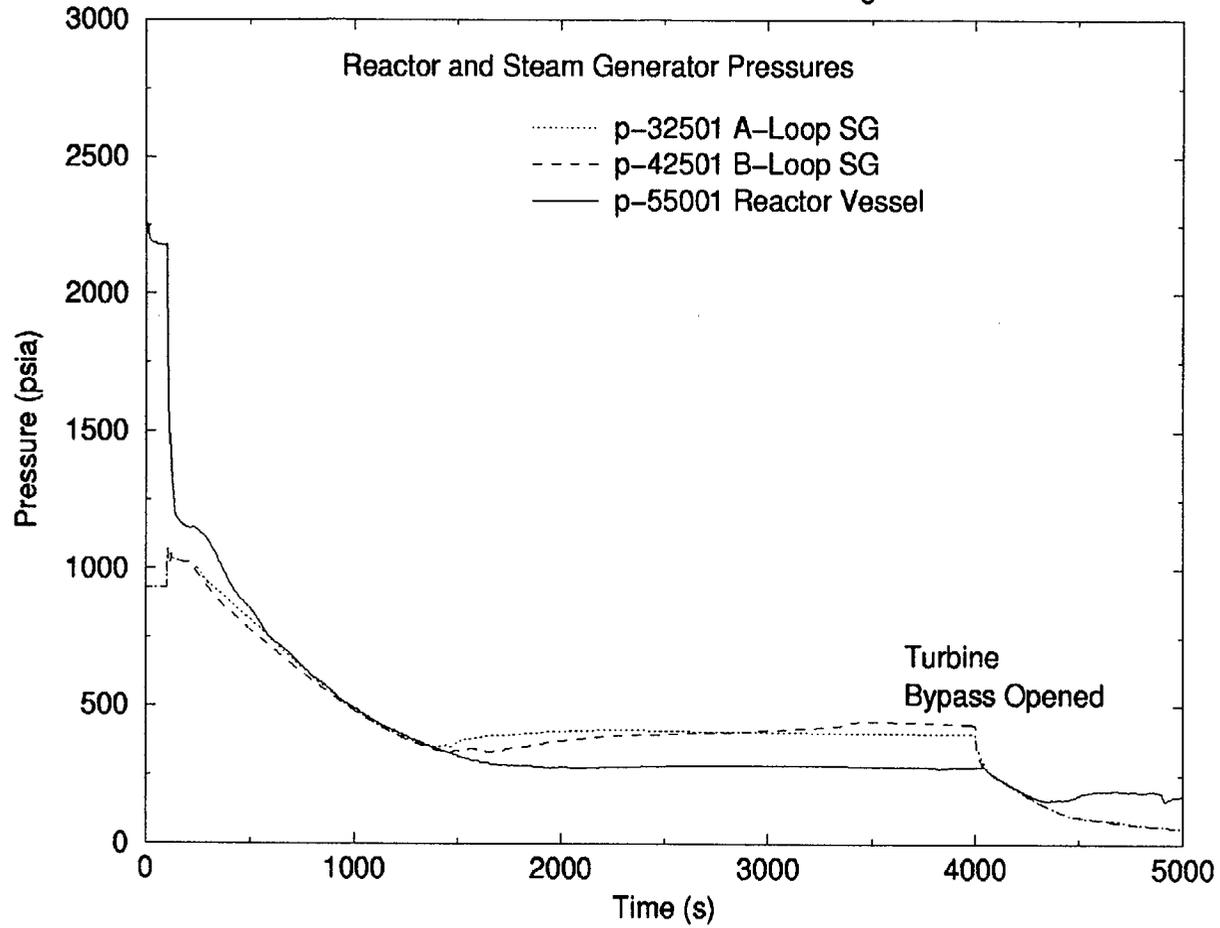
Figure 5

Case 2: The rupture of two CRDM thimbles with AFW and minimum HPI flow. See Figures 5 and 6.

Break of Two Control Rod Housings

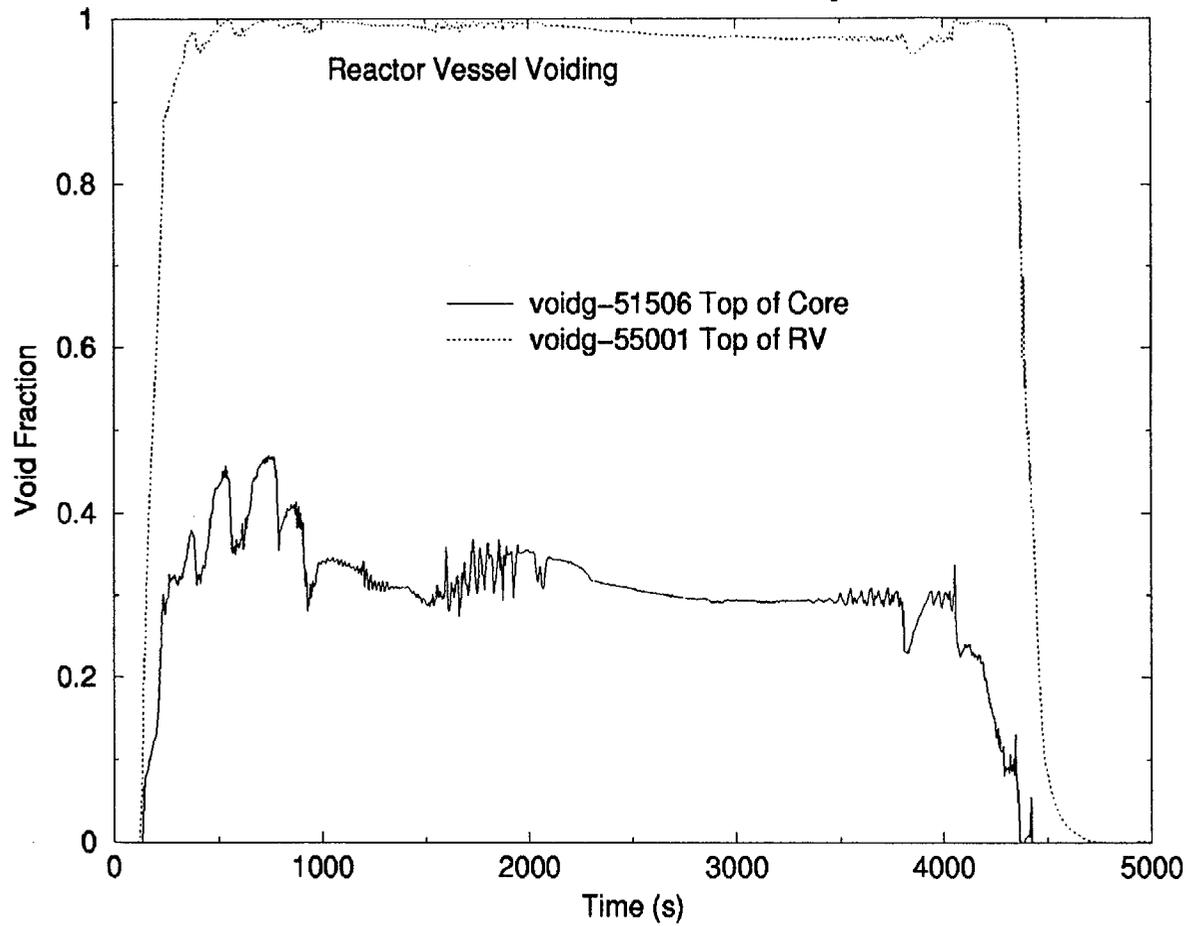
Figure 6

Break of Two Control Rod Housings

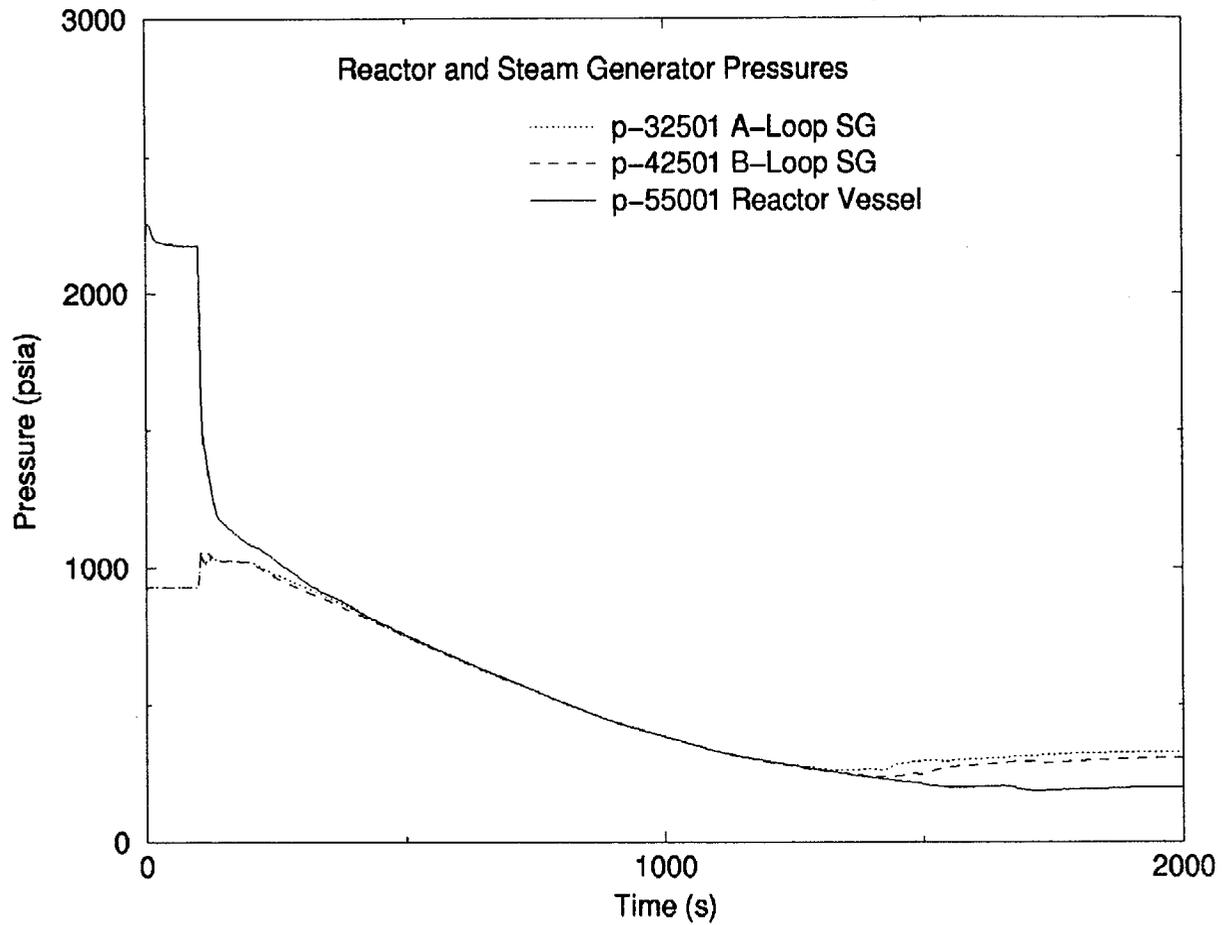
Figure 7

Case 3: The rupture of three CRDM thimbles with AFW and minimum HPI flow. See Figures 7 and 8.

Break of Three Control Rod Housings

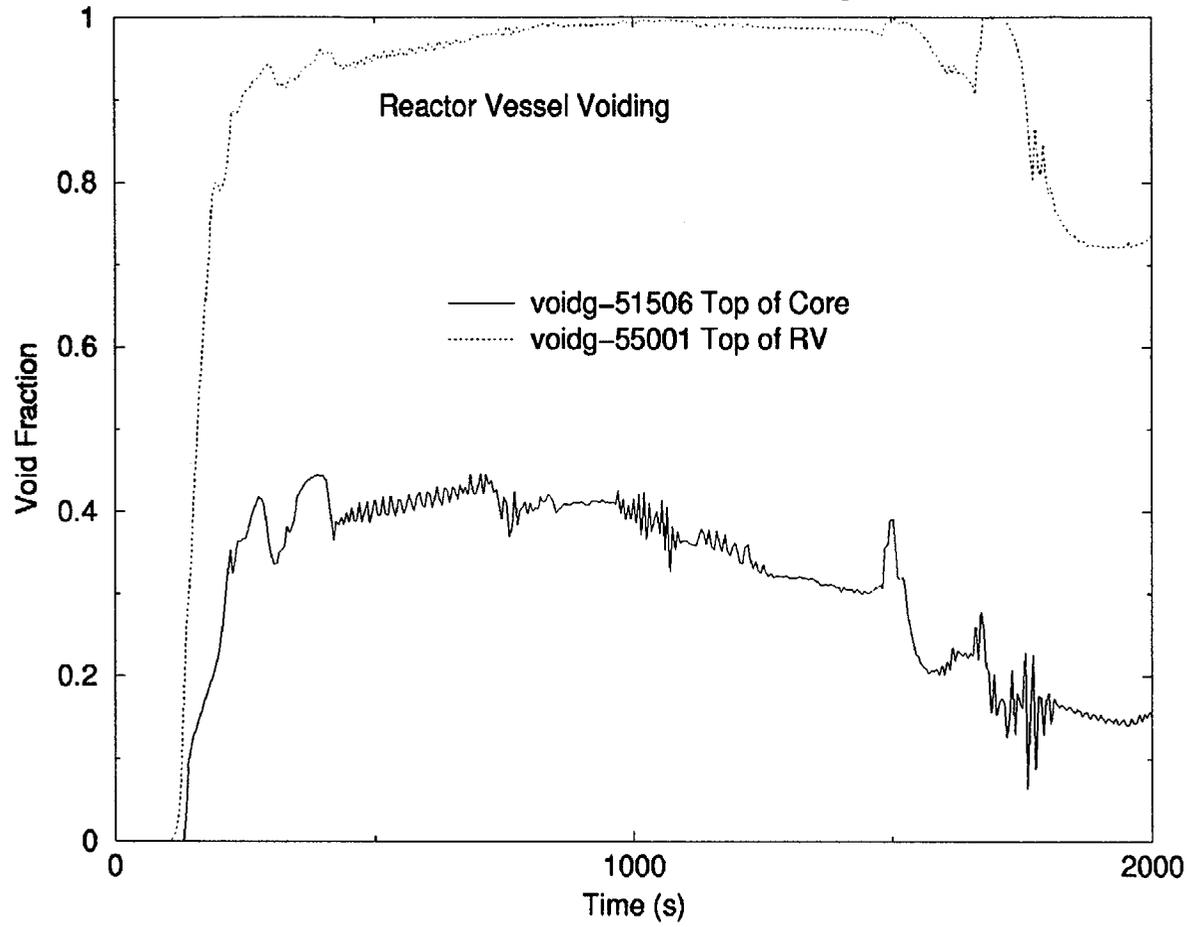
Figure 8

Break of Three Control Rod Housings

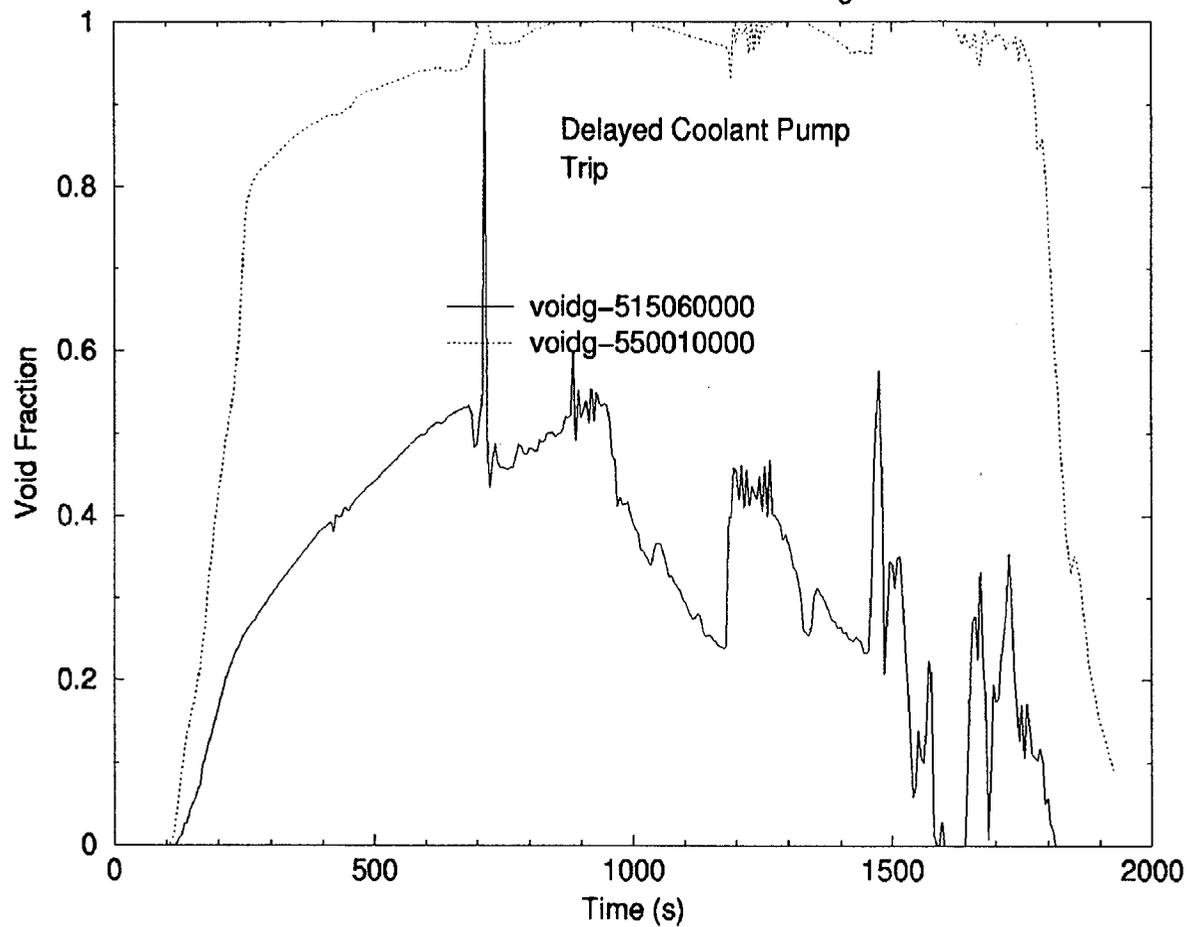
Figure 10

Case 4: The rupture of three CRDM thimbles with AFW and minimum HPI flow and delayed reactor coolant pump trip. See Figure 10.

Break of Three Control Rod Housings

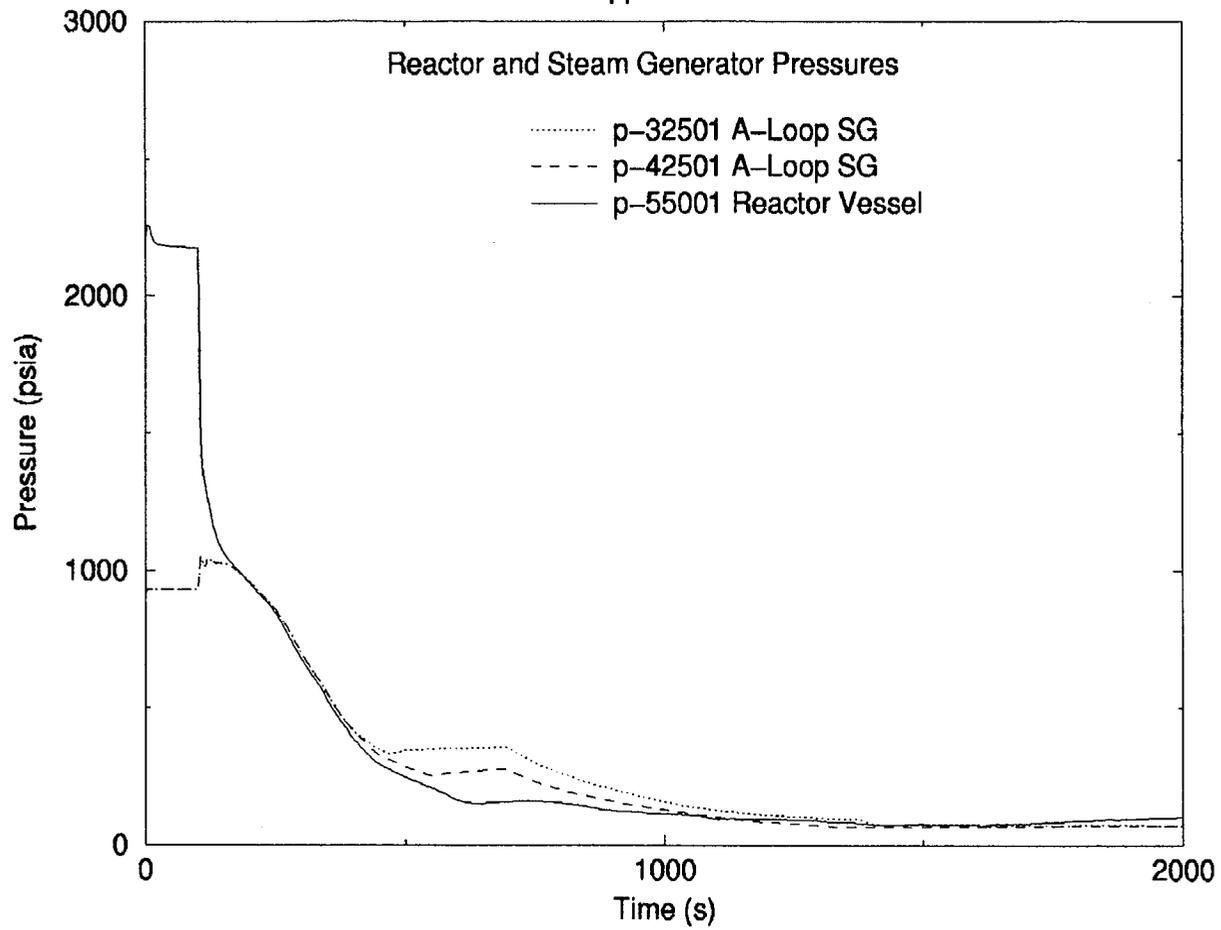
Figure 11

Case 5: A rupture in the reactor vessel head 8 inches in diameter with AFW and minimum HPI flow. See Figures 11 and 12.

For the 8 inch break size the reactor system was predicted to depressurize rapidly and decrease below that of the steam generators since this break size is sufficient to remove all decay heat (Figure 11). LPI was automatically initiated and no core uncover was predicted (Figure 12). The effect of failure of the control rods to enter the core was minimal. The core did not uncover for this case and the calculated core void fractions (Figure 13) are almost identical to those for the case for which the control rods were assumed to be inserted. The reason for this is that voiding in the reactor core shuts down the reactor with negative reactivity soon after the break occurs. See Figure 14. Further negative reactivity is added by the boric acid in the core flood tanks and in the HPI and LPI water. A degree of positive reactivity addition occurs from temperature reactivity feedback but the boric acid addition is sufficient to overcome this effect.

8 Inch Upper Head Break

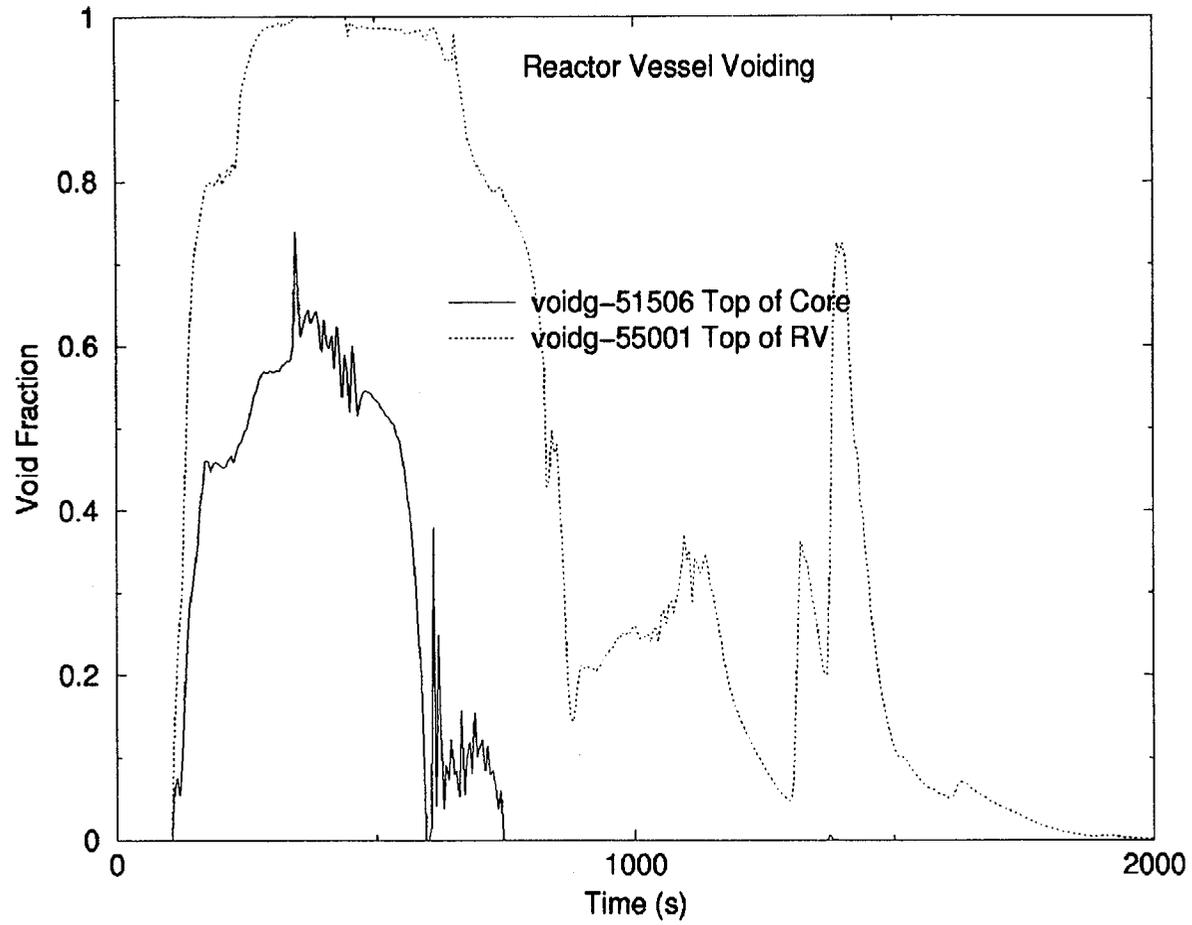
Figure 12

8 Inch Upper Head Break

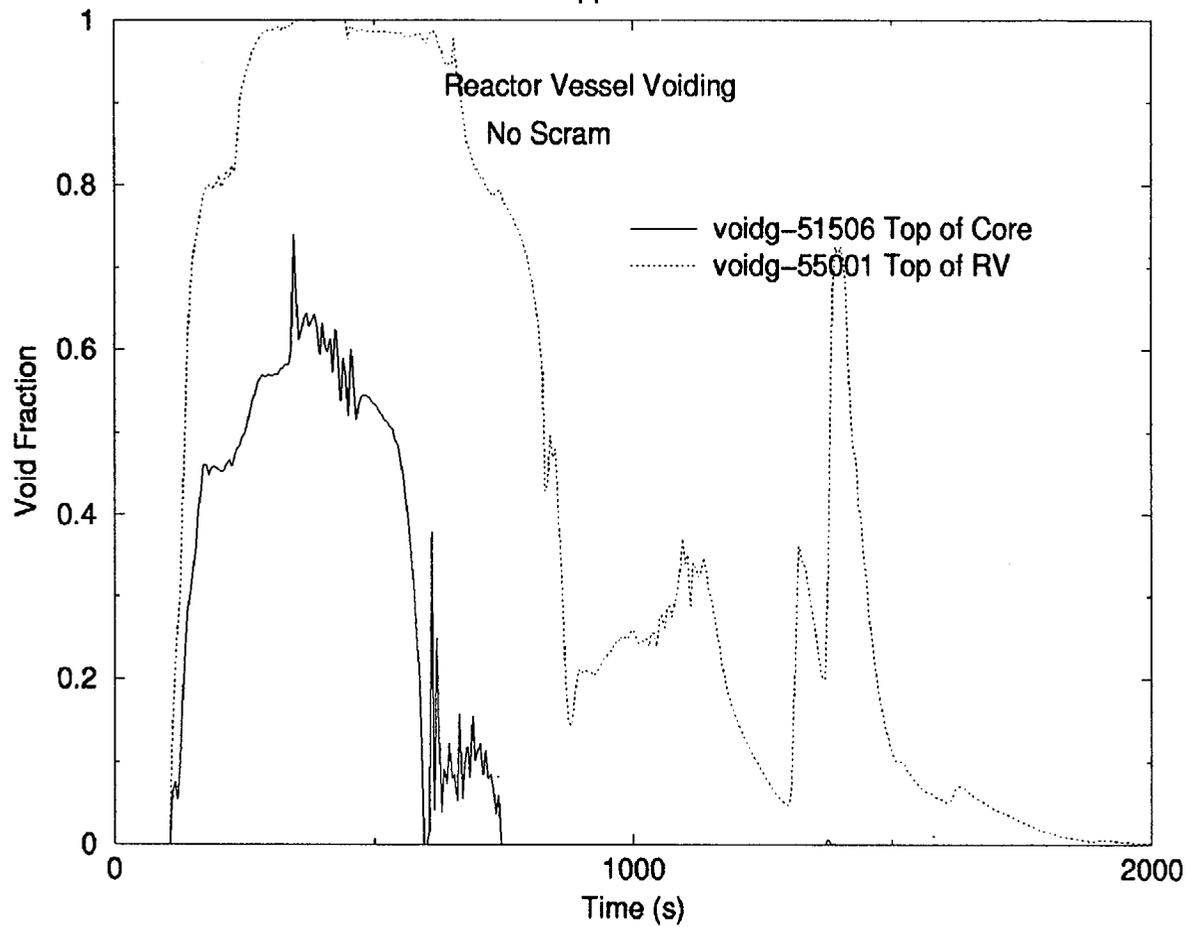
Figure 13

Case 6: A rupture in the reactor vessel head 8 inches in diameter with AFW and minimum HPI flow for which the control rods did not insert. See Figures 13 and 14.

8 Inch Upper Head Break

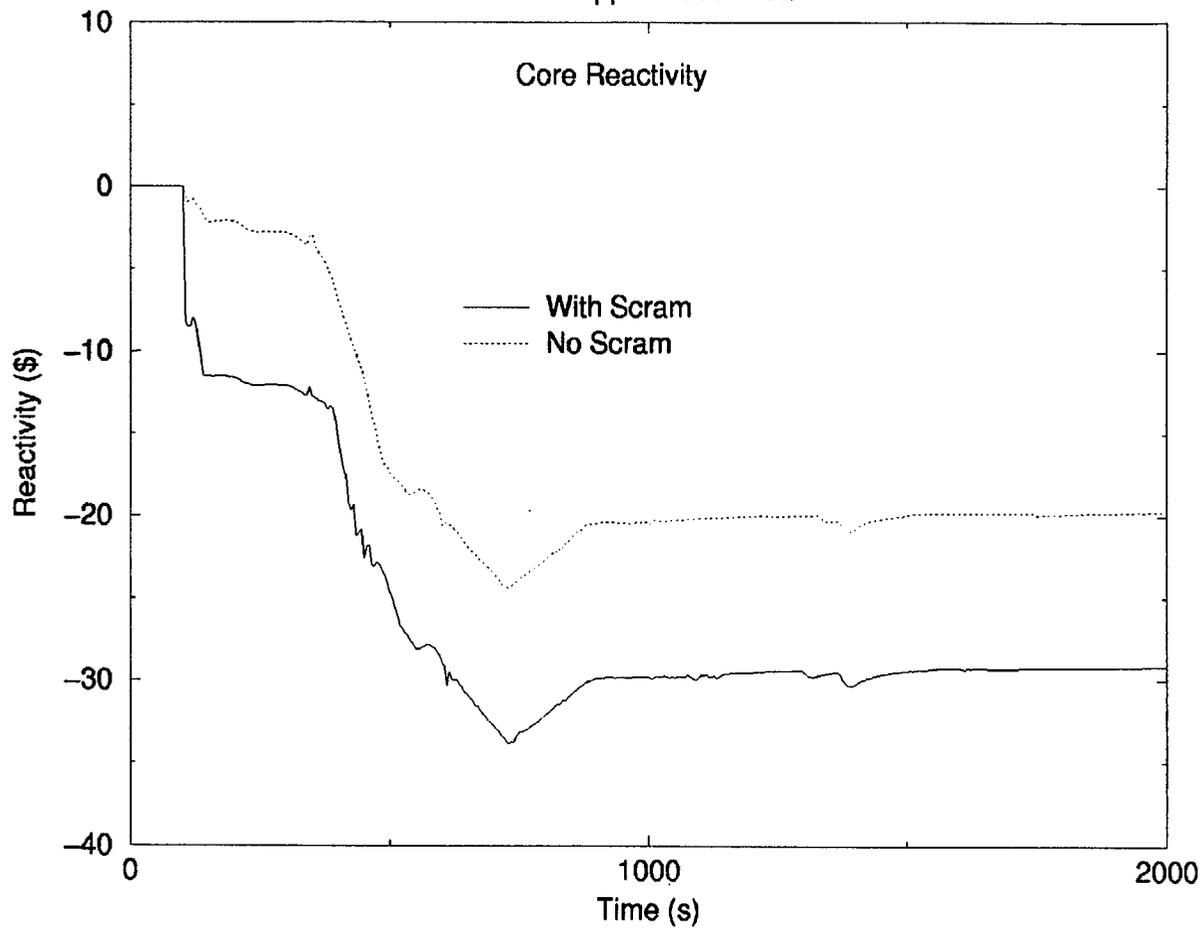
Figure 14

8 Inch Upper Head Break

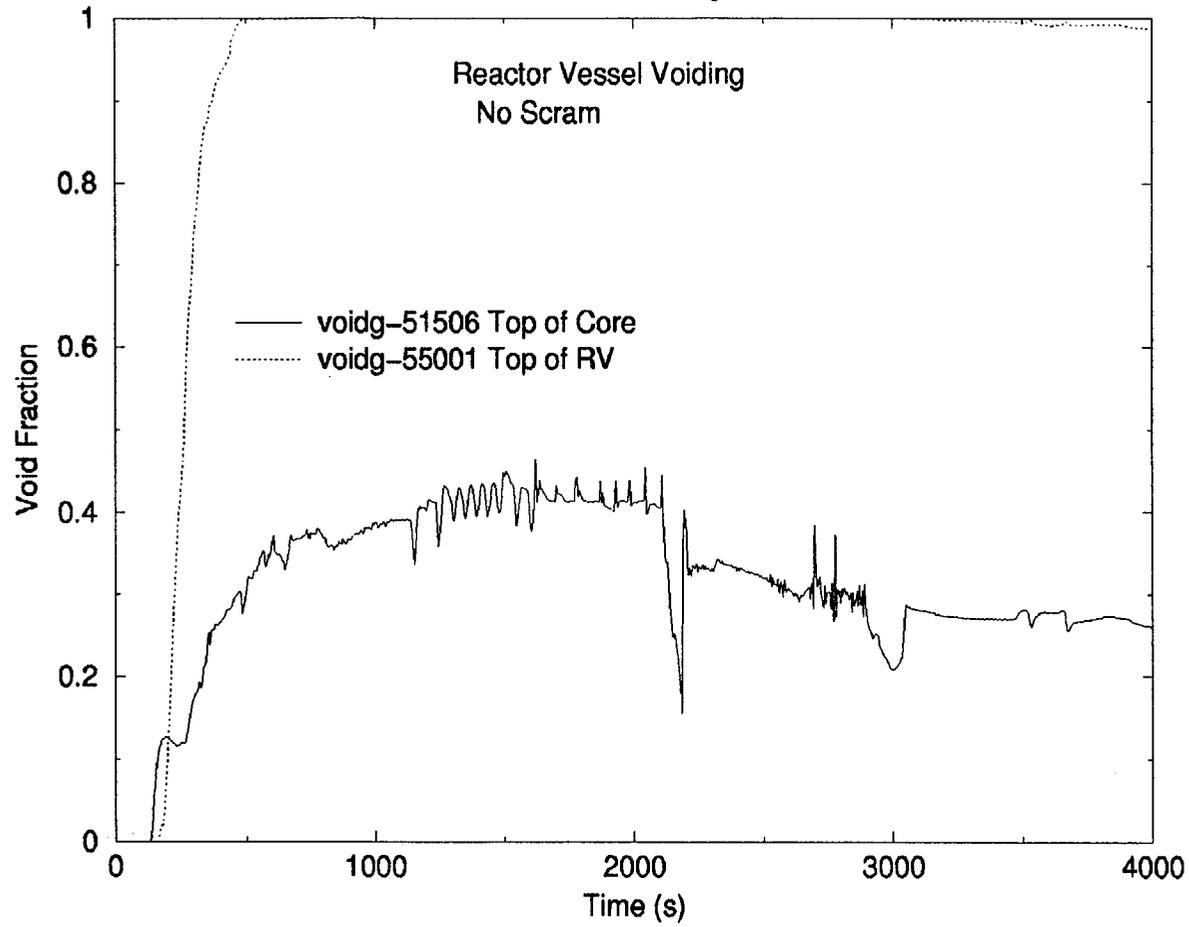
Figure 15

Case 7: The rupture of a single CRDM thimble with AFW and minimum HPI flow for which the control rods did not insert. See Figures 15 and 16.

The failure of a single CRDM thimble was also analyzed with the assumed failure of the control rods to enter the core. This break size would be expected to depressurize slower than the 8 inch break size so that negative reactivity from void formation and boron addition would be expected to occur later. This case is the same as case 1 with the exception that the control rods did not enter the core. The failure of the control rods had little effect on the results. Void formation rapidly reduced the core power level. The core was predicted to remain covered with water. See Figure 15. Core reactivity with and without scram is shown in Figure 16. The reactivity is continuously negative. The sudden increase in reactivity after 2000 seconds is the result of cold water entering the core from the core flood tanks displacing some of the steam bubbles. The core cannot return to critical from addition of this water since it contains 2000 ppm of boric acid.

Control Rod Housing Break

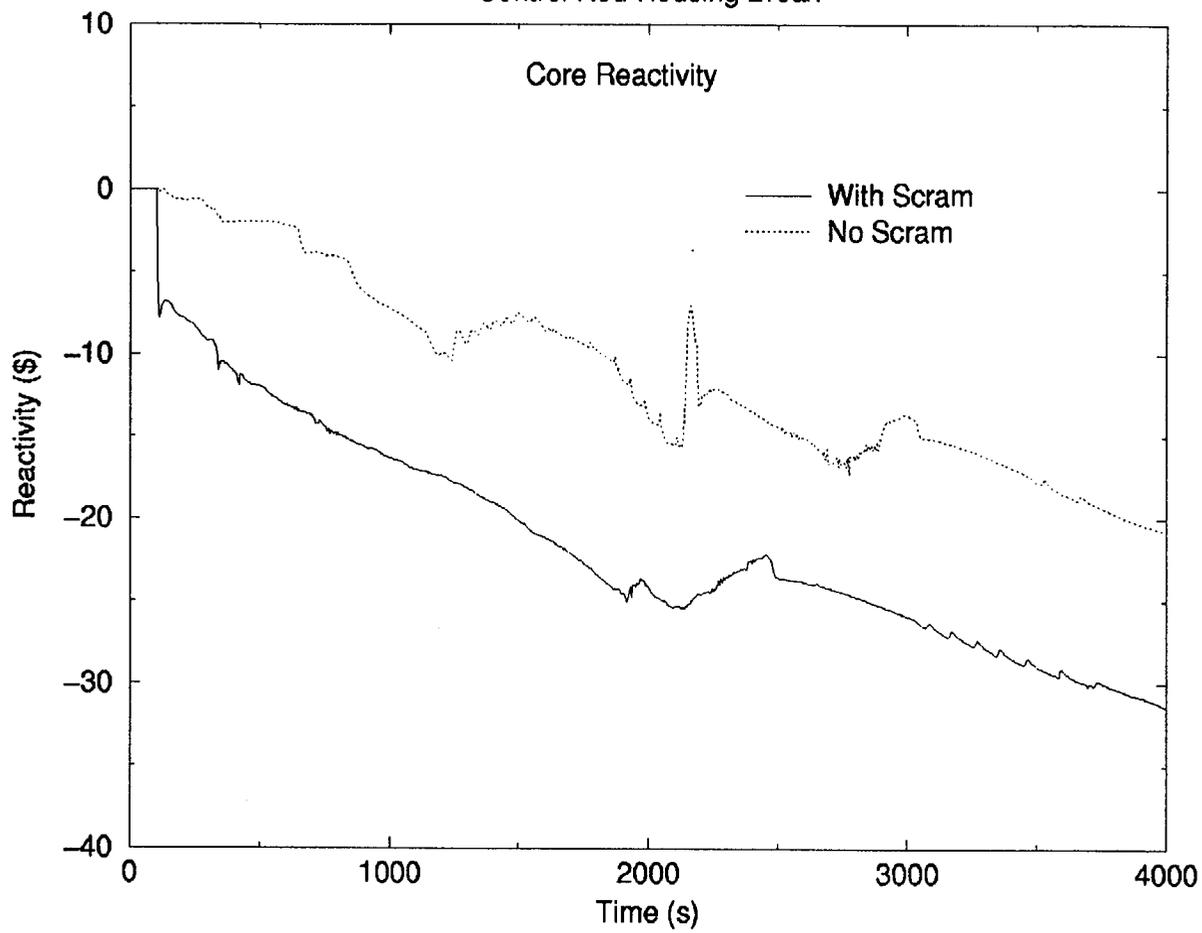
Figure 16

Control Rod Housing Break

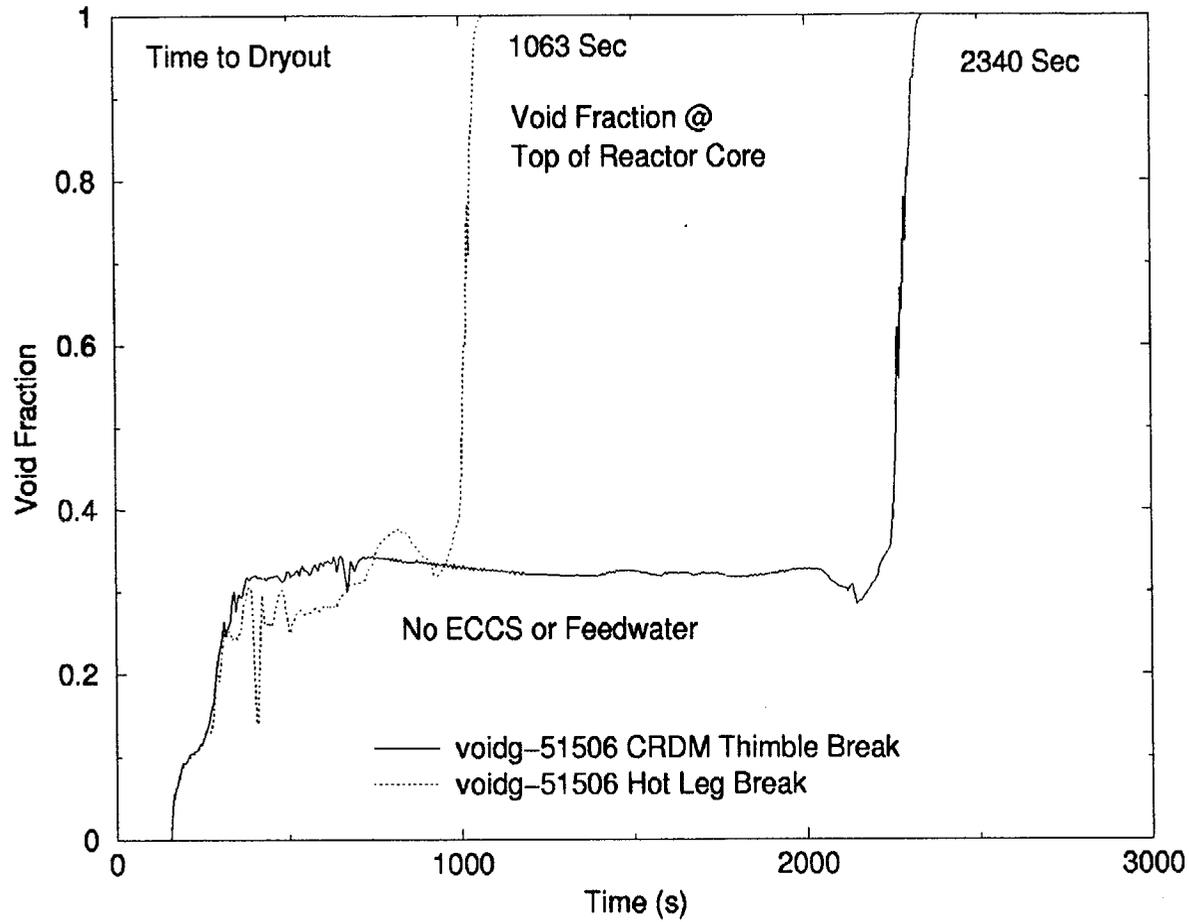
Figure 17

Case 8: The rupture of a single CRDM thimble without AFW, HPI or steam dump capability to the condenser. See Figure 17.

Case 9: A hot leg leak equivalent in area to a CRDM thimble. AFW, HPI and steam dump capability to the condenser were assumed to be unavailable. See Figure 17.

2.765 Inch HL Break vs. CRDM Housing Break

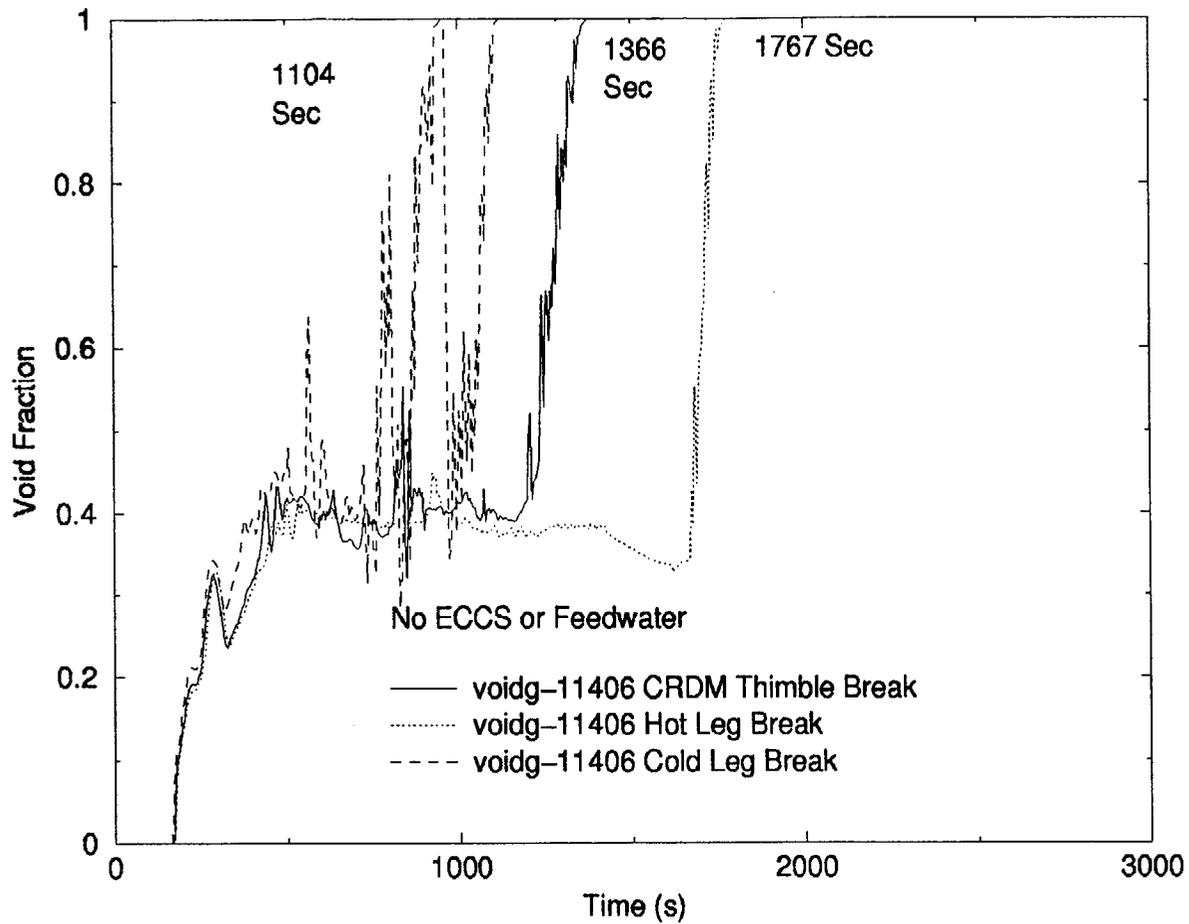
Figure 18

Case 10: The rupture of a single CRDM thimble without AFW, HPI or steam dump capability to the condenser for a four loop Westinghouse plant (Seabrook). See Figure 18.

The conclusions for Seabrook in comparing a CRDM break and a hot leg break are the opposite of those for Oconee. For Seabrook a CRDM thimble break at the top of the vessel caused core dryout to begin earlier than for a hot leg break (Fig. 18). The reason for the difference in results lies in the design of the reactor vessel internals. In both designs the upper head is separated from the upper plenum by a plenum cover plate. In the Oconee design the plenum cover plate is porous providing an open path for coolant to flow up through the control rod guide tubes and down through the plenum cover plate into the upper plenum. The upper head at Oconee is heated to the temperature of the core outlet during operation. For the Seabrook design, flow within the upper head is restricted. During operation leakage flow is permitted from the reactor vessel downcomer into the upper head. Flow then passes downward through the control rod guide tubes to the top of the core.

2.765 Inch HL & CL Break vs. CRDM Break

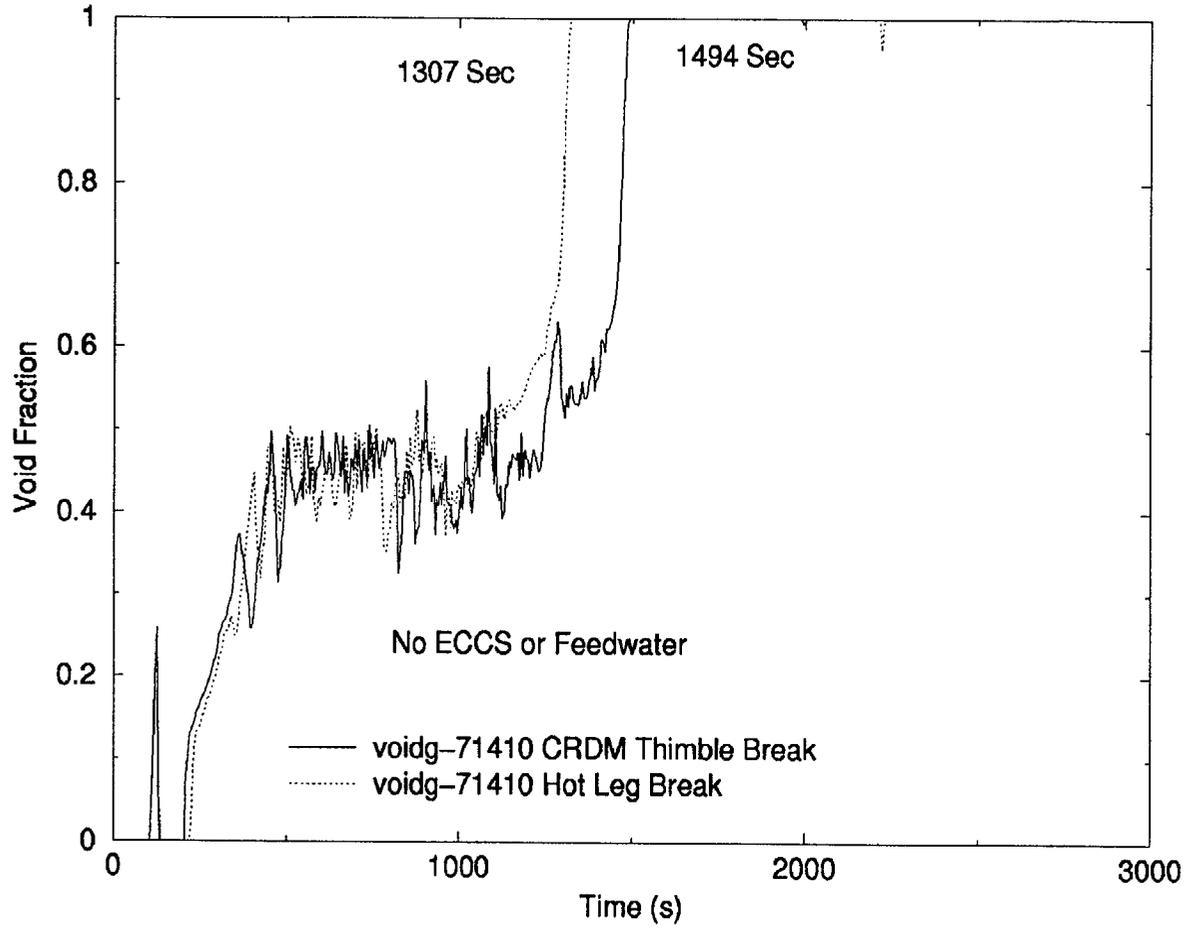
Figure 19

Case 13: The rupture of a single CRDM thimble without AFW, HPI or steam dump capability to the condenser at a Combustion Engineering plant (ANO-2). See Figure 19.

The upper head flow design at ANO-2 is less restrictive than that for Seabrook but more restricted than Oconee. During operation the upper head temperature is between that of the core inlet and that of the core outlet. The time for the beginning of core dryout was found to be approximately the same whether the break was in the upper head or in a hot leg. See Figure 19.

2.765 Inch HL Break vs. CRDM Break

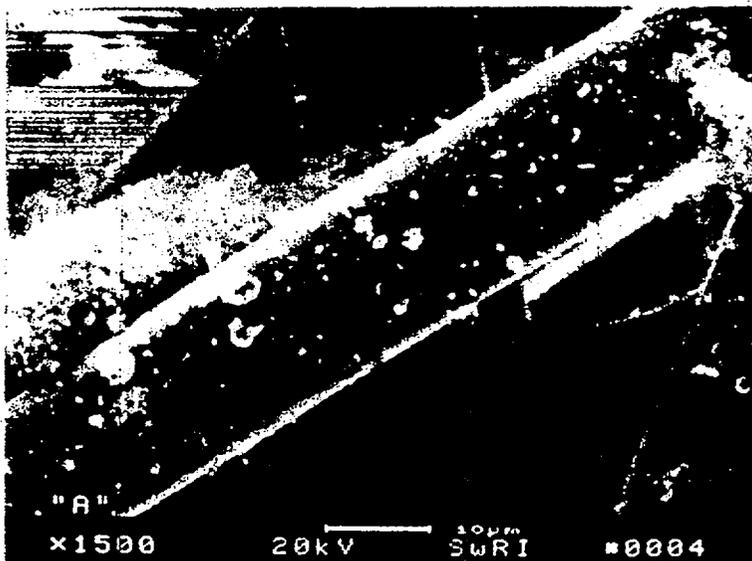
Figure 11. Scanning electron micrographs of an area of deposits on filter 4597BA 7/3/99@1400 following application of a gold/palladium coating.
