SACRAMENTO MUNICIPAL UTILITY DISTRICT P. O. Box 15830, Sacramento CA 95852-1830, (916) 452-3211
AN ELECTRIC SYSTEM SERVING THE HEART OF CALIFORNIA

Docket No. 72-11
Rancho Seco Independent Spent Fuel Storage Installation
License No. SNM-2510
REQUEST FOR ASME CODE EXCEPTION

NONCONFORMANCE REPORT (NCR)

Subject: Flaw Evaluation of Potential Defects in the NUHOMS® FF DSC Stainless Steel Bottom Forging

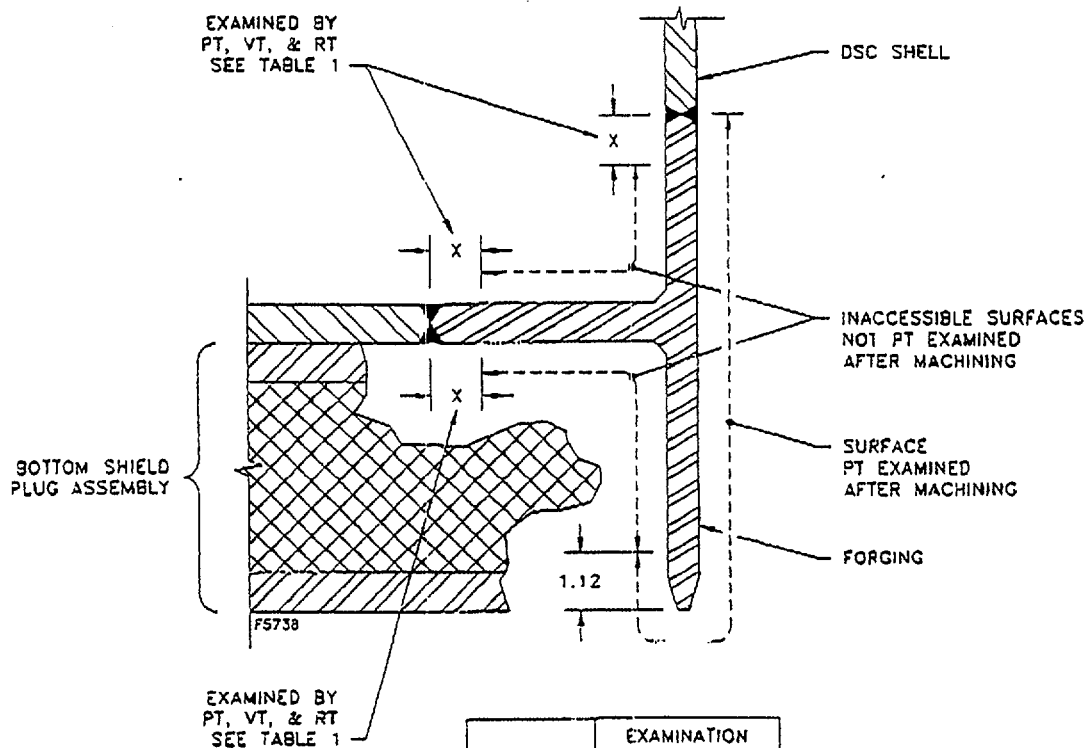
The bottom end forging is to be fabricated to Subsection NB in accordance with procurement drawing NUH-05-1032. While the material supplier examined the bottom forging material using PT and UT, additional machining of the forging (approximately 1/8 in. removed from all surfaces) was performed during the fabrication process. Subsequent to the additional machining, surface examination of some forging surfaces was not performed in accordance with ASME Paragraph NB-4121.3. Once this nonconformance was discovered, accessible areas of the forging were PT examined in accordance with NB-4121.3. Areas that were and were not PT examined after final machining are shown in the following figure.

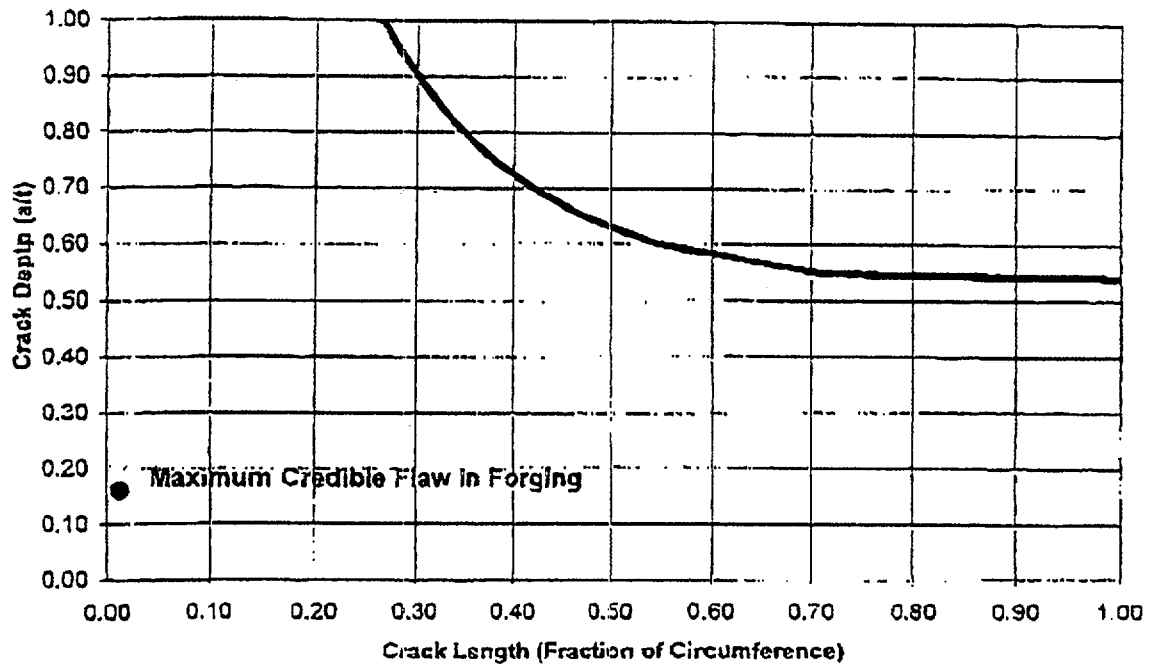
Figure 2. Allowable Flaw Sizes for Service Level A/B

The maximum credible defect in the forging is relatively small compared with ASME Code Section XI allowable flaw size shown in Figures 2, 3, and 4. There are no potential flaw growth mechanisms identified which will propagate this defect to encroach upon the ASME Code Section XI allowables. It is therefore concluded that in spite of the fact that PT was not performed on the final machined surfaces of the bottom forging of TN's NUHOMS® FF DSC, the canister is acceptable for use.

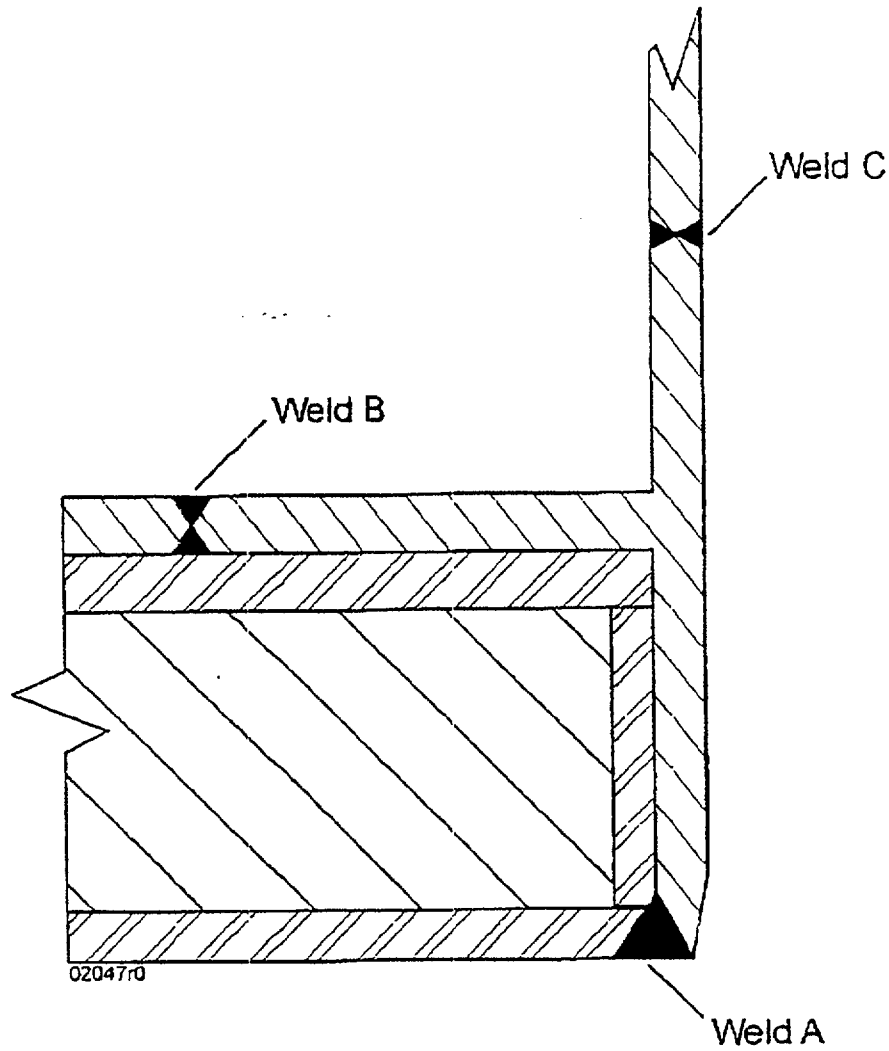
Figure 5. Section of Bottom Flange of NUHOMS® FF Canister

For environmental assisted degradation to occur, including general corrosion, corrosion fatigue, or stress corrosion cracking (SCC), the flaw must be exposed to a corrosive environment. As identified in Reference 6, and illustrated in Figure 5 [7], there are three surfaces that may be subjected to environmental assisted degradation either during final fabrication or in service. These surfaces are identified from Figure 5 as surface A-C, from weld A to weld C on the outside of the forging, surface A-B, on the inside of the forging, and surface B-C, on the inside of the forging. Surface A-C is accessible following all machining and welding and will be subjected to a PT surface examination following the completion of all fabrication activities, in accordance with the ASME Code requirements. Surface A-B has never been wetted, has been sealed as a result of the welding of the plug to the forging, and will not be exposed to any environment, other than the minute air or inert gas environment to which it was exposed during welding. The maximum temperature seen by this surface is 300°F and the nominal temperature is less than 200°F. Surface B-C is the inside surface of the canister and will see a mild boric acid environment representative of the PWR primary environment at the fuel pool at a maximum temperature of 110°F. The surface is then dried and exposed to an inert helium overpressure, then it is vacuum dried twice, and back-filled with helium as its final environment. The maximum temperature of this surface is 300°F.
