Subject: Duke Power Company, Oconee Nuclear Station, Unit 1  
Docket No. 50-269  
Reactor Vessel Head and Penetration Nozzle Condition Report

**Oconee Unit 1  
End-of-Cycle 20 Refueling Outage  
Reactor Vessel Head Penetration Nozzle Indication Report**

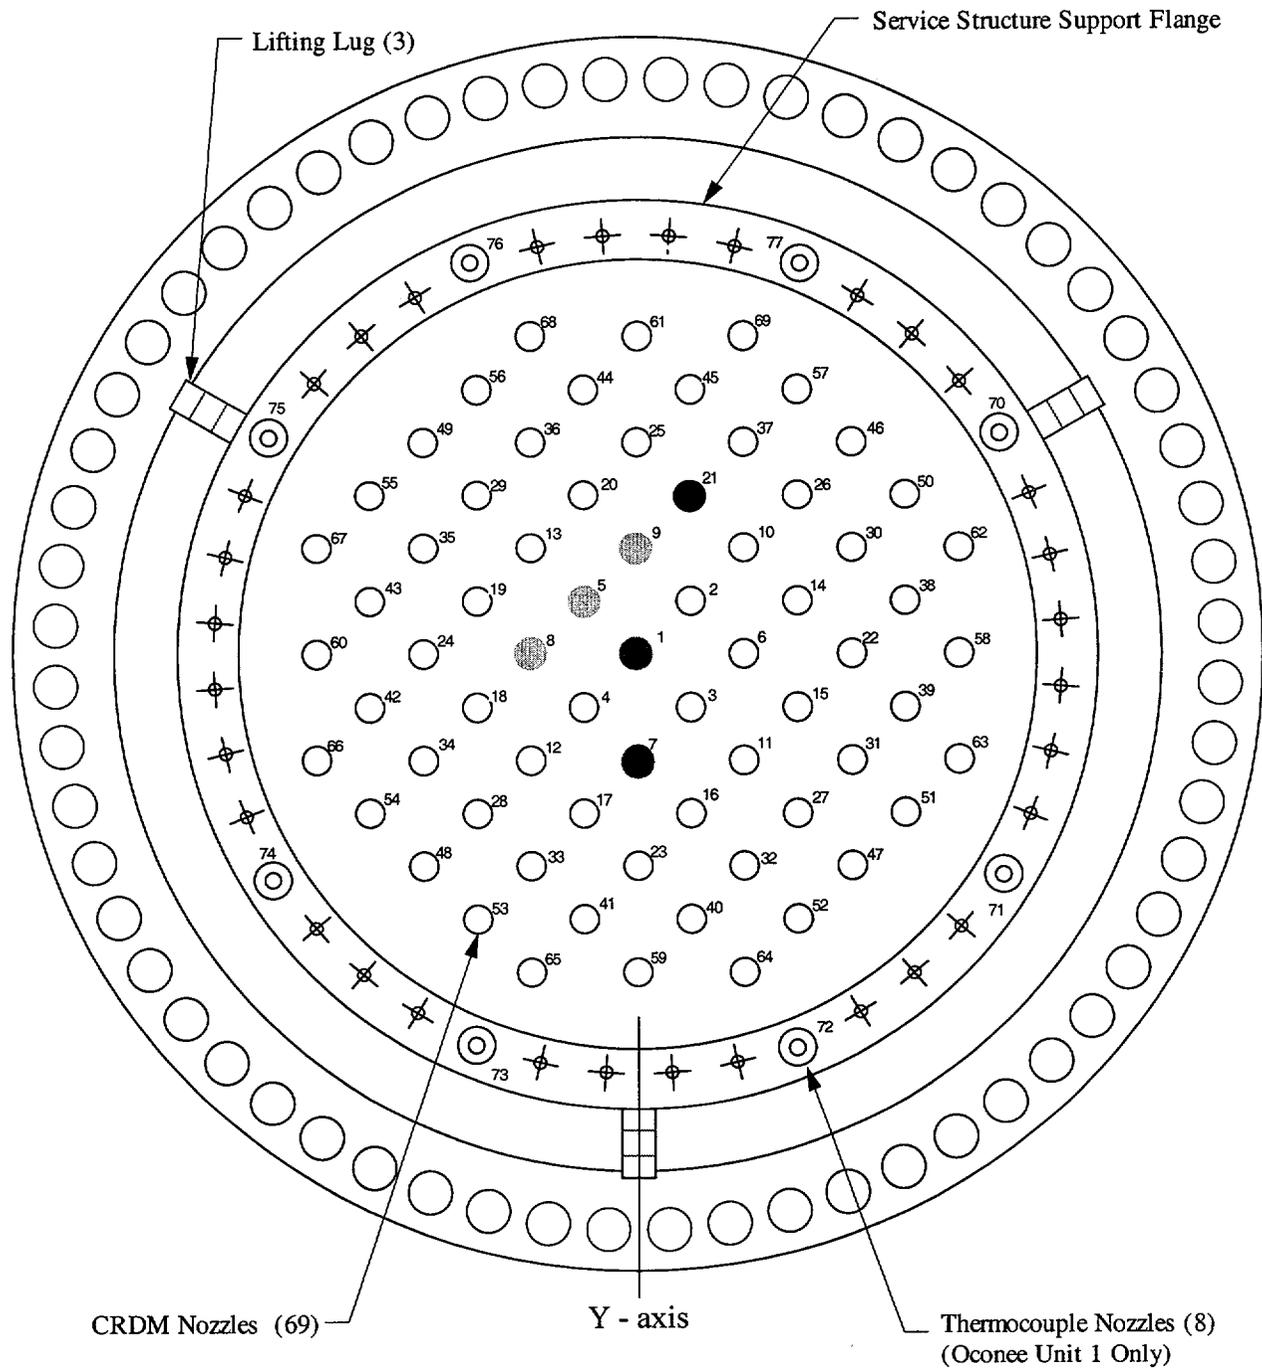
**Figure 2** Bare metal visual inspections of RV head, Oconee Unit 1 CRDM nozzles identified as suspect, during EOC-20 refueling outage, March 31, 2002

On March 24, 2002, during the End-of-cycle (EOC) 20 refueling outage, a visual inspection of the top surface of the Oconee Unit 1 reactor vessel closure head while the head was still on the vessel showed two nozzles where boron deposits were evident and their source inconclusive. These nozzles were classified as "masked". This inspection was performed in accordance with Duke's response to NRC Bulletin 2001-01<sup>1</sup> as a "Qualified Visual" inspection. Examination of the eight repaired thermocouple locations did not identify any leakage. Nozzle 1 had a thin film of boric acid crystals surrounding it which appeared to come from an old flange leak. A quantity of boric acid crystal deposits was seen on nozzle 7, however the source of the leakage was not immediately apparent. Three additional CRDM Nozzles (Number 5, 8, and 9) were identified as not being able to see completely 360° around the nozzle and were also examined.

After the head was cleaned and placed on the reactor vessel head stand, a visual inspection was performed looking for wastage. The inspection using fiber scopes where needed was able to see 360° around each nozzle and no wastage was identified. Figure 2 shows the location of the above described CRDM nozzles on RV head for this outage (EOC-20) and the location of Nozzle 21, which was found to be leaking in November 2000.

- Nozzles 1 and 7 identified as masked during EOC-20
- Nozzles 5, 8 and 9 identified as not being able to see 360° around nozzle
- Nozzle 21 identified as leaking by top of head visual inspection during EOC-19 and repaired
