June 2, 1975

Docket No. 50-278

RELATING TO
CHANNEL BOX WEAR
IN THE
VERMONT YANKEE NUCLEAR POWER STATION
(Docket 50-271)
AND THE
PILGRIM NUCLEAR POWER STATION
(Docket 50-293)

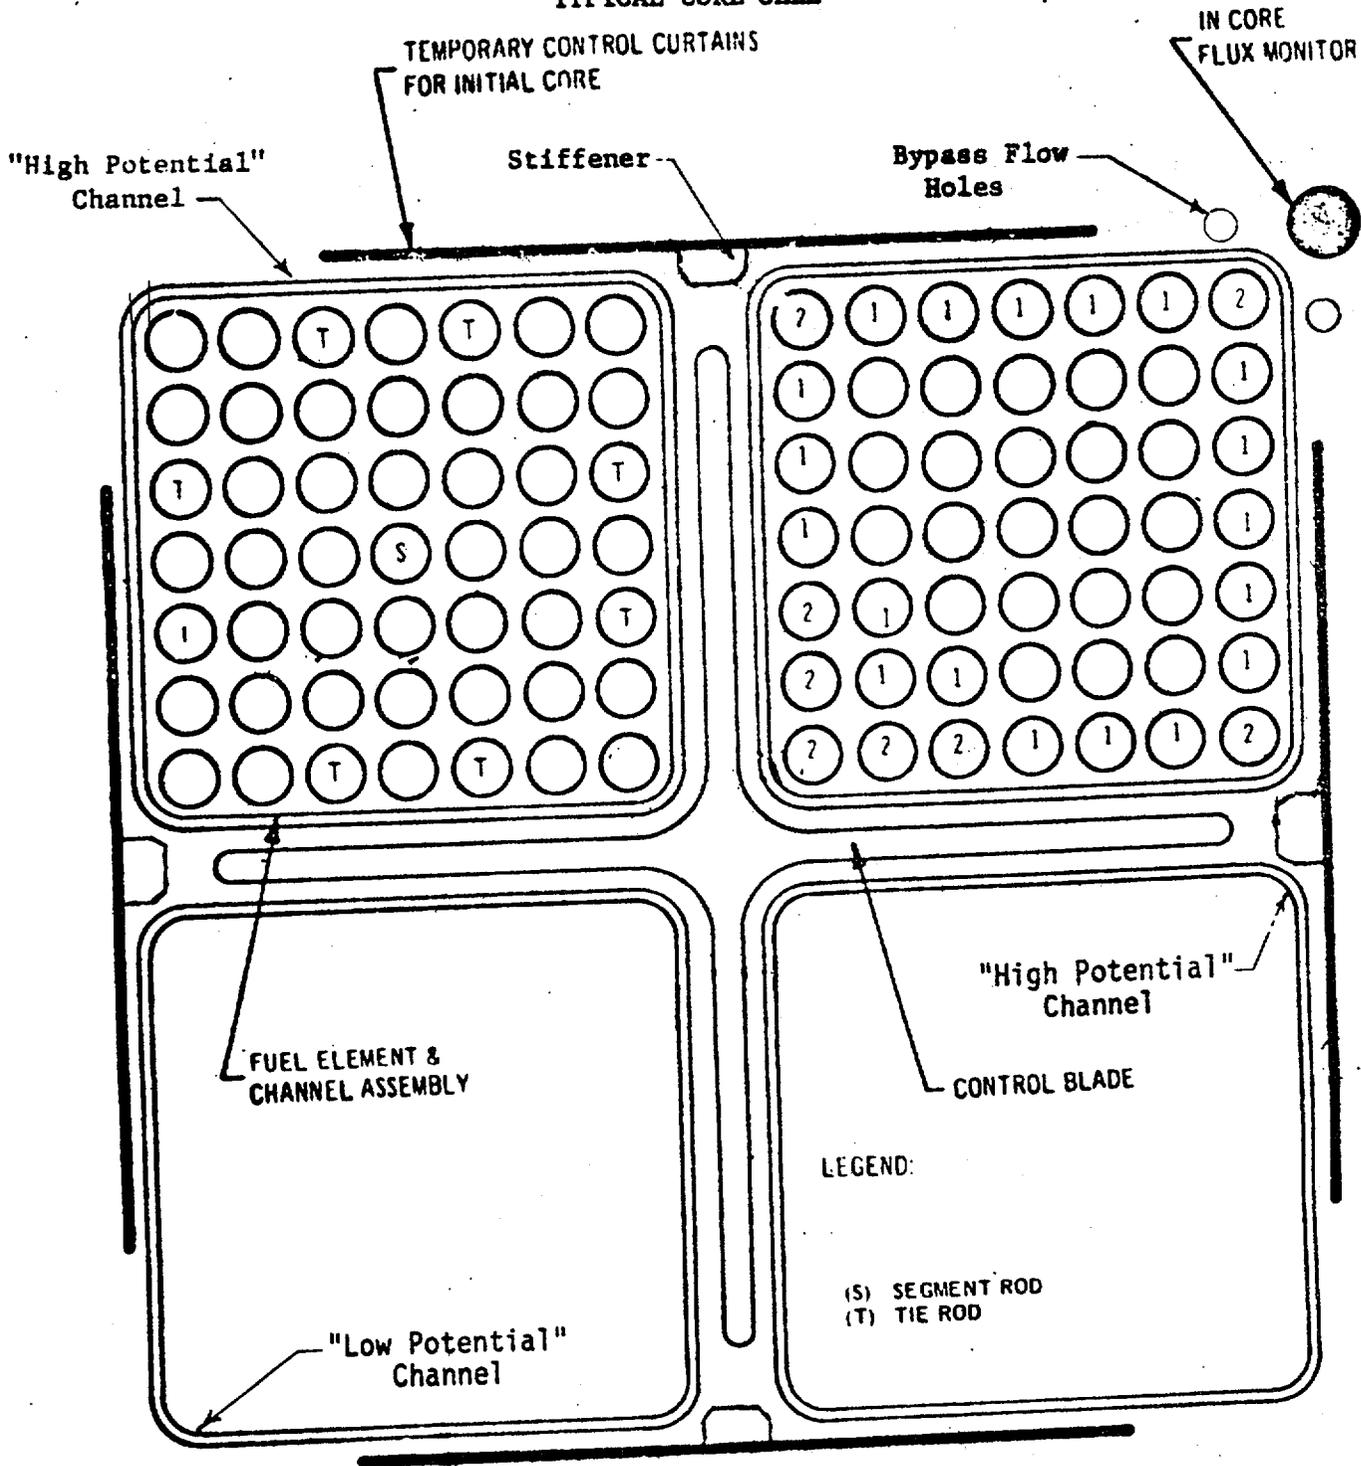
FIGURE 3
TYPICAL CORE CELL

Figure 3 depicts a cross-section of a fuel cell containing all of the elements discussed above. This particular arrangement, combining bypass flow holes with temporary control curtains, is found

in only two operating U.S. reactors, the Vermont Yankee Nuclear Power Station and the Pilgrim Nuclear Power Station. The KKM reactor in Switzerland is the only other facility which contains both of these design features.

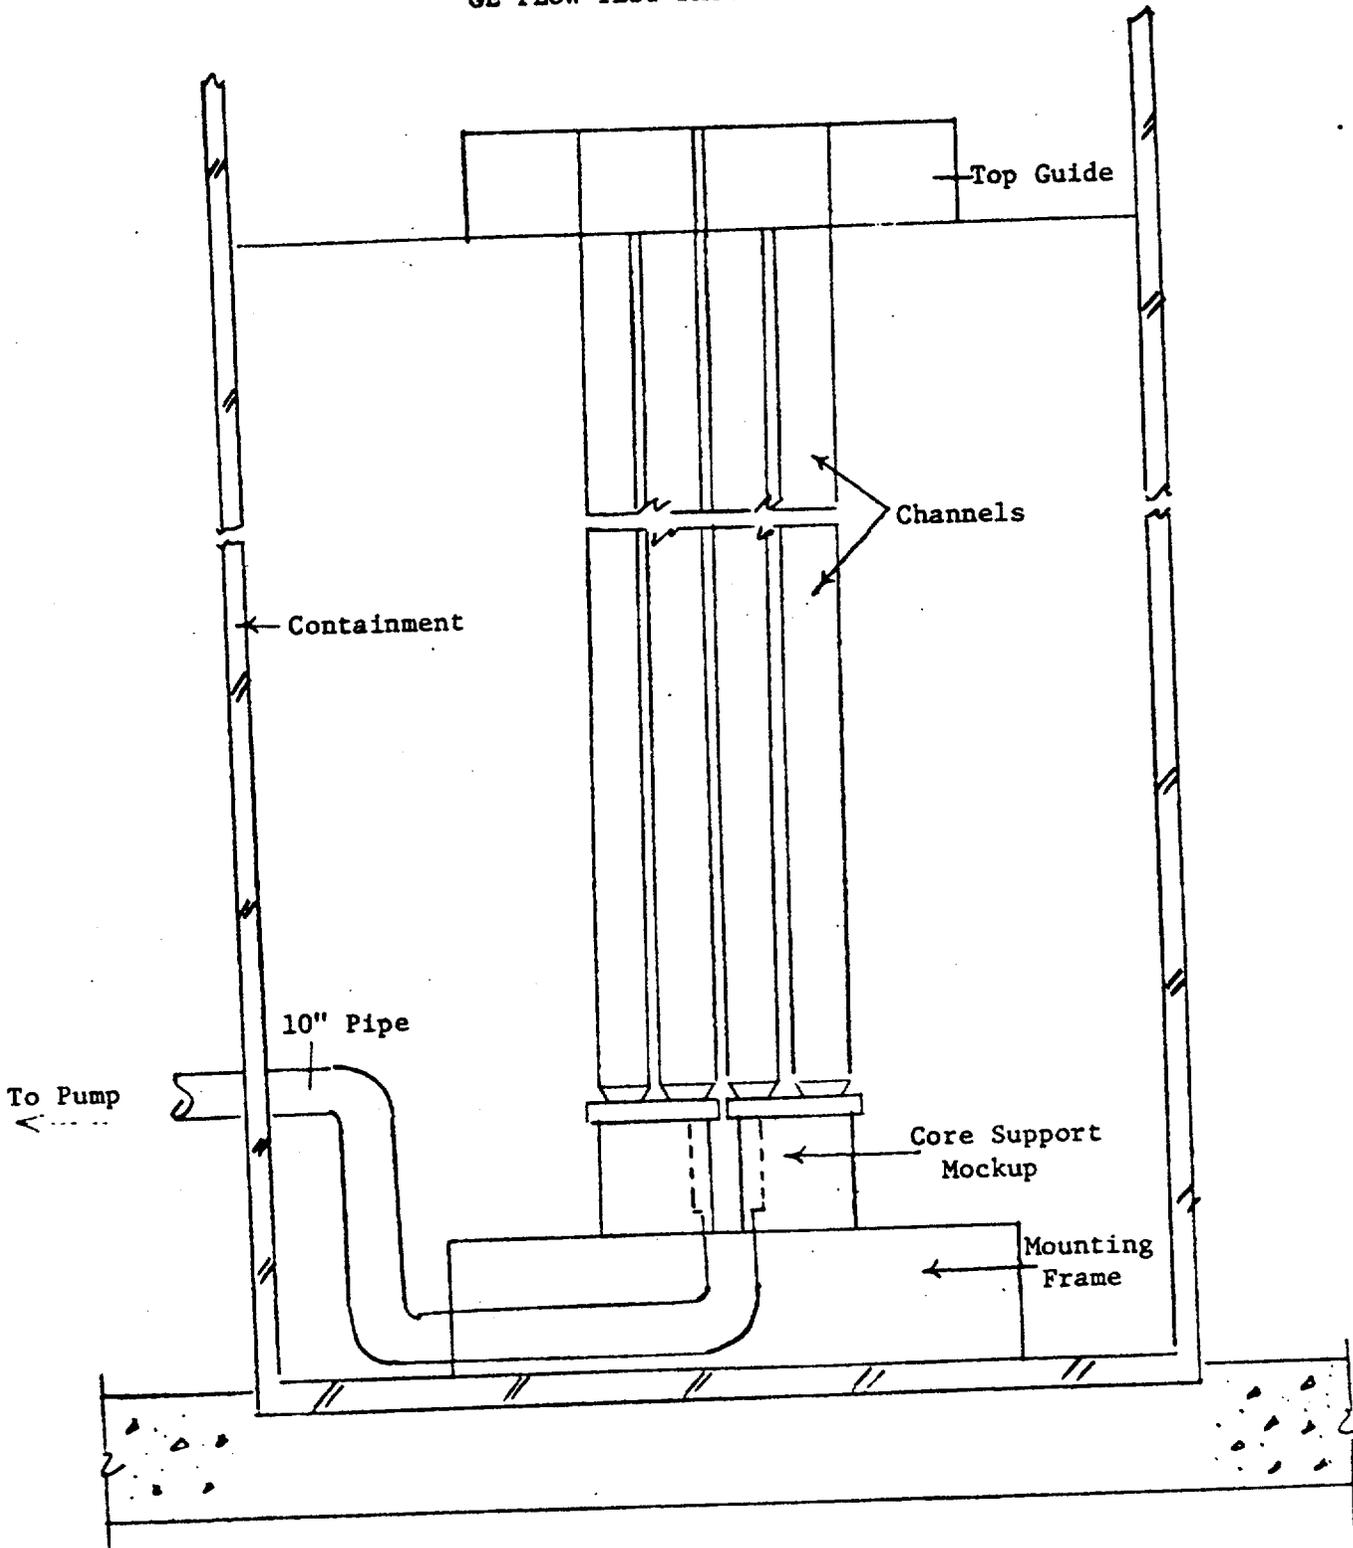
GE FLOW TEST FACILITY ELEVATION

The configuration of control curtains, bypass flow holes and fuel assemblies has been simulated by General Electric in a test facility (Figure 4). The facility consists of twelve fuel assembly channels, four temporary control curtains, and a support plate with four, one-inch-diameter flow bypass holes (Figure 5). A pump and piping provide

Although only preliminary test results are available, both visual observation and the transducer output confirmed that curtain vibration occurs. Visual observation showed the curtains are displaced in a direction opposite from the flow holes. The degree of displacement as well as the amplitude of vibration decreased with decreased bypass flow. No evidence of resonant vibration was observed.

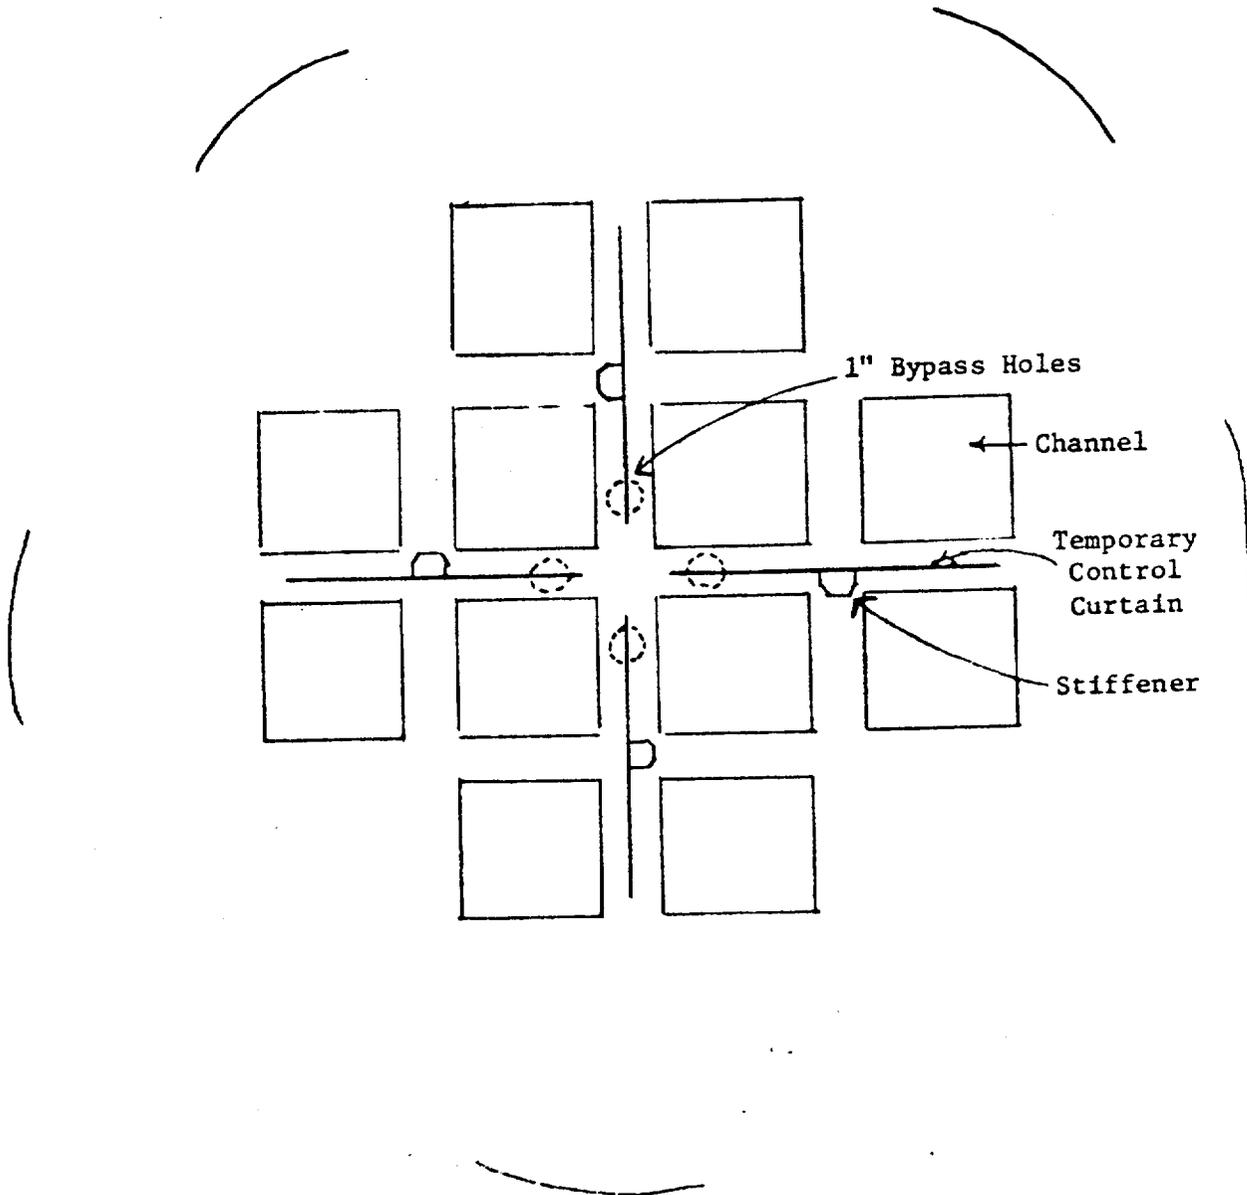
Figure .5
GE FLOW TEST FACILITY
PLAN

flow through the bypass holes equivalent to the bypass flow in a reactor operating at up to 120% of rated core flow. The channels contain no fuel rods and no flow is directed up through the channels. Proximity transducers were mounted on the bottom of three channels and the top of one channel.
