Subject: Oconee Nuclear Station, Unit 1
Docket Nos. 50-269
Licensee Event Report 269/2002-003, Revision 0
Problem Investigation Process Report No. O-02-01402

LICENSEE EVENT REPORT (LER)

TITLE (4)
Minor Reactor Pressure Vessel Head Leakage Due to Primary Water Stress Corrosion Cracking of An Alloy 600 Control Rod Drive Nozzle

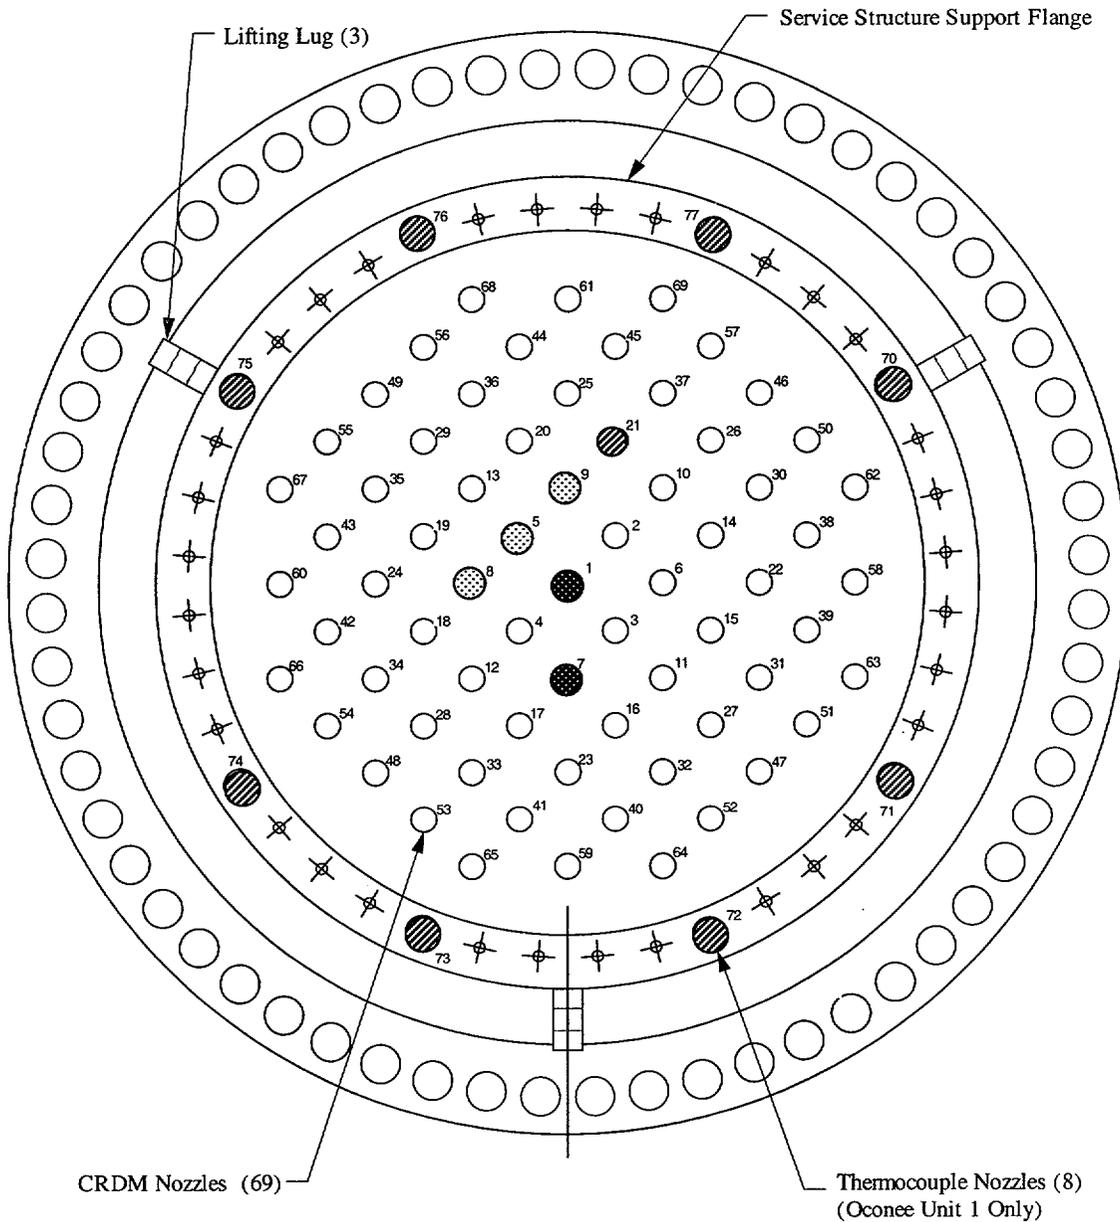
Figure 1 – Oconee Unit 1 RVH Map

From this visual inspection, no leakage was noted from the T/C nozzles. However, two CRDM nozzle penetrations (Nos. 1 and 7, see Figure 1) were identified with boron deposits on the CRDM

Following this initial inspection, a question was raised regarding the ability to effectively see around certain nozzles located high on the RVH. In particular, there were several nozzles whose full periphery would have been partially obstructed by the mirror insulation support beams that traverse the head. With the head installed, this configuration could have prevented a 360 degree perspective of these nozzles. To prevent outage impact while resolving these concerns, three additional nozzles (Nos. 5, 8 and 9) were subsequently identified as requiring additional nondestructive examination (NDE) inspections (Figure 1).

Results of the UT inspection revealed partial through-wall outside diameter (OD) cracks for nozzles 1, 7 and 8. The nozzle 7 and 8 findings appeared to be very similar to those seen from previous nozzle inspections on the other Oconee units. There were five flaws and a potential leak path identified for nozzle 7 and one axial flaw but no identified leakage path for nozzle 8. Nozzle 1 showed three minor indications in a region of rough weld contour while nozzles 5 and 9 did not show any UT indications. Since the UT scans for nozzles 5 and 9 were clear, no further inspection or repair was required.

A liquid dye-penetrant test (PT) of the bore of nozzle 7 (after removal of the nozzle) revealed two axial indications high in the original weld. This indicated a potential leak path through the weld. The video inspection for CRDM flange leaks found no leaking flanges and a review of a video of the top of the head made during the previous outage (1EOC19) did not show evidence of the new deposit around nozzle 7. Consequently, there was strong evidence that nozzle 7 was leaking through the weld and that the leak initiated during the past operating cycle.

The apparent root cause of the leaking Alloy 600 CRDM nozzle (No. 7) was Primary Water Stress Corrosion Cracking (PWSCC).

- Nozzles 1 and 7 were initially masked; Nozzle 7 was found to be leaking and was repaired
- Nozzles 5, 8 and 9 identified as being obstructed from 360° view; Nozzle 8 was repaired
- From 1EOC19: Nozzle 21 (leaking/repaired) and 8 Thermocouple Nozzles (leaking/plugged)

Nozzles 7 and 8 were repaired utilizing a similar process used for previous Oconee Units 2 and 3 nozzle repair campaigns. From under the RVH, the protruding portions of the nozzles, and a length of about 5 inches into the RVH bore, were removed by machining. A new pressure boundary weld was installed within the bore, inspected, and surfaced conditioned with a water jet peening process.

CRDM Nozzles 7 and 8 were repaired.
