MONTICELLO NUCLEAR GENERATING PLANT  
Docket No. 50-263 License No. DPR-22

**LER 2002-001, Rev 1 and LER 2002-002, Rev 1**

**4. TITLE**  
 Mechanical Pressure Regulator Failure Causes Reactor Scram

4. TITLE  
Application of Instrument Deviation Acceptance Criteria Allowed As-Found Settings to be Outside Technical Specification Value

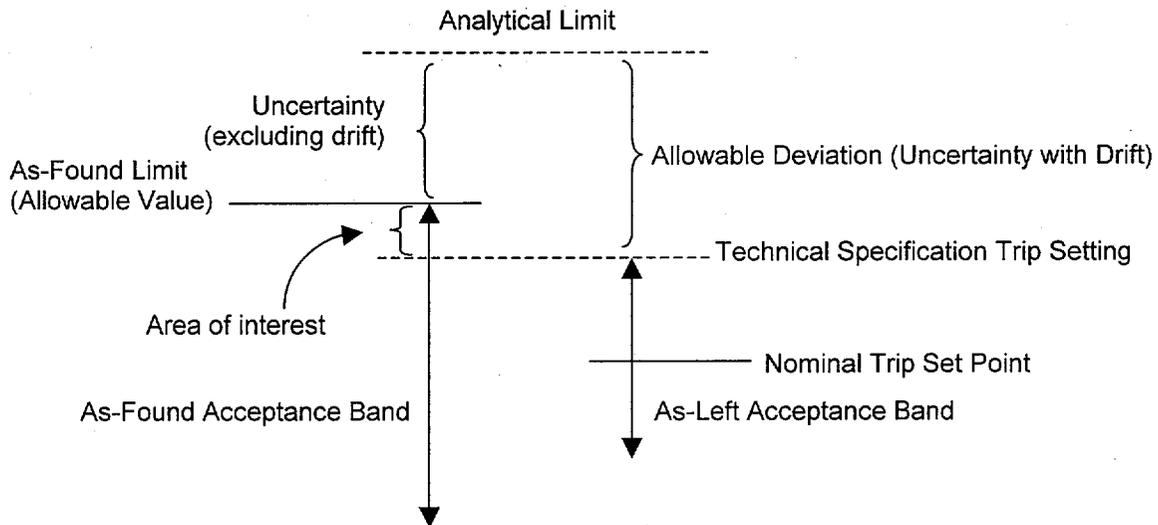
During an observation of a Rod Block Monitor<sup>1</sup> Functional Test and Calibration, it was noted that the instrument calibration As-Found Acceptance Band criteria allowed exceeding the Technical Specification (TS) value (see "Area of Interest" below). The actual As-Found calibration data was within TS values for the observed procedure. The As-Found Acceptance Band criteria is based on an allowable deviation from the TS trip setting which takes into account drift and uncertainty to assure that analytical limits of the safety analyses are not exceeded. However, the allowable deviations are contained in tables in the Bases of the TS and should not be construed as an allowance to deviate from the TS. It should be noted that the following statement was included in the original TS Bases and was never removed: "A violation of this specification is assumed to occur only when a device is knowingly set outside the limiting trip settings, or, when a sufficient number of devices have been affected by any means such that the automatic function is incapable of operating within the allowable deviation while in a reactor mode in which the specified function must be operable or when actions specified are not initiated as specified."

The application of the Allowable Deviations (from the Bases) to the Trip Settings (in the TS) is illustrated below.
