Subject: Catawba Nuclear Station, Units 1 and 2
Docket Nos. 50-413 and 50-414
Licensee Event Report 413/02-001, Revision 1

LICENSEE EVENT REPORT (LER)

4. TITLE
Both Trains of Control Room Area Chilled Water System Were Inoperable Simultaneously as a Result of Inadequate Troubleshooting Follow-Up

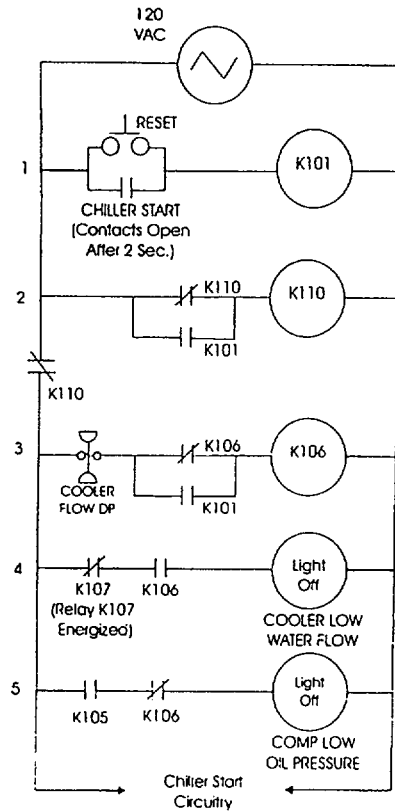
Figure 1a
CRACWS Chiller Control Circuitry
(Chiller Running/Normal Operation)

functioning of K101 is required for chiller operability. In the event that power is lost to the chiller control panel, K101 must reenergize when a start is attempted, or the remainder of the control circuit will not receive power and the chiller will not start. One of the relays downstream of and reset by K101 is K106. The purpose of K106 is to provide indication for loss of cooler flow and compressor low oil pressure conditions. K106 affects indication only and proper functioning of this relay is not required for chiller operability. Refer to Figure 1a on Page 8 of this LER for a simplified diagram of the control circuitry for the CRACWS chillers.

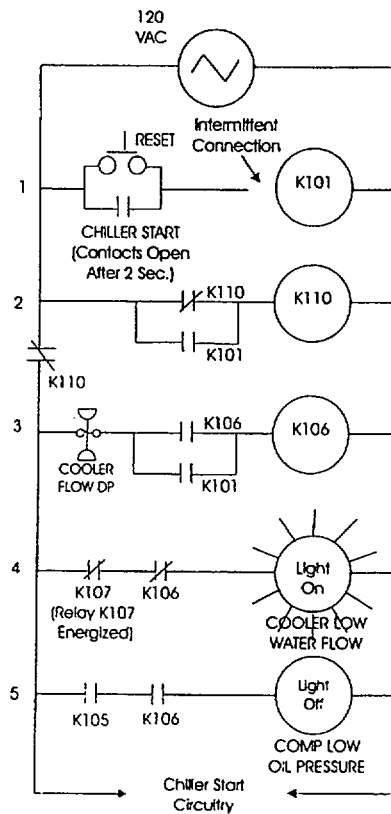
Figure 1b
CRACWS Chiller Control Circuitry
(Chiller Running/As-Found 2/21/02)

The root cause of this event was determined to be inadequate troubleshooting follow-up of the anomalous indication concerning the CRACWS Train A chiller prior to taking the CRACWS Train B chiller out of service for preventive maintenance. Had the suspected problem with relay K106 been validated, it would have become apparent that the problem was not with K106, but with K101 instead. K101 had relay leads which had become loose over time and had disconnected. The reason for the relay leads becoming loose could not be determined. No work activities were traced to this relay which could have resulted in the leads becoming loose. When the leads became disconnected, the ability of the chiller to be restarted automatically or manually in response to a loss of power event was lost, thus rendering the chiller inoperable.

During troubleshooting activities associated with the CRACWS Train A chiller on February 21, the problem with the leads was not discovered due to inadequate follow-up and validation/verification of the suspected problem. It is believed that the leads were making intermittent contact for a period of time prior to becoming disconnected. When relay K106 was discovered to be deenergized on February 21, the problem was believed to be limited to K106. If the problem were limited to K106, the design function of the chiller to restart following a loss of power event would not have been lost. As a result, the decision was made to take the CRACWS Train B chiller out of service on February 24 for preventive maintenance activities. Therefore, from February 24 at 1735 hours until February 27 at 2255 hours, both units were unknowingly in TS 3.0.3 and in violation of TS 3.7.11.

1. Following the discovery of the disconnected wiring for relay K101 of CRACWS Train A chiller, other wiring associated with the chiller controls for both chillers was examined and checked for tightness.

1. Engineering and Maintenance management will communicate to appropriate staff personnel the troubleshooting aspects of this event. Specifically, as part of troubleshooting activities, personnel suspecting failed components shall validate the suspicion prior to considering a structure, system, or component operable. Also, personnel shall consider that components providing input to a suspected failed component may themselves be failed, thereby affecting the end component.
2. The communications and expectations associated with troubleshooting activities in Planned Corrective Action 1 will be covered with Operations personnel via formal training to ensure that Operations is aware of this policy.
