Dominion Nuclear Connecticut, Inc.  
Millstone Power Station  
Rope Ferry Road  
Waterford, CT 06385

Docket No. 50-336  
B18662

Millstone Nuclear Power Station, Unit No. 2  
Reply to Request for Additional Information  
Related to NRC Bulletin 2001-01

Reply to Request for Additional Information  
Related to NRC Bulletin 2001-01

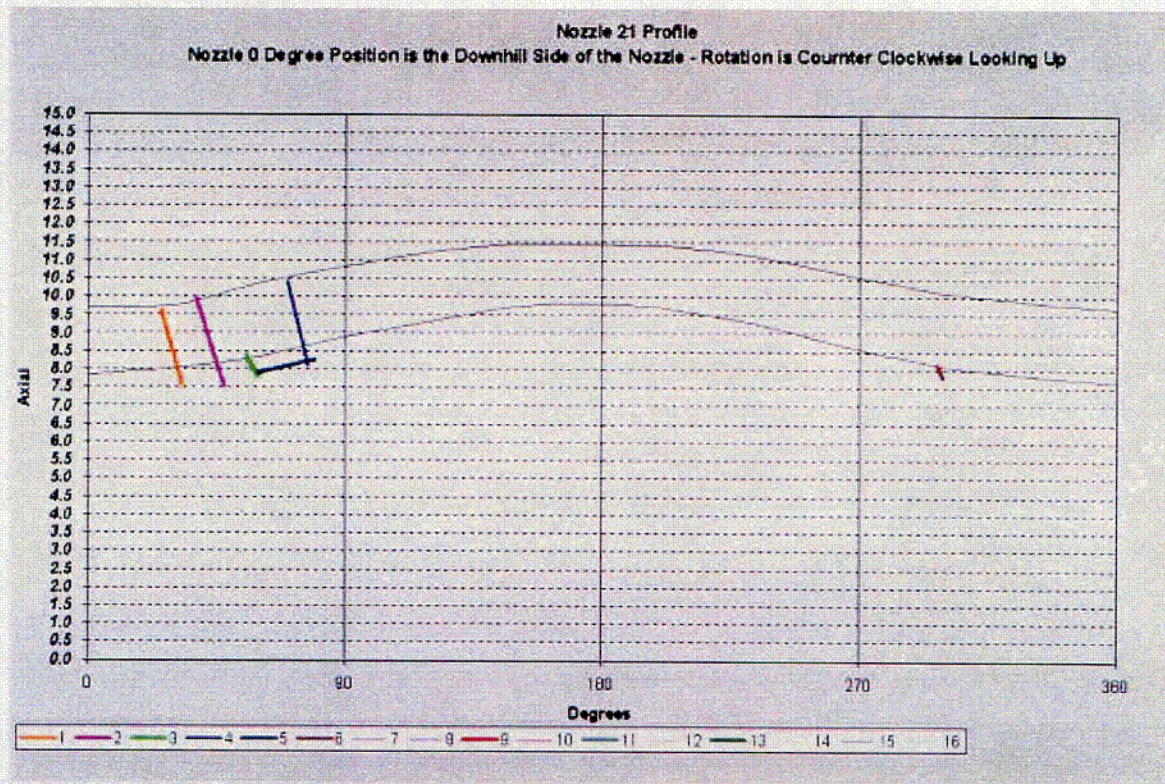
Indication No.	1	2	3	4	5	6
Location	OD Downhill	OD Downhill	OD Downhill	OD Downhill	OD Downhill	OD Downhill
Orientation	Axial	Axial	Axial	Axial	Circ	Axial
Length (in.)	2.04	2.44	.59	2.28	.77	.37
Depth (in.)	.20	.19	.19	.09	.18	.15

Figure 1 Location of UT indications in Nozzle 21 from 2R14 Inspection

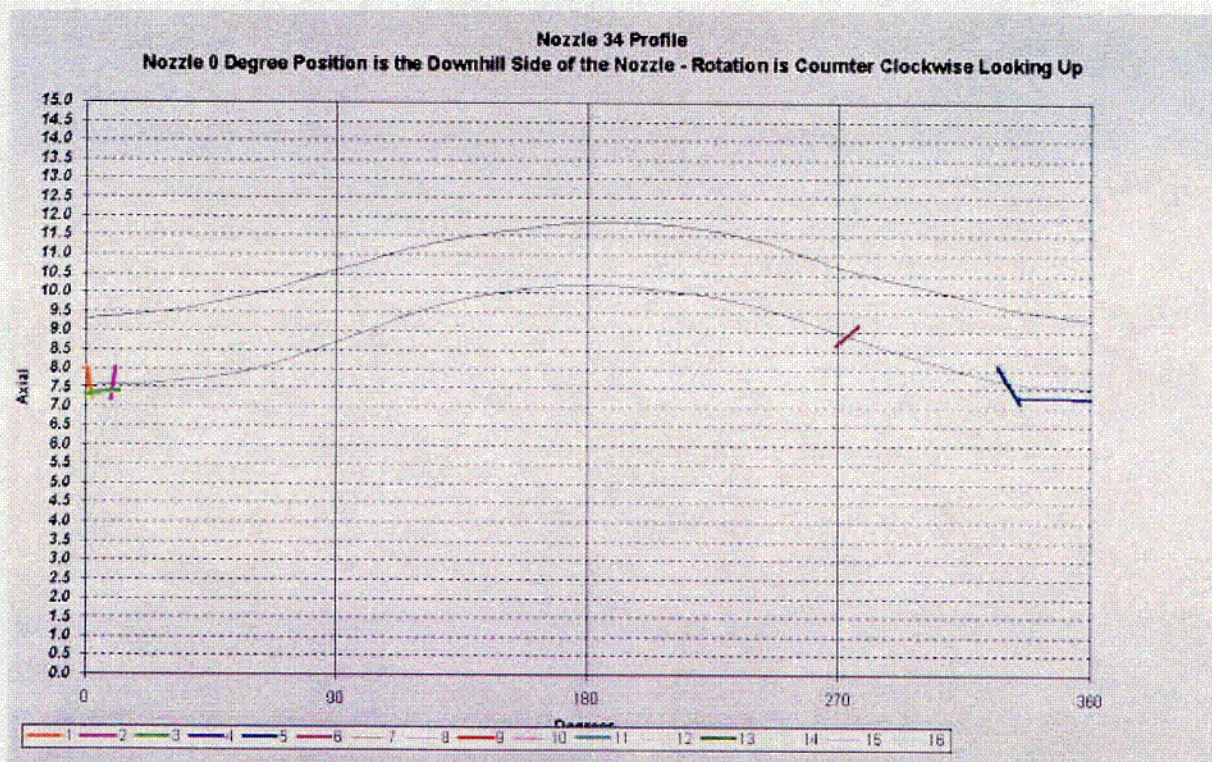
Figure 2 Location of UT indications in Nozzle 34 from 2R14 Inspection

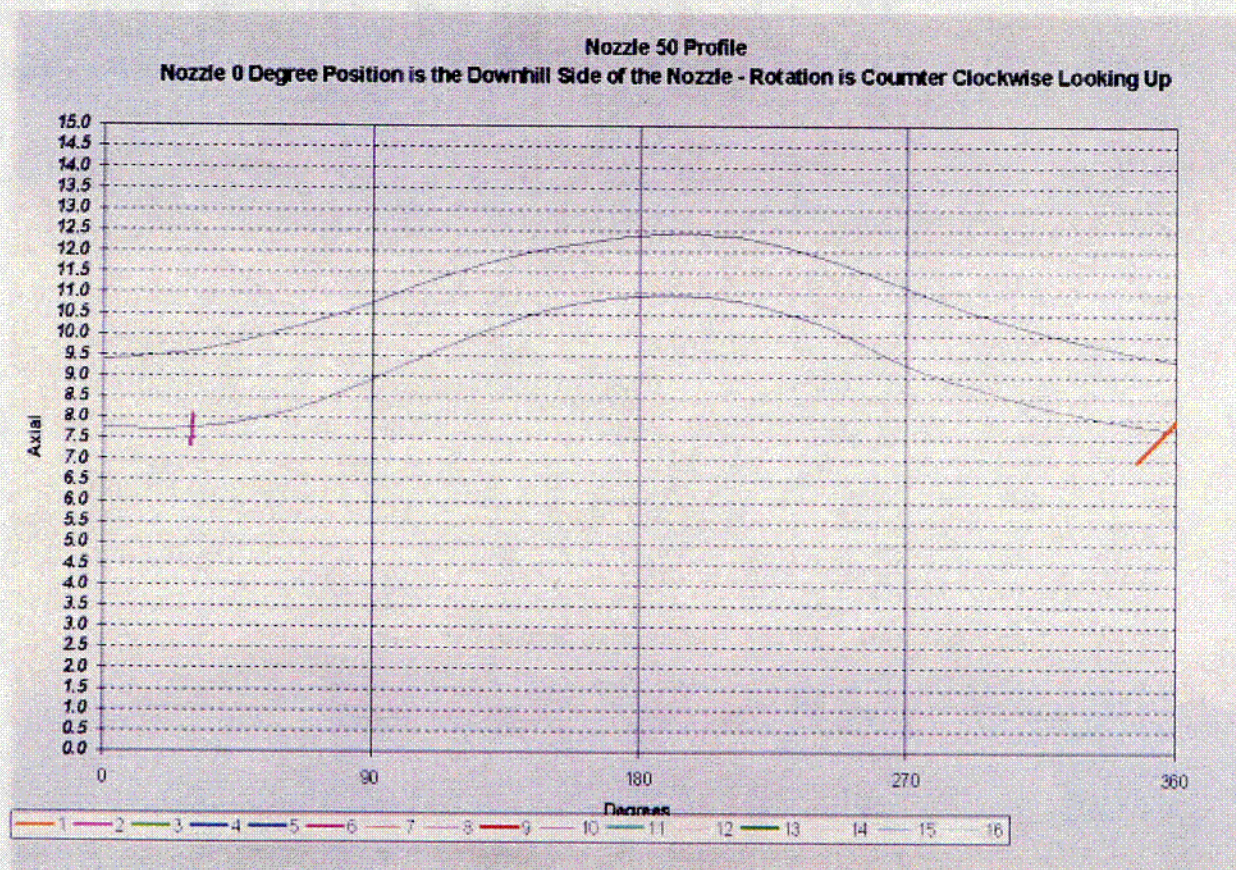
Figure 3 Location of UT indications in Nozzle 50 from 2R14 Inspection
