**TENNESSEE VALLEY AUTHORITY - BROWNS FERRY NUCLEAR PLANT (BFN) -
UNIT 3 - DOCKET 50-296 - FACILITY OPERATING LICENSE DPR - 68 -
LICENSEE EVENT REPORT (LER) 50-296/2002-003-00**

LICENSEE EVENT REPORT (LER)

TITLE (4)
Actuation of RPS while shutdown due to inadvertent depressurization of scram pilot air header

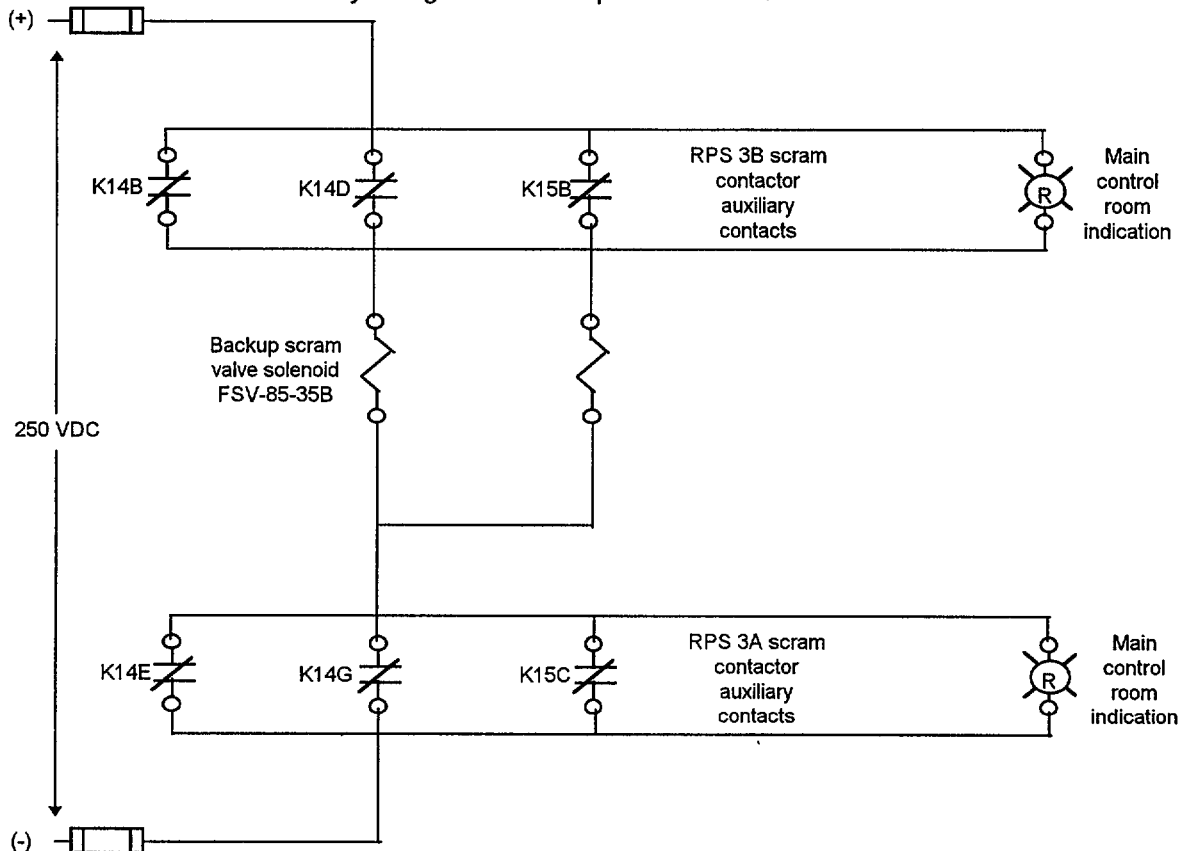
The simplified schematic below depicts the electrical circuit containing backup scram valve 3-FSV-085-0035B. It can be seen that with the K15C contacts from RPS 3A closed (having failed to open when the contactor itself was energized), the closure of the contacts from any of contactors K14B, K14D, or K15B in RPS 3B would directly energize the backup scram valve.

Over time, the plunger arm hold screw loosened such that the auxiliary contacts of scram contactor BFN-3-CONT-099-05AK15C did not open.

The logic for backup scram valve operation was partially completed without the knowledge of the Maintenance nor Operations personnel. When the PM work proceeded to the opposite RPS trip system, the backup scram circuit was completed, the backup scram valve opened, and the full scram resulted from scram pilot air header low pressure.

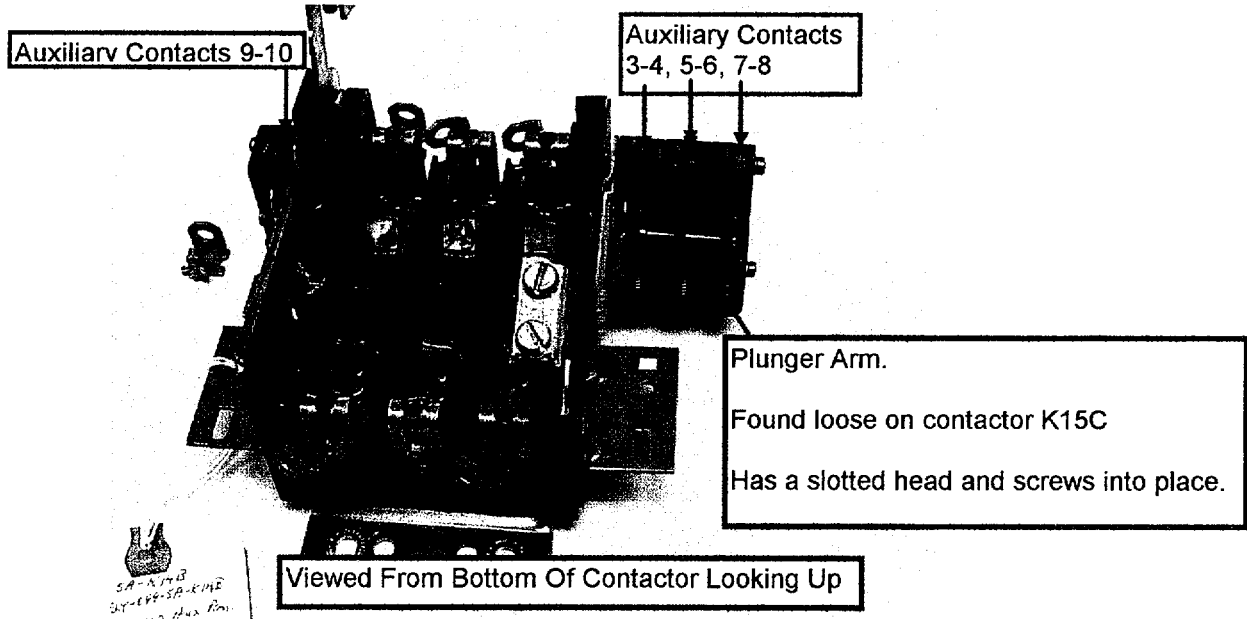
A loose plunger arm screw on RPS scram contactor 3-CONT-099-05AK15C [CONT] was discovered. This loose plunger arm prevented proper operation of the associated auxiliary contacts. These contacts are designed to open when the main contactor is energized, however, with the plunger arm in a loose condition, these contacts were remaining closed when the main contactor was energized. It was determined that faulty operation of the auxiliary contacts on this RPS contactor had allowed the RPS 3A portion of the energization circuitry for backup scram valve 3-FSV-085-0035B to be partially completed when it should not have been. During subsequent work on the RPS 3B contactors, the backup scram valve energization circuit was unknowingly completed, resulting in the valve's actuation. The purpose of the backup scram valve is to vent and depressurize the scram pilot air header upon a full scram condition; the inadvertent operation of this valve directly caused the actual scram pilot air header low pressure and the resulting full actuation of the RPS logic.

The cause of this event was loosening of the contactor plunger arm screw. The loosening of this screw prevented the proper operation of the RPS contactor auxiliary contacts. The faulty operation of these auxiliary contacts in conjunction with the continuing PM work on other RPS contactors led to the unexpected full scram condition.

RPS contactor - General Electric type CR105X auxiliary contact operating arm. The picture below shows part of this component, including the auxiliary contacts and the auxiliary operating rod.

Work order 01-007824-001 was planned and worked to identify and repair faulty scram contactor auxiliary contacts. The plunger arm screw on BFN-3-CONT-099-05AK15C was tightened two full turns. The remaining Unit 3 scram contactors were inspected and six different screws were found loose. These screws were tightened from one-half to one full turn. Unit 3 has twelve total RPS scram contactors.

Electrical Maintenance instructions are being revised to ensure the scram contactor auxiliary contacts are inspected during preventive or corrective maintenance activities. Note that subsequent to this event General Electric published 10 CFR 21 notification SC02-05 on scram contactor auxiliary contact operation. The Electrical Maintenance instructions will use the inspection criteria as defined in the notification.
