Re: Highland Reclamation Project
Source Materials License SUA-1139
Docket No. 40-8102.
As-Built and Construction Quality Assurance Report
Converse County, WY

**AS-BUILT AND CONSTRUCTION QUALITY
ASSURANCE REPORT FOR THE URANIUM
TAILINGS BASIN AT THE HIGHLAND
RECLAMATION PROJECT**

Prepared By:
Shepherd Miller
3801 Automation Way, Suite 100
Fort Collins, Colorado 80525

May 31, 2002

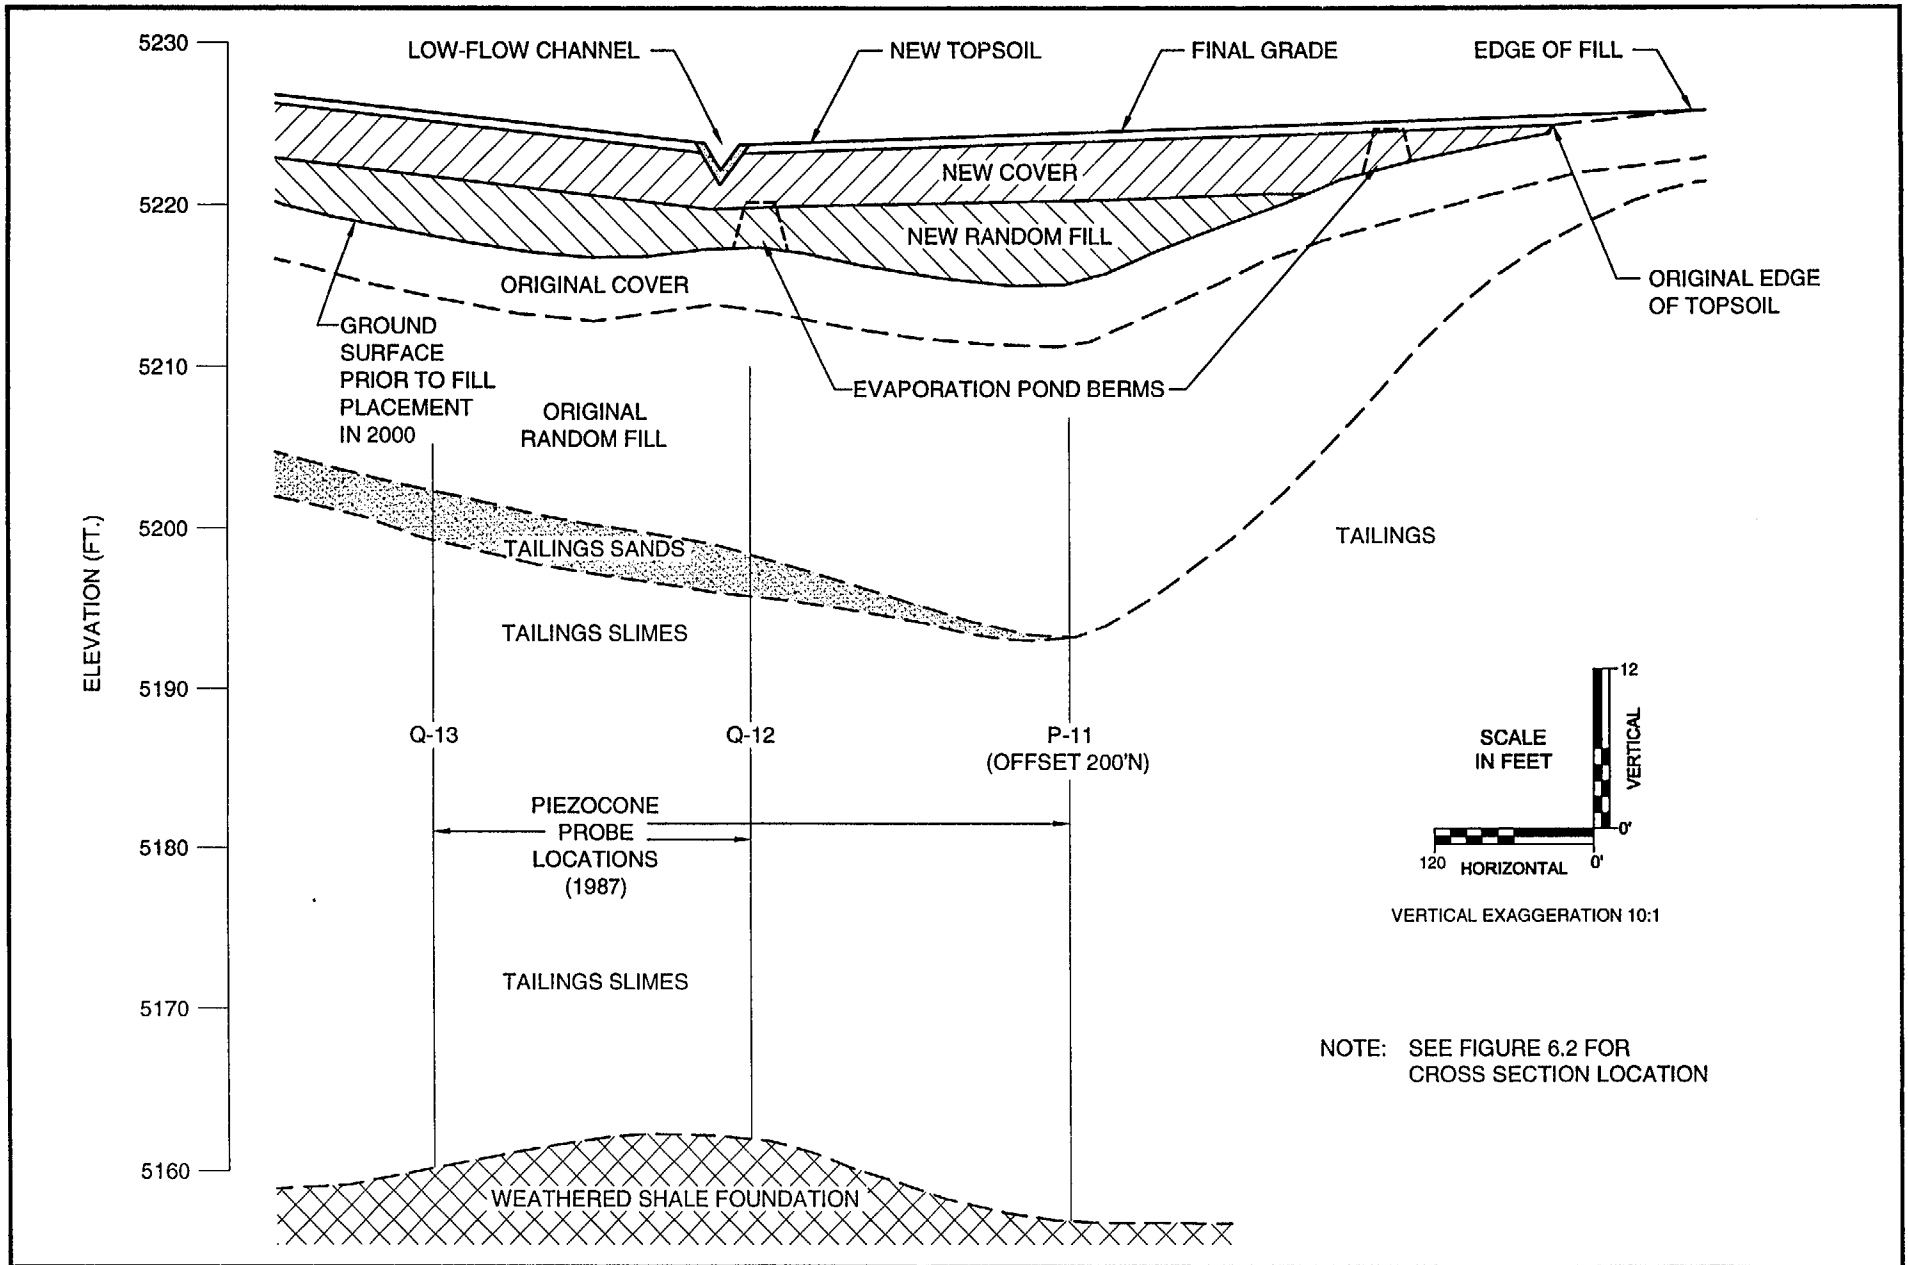
FIGURE 6.3
ADDITIONAL FILL AREA CROSS SECTION

The additional cover material in the fill placement area resulted in a cover system that was significantly thicker than the original cover (Figure 6.3), and would significantly enhance the anticipated performance of the cover over the fill placement area (for radon attenuation and reduction of infiltration).

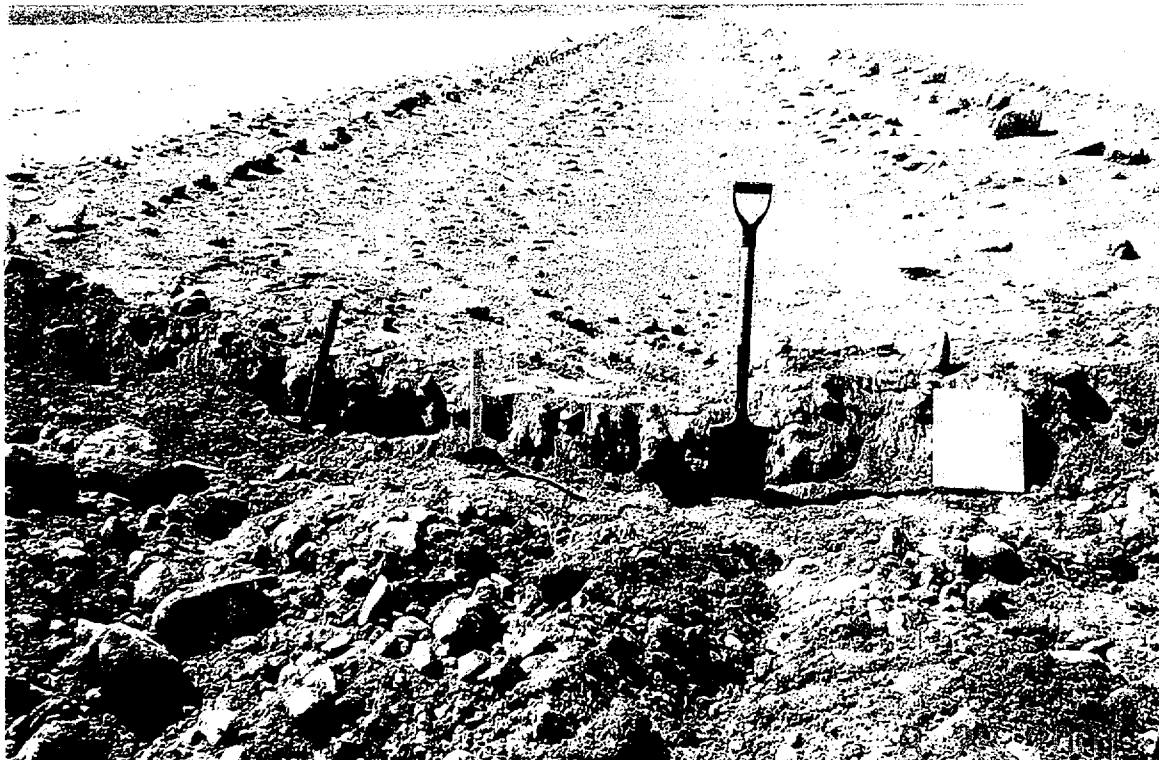
Photo A.13.2 Looking south up south low-flow channel, with trench to check rock layer thickness and particle-size distribution. (Aug 2001)

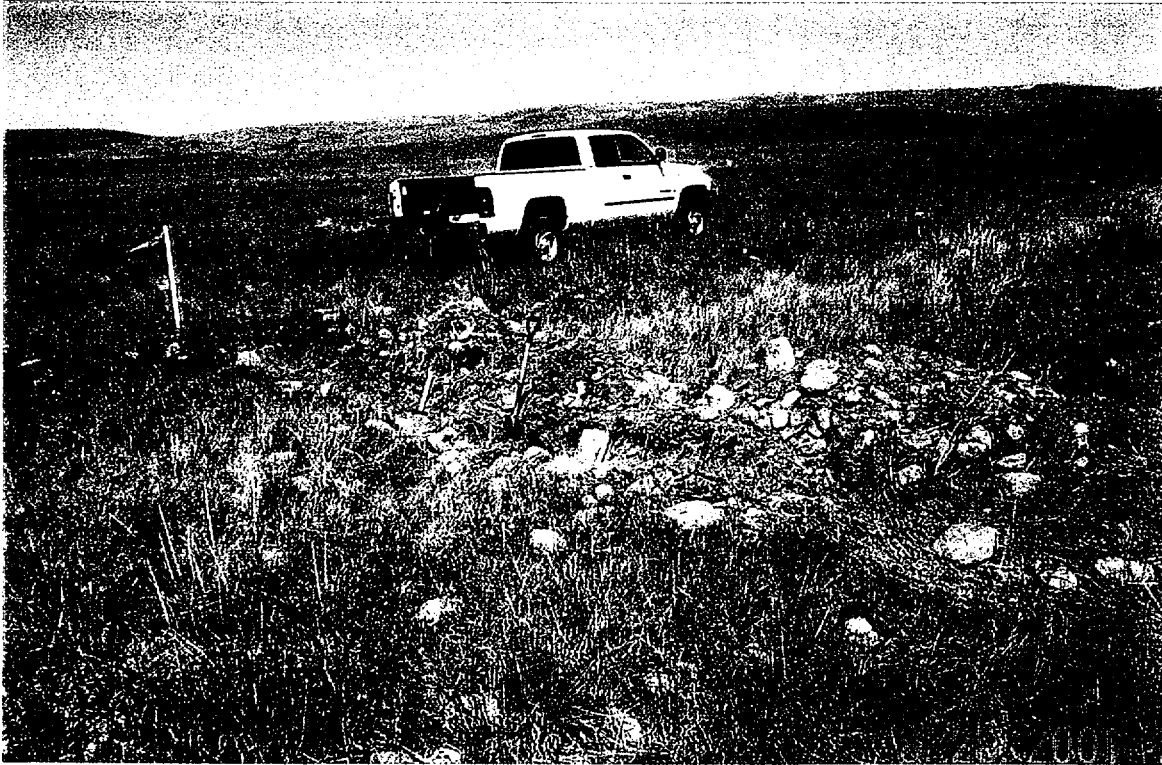
Photo A.14.1 Trench across old section of south low-flow channel, checking rock layer thickness and particle-size distribution. (Aug 2001)
