**SEQUOYAH NUCLEAR PLANT (SQN) - UNIT 2 ITEM 5 RESPONSE TO NRC BULLETIN 2001-01, "CIRCUMFERENTIAL CRACKING OF REACTOR PRESSURE VESSEL HEAD PENETRATION NOZZLES," DATED AUGUST 3, 2001 (TAC No. MB2660) - UNIT 2 ITEM 2 RESPONSE TO NRC BULLETIN 2002-01, "REACTOR PRESSURE VESSEL HEAD DEGRADATION AND REACTOR COOLANT PRESSURE BOUNDARY INTEGRITY," DATED MARCH 18, 2002 (TAC No. MB4579)**

TENNESSEE VALLEY AUTHORITY  
SEQUOYAH NUCLEAR PLANT (SQN)  
UNIT 2

THIRTY-DAY, AFTER PLANT RESTART, RESPONSE TO:  
NRC BULLETIN 2001-01, "CIRCUMFERENTIAL CRACKING OF REACTOR PRESSURE  
VESSEL HEAD PENETRATION NOZZLES"

NRC BULLETIN 2002-01, "REACTOR PRESSURE VESSEL HEAD DEGRADATION AND  
REACTOR COOLANT PRESSURE BOUNDARY INTEGRITY"

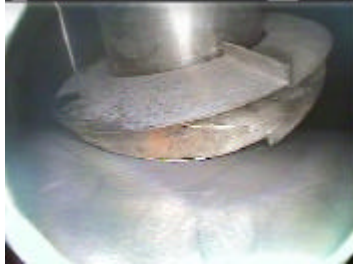
penetrations, 16 penetrations were found with slipped ISRs resulting in reduced inspection access. In these cases, the penetration interface could not be seen (usually on the uphill side), however; no evidence of boron crystals was noted outside the ISR. Where physical access was permitted, the ISRs were moved to allow additional examination. Figure Nos. 1 and 2 (CRDMP No. 58) provide a typical example of the ISR inspection interference before the ISR was moved and after movement.

Figure 1 - CRDMP No. 58  
Typical Insulation Support Ring  
Interference Before Repositioning

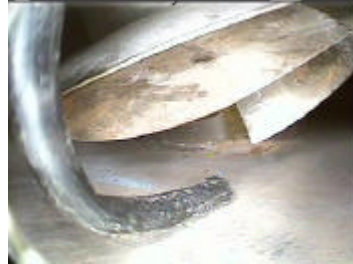
Figure 2 - CRDMP No. 58  
Typical Insulation Support Ring  
Interference After Repositioning

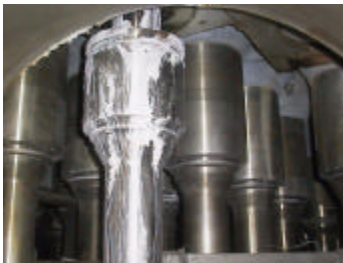
One area of concern was located at CRDM No. L-15 (CRDMP No. 75) which is an outer peripheral penetration. A Conoseal mechanical joint leak was identified at CRDM No. L-15. The leakage path extended to the penetration interface at the head and continued down the RPV head onto the flange. The characteristics of residue and corrosion product indicates that the leakage had occurred sometime prior to plant shut

down. There was no evidence of leakage at the penetration to RPV head interface. Figures 11, 13, and 15 show the as found condition.

Figure 11 - CRDMP No. 75  
L-15 Conoseal Leakage Path at CRDM  
Column (As Found)

The leakage condition at CRDM No. L-15 (CRDMP No. 75) that resulted from the Conoseal mechanical joint was entered into the TVA corrective action program and evaluated under TVA's BWC Program. As part of the corrective actions taken, the boron residue and corrosion product was removed from the CRDM column (accessible areas), RPV head penetration area, RPV head, and flange area. Residue was sufficiently removed on the CRDM column so as to not mask any critical areas (e.g. canopy seal weld area, bi-metallic weld, head penetration, etc.) for future evaluations for leakage. Figures 12, 14 and 16 show the cleaned, as left, condition. The corrosion on the RPV head, as a result of CRDM No. L-15 leakage, was superficial and had no indication of material degradation after removal. This location is on the outer periphery of the RPV head and is inspected each refueling outage. The inspection is required by site procedure to monitor for penetration leakage. The root cause of CRDM No. L-15 leakage was indeterminate. The most likely causes are either: 1) foreign material was present that did not cause a scratch or sealing surface flaw, or 2) the connecting clamp was insufficiently torqued during previous reassembly. Neither cause could be confirmed from the evidence at hand, and both appear to have sufficient steps in place in the reactor reassembly procedure to prevent recurrence.
