SUBJECT

Contaminated Water Release - 6/2/60

WESTINGHOUSE TESTING REACTOR

CONTAMINATED WATER RELEASE TO STORM SEWER

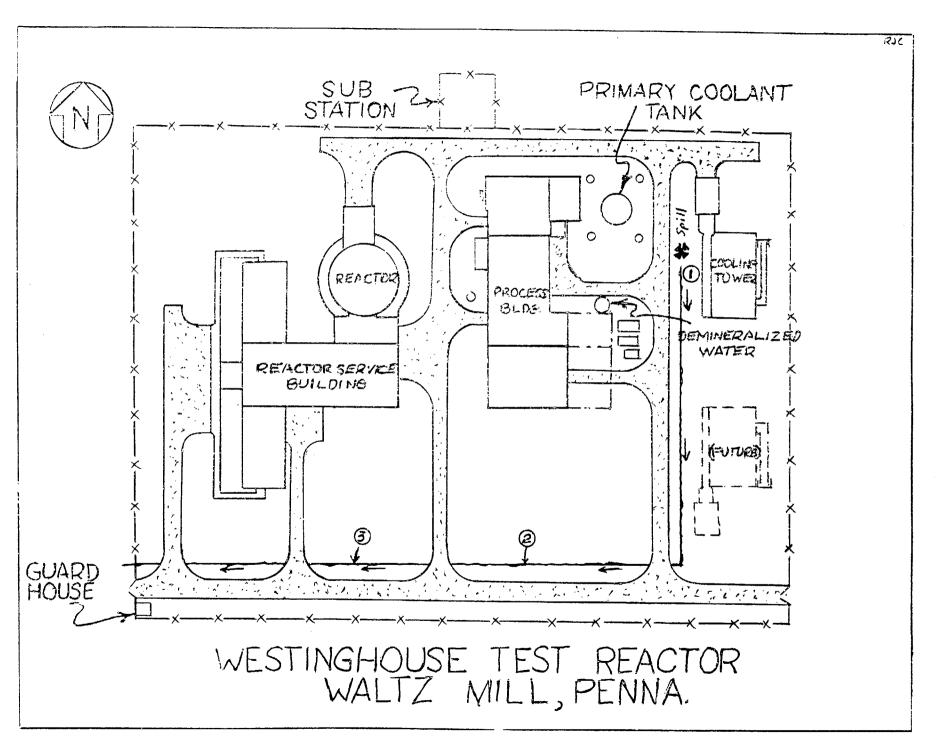
Figure 1

A third crew started taking water samples and processing these for contamination level determinations. These samples were continued and aliquots of most of these set aside for analysis by the State Sanitary Water Group. The results are given in Table I, and the sampling points are shown in Figures 1 and 2. The Health Physics Section offered to process any samples that might be requested or furnished by the State engineers and this offer was accepted by Mr. Heil, the Regional Sanitary Water Engineer, due to a lack of such facilities in the area by the State.

GEOLOGICAL SURVEY MAP OF THE REACTOR SITE
