July 11, 1960

**REPORT ON
WTR FUEL ELEMENT
FAILURE APRIL 3, 1960**
JULY 7, 1960

REPORT ON WTR FUEL ELEMENT FAILURE APRIL 3, 1960

FUEL ELEMENT FAILURE
IN THE
WESTINGHOUSE TESTING REACTOR

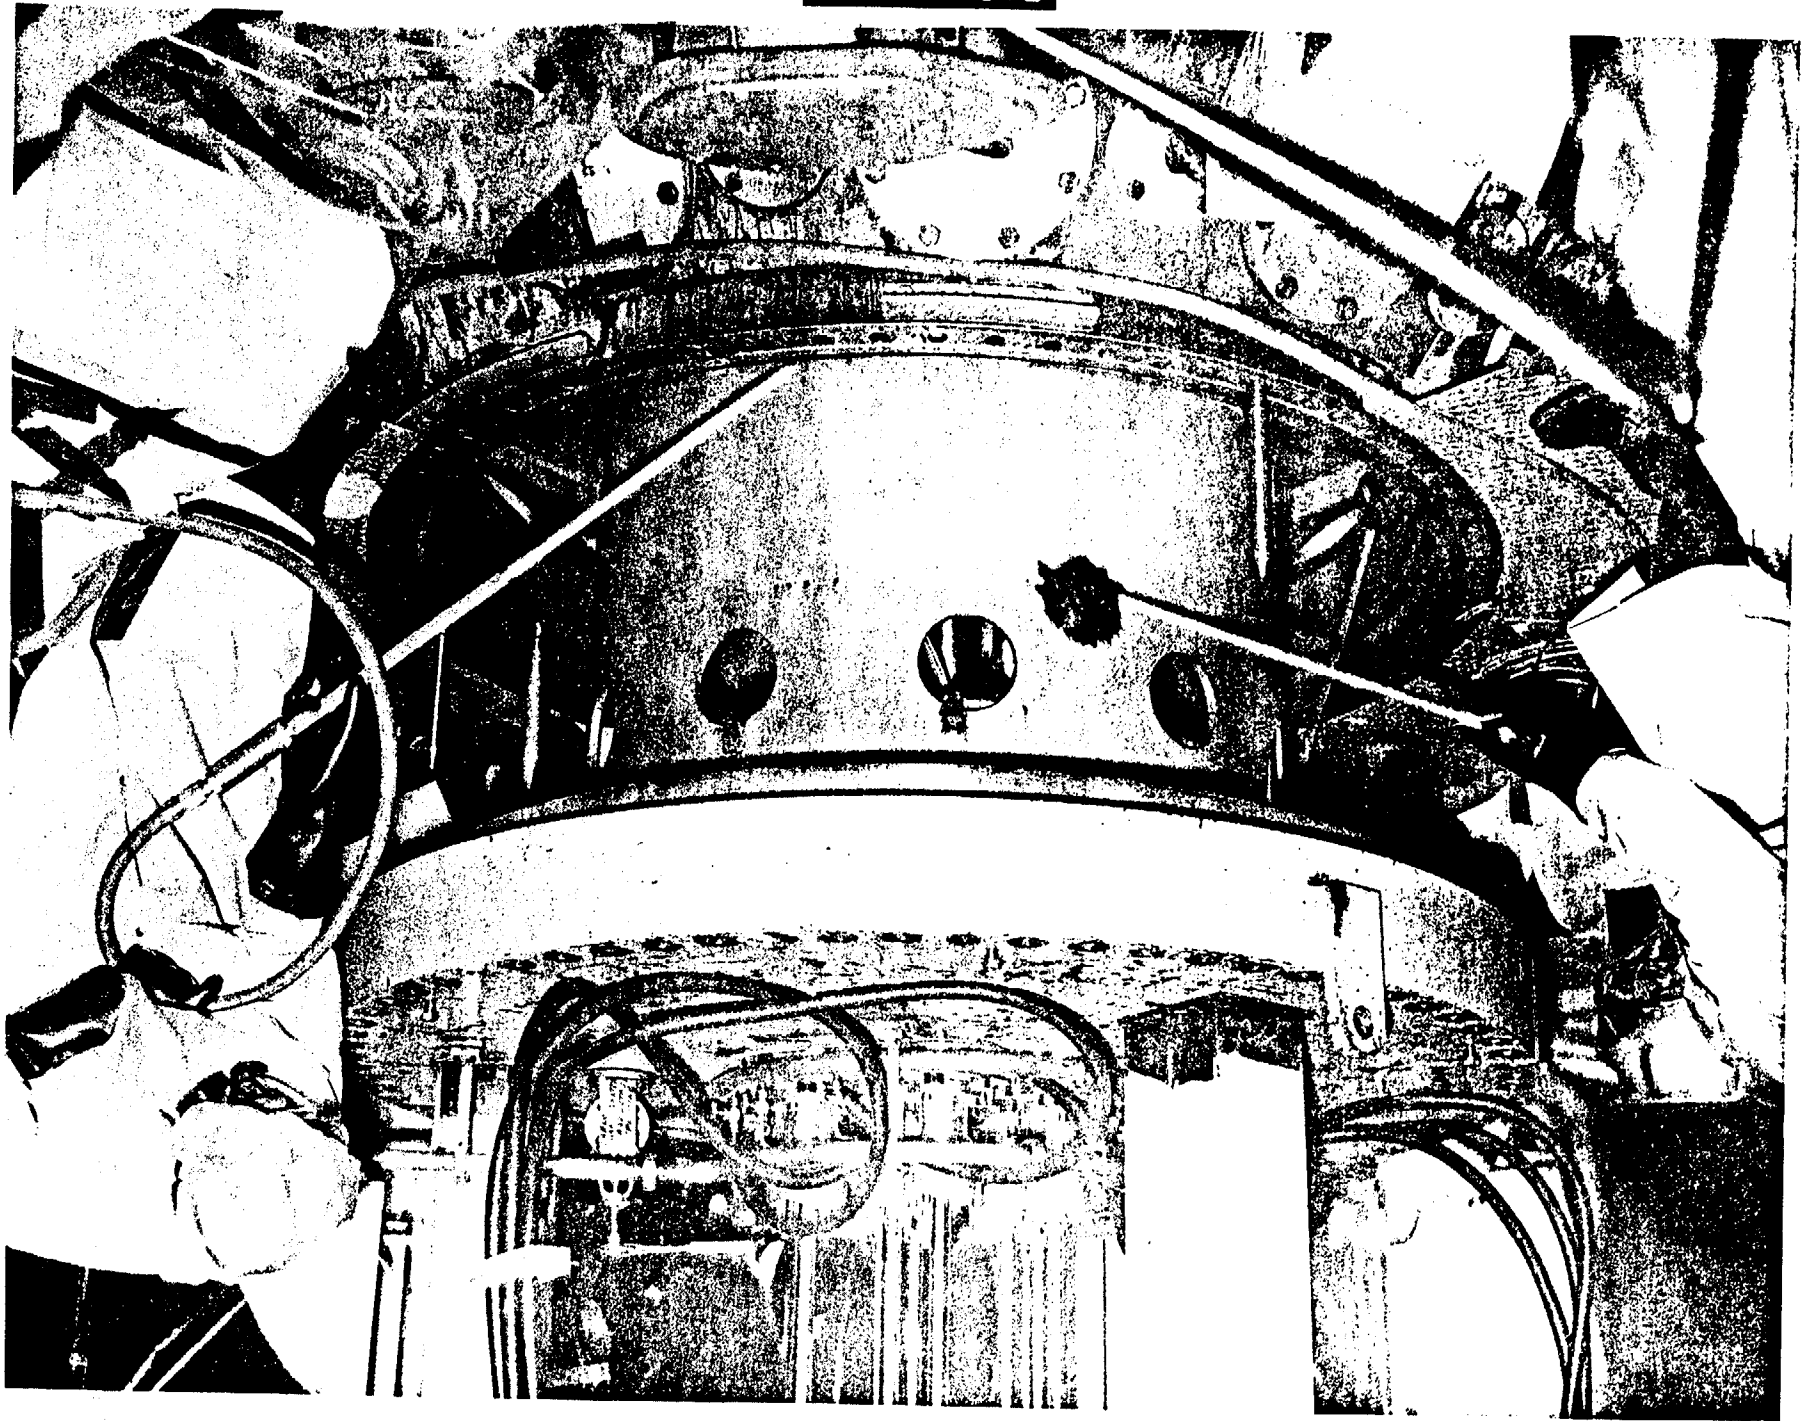
Figure 23a
View of Core - April 11, 1960

In order to permit visual observation of the core and to begin unloading the core, a 3 inch thick iron shielding platform was constructed. This reduced the radiation level to 35 mr/hr gamma at the working level. Figure 23a shows a photograph of the core taken on April 11. No visible damage was apparent at the time.

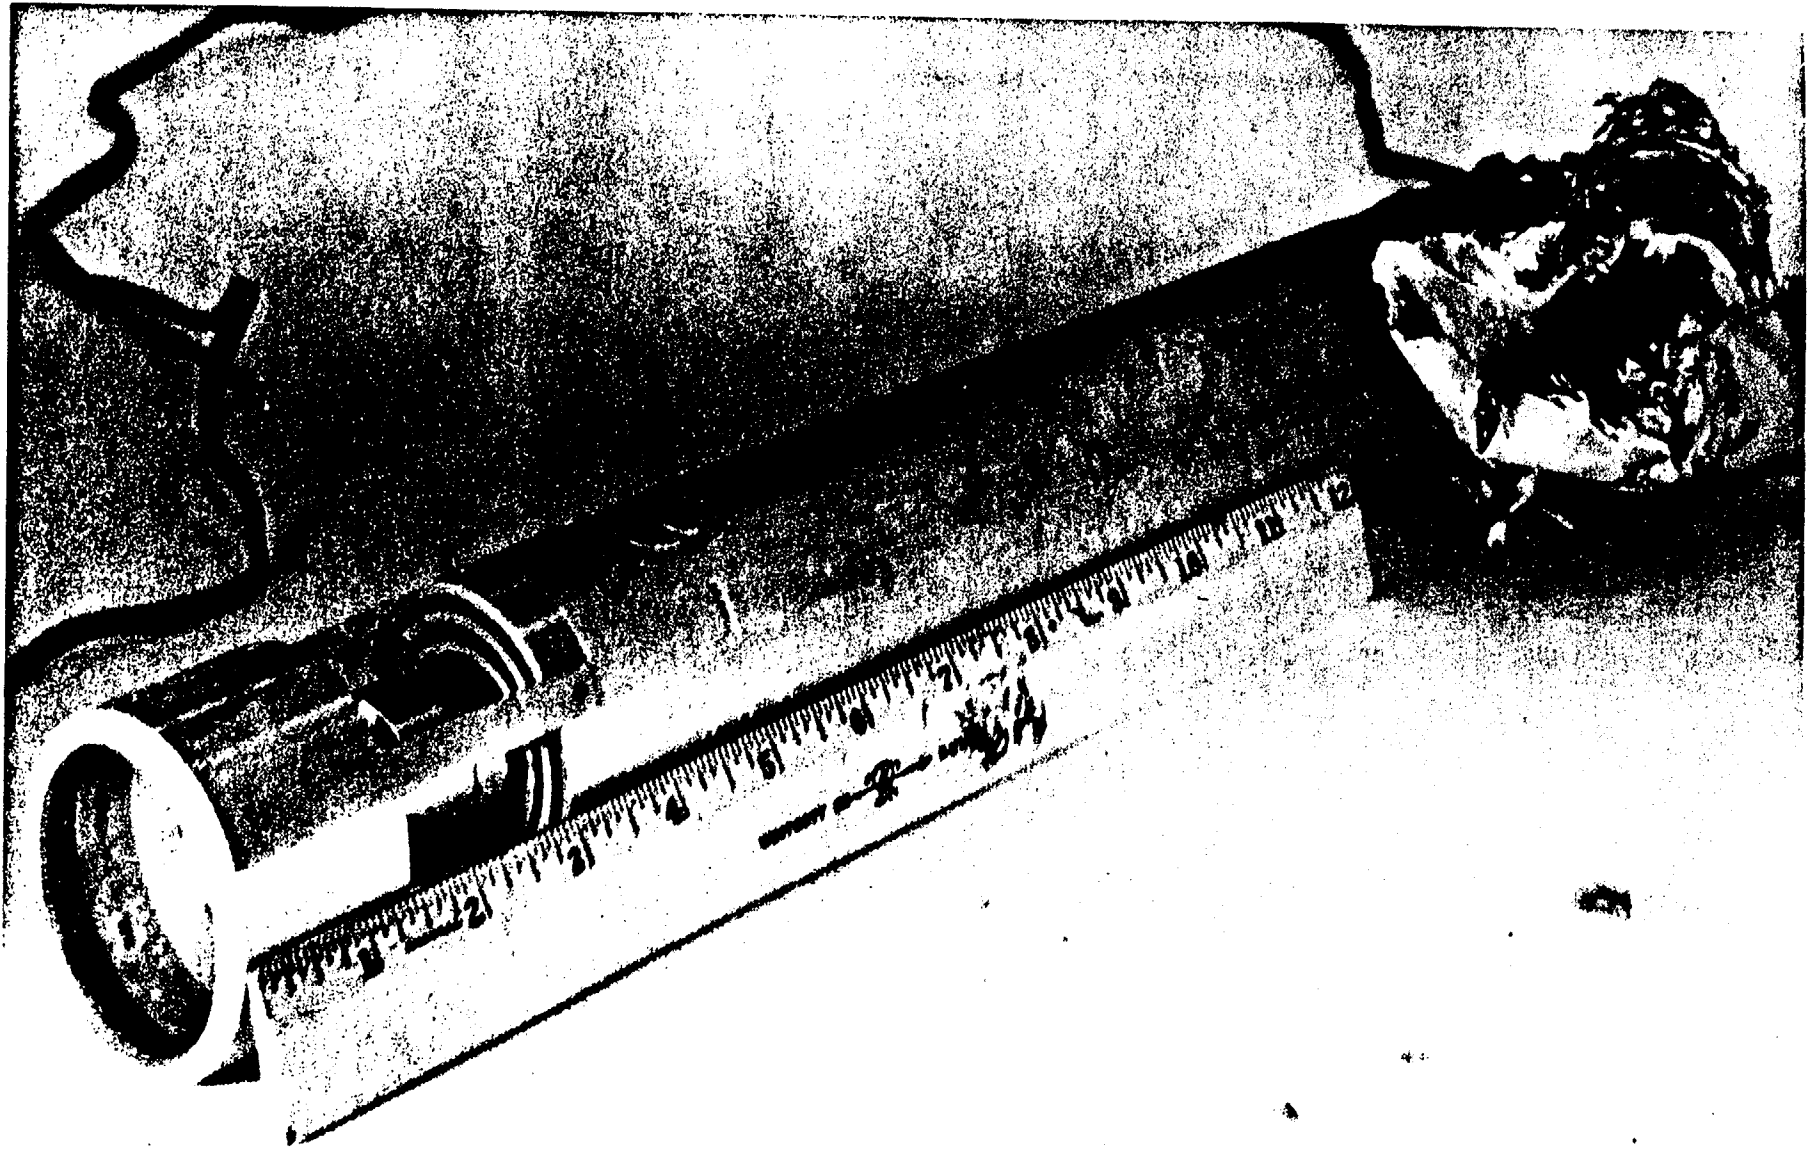
Upon examination, all fuel elements thus removed from the core appeared discolored but without apparent physical damage. The stuck element was finally removed by a 500 lb. force and only the upper third of the element came loose. This section, after it was removed from the core in a special cask is shown in Figure 24. Several futile attempts were made to push up the lower portion of the failed element from the core. The bottom end of the shroud tube appeared to be solidly plugged and through the water had a cast-iron-like appearance. Finally a core drill type hole saw was fabricated to remove this section from the element shroud. The drilling operation began on April 21 and terminated on April 25 when the final portion of the damaged element was removed in the core drill. Figure 25 shows the remains of this portion of the element after it was extracted from the drill. In this figure some of the center section has also been removed. This drilling operation greatly increased the vessel water and airborne activity levels. Visual examination of the shroud holes and a later check with a sizing tool indicated that the core structure had not been damaged.

FIGURE 24
VIEW OF UPPER SECTION OF FAILED FUEL ELEMENT

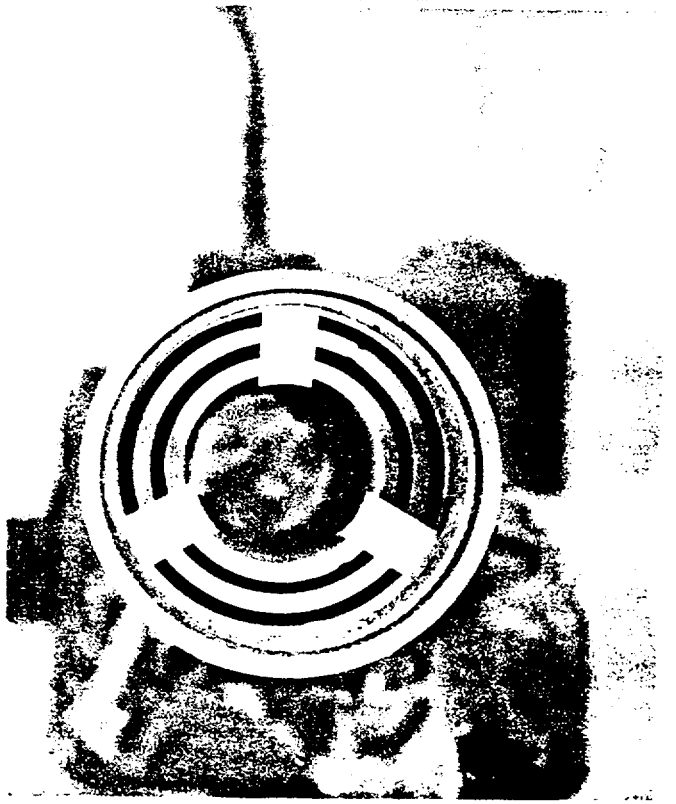
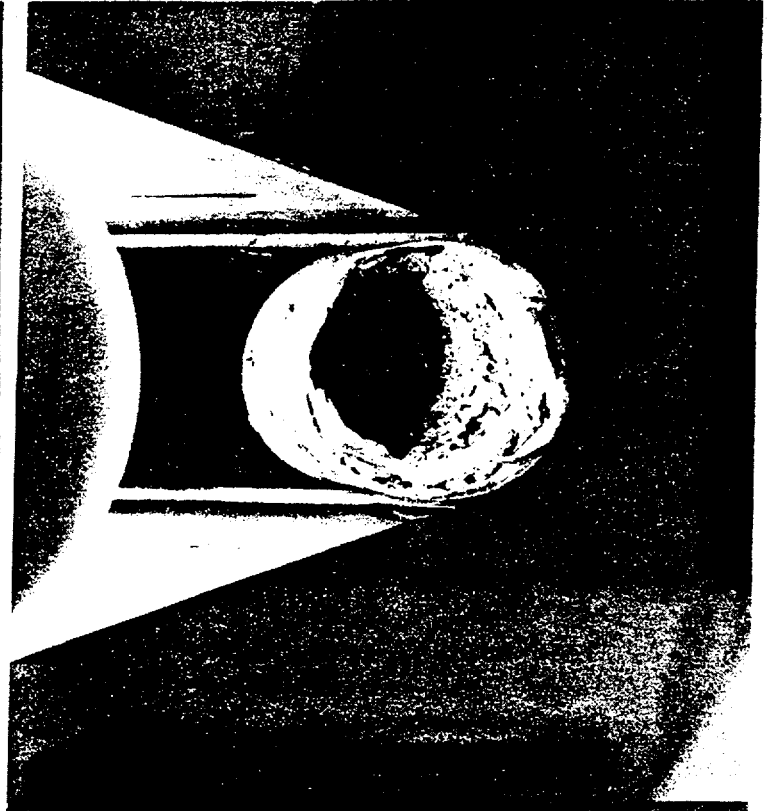
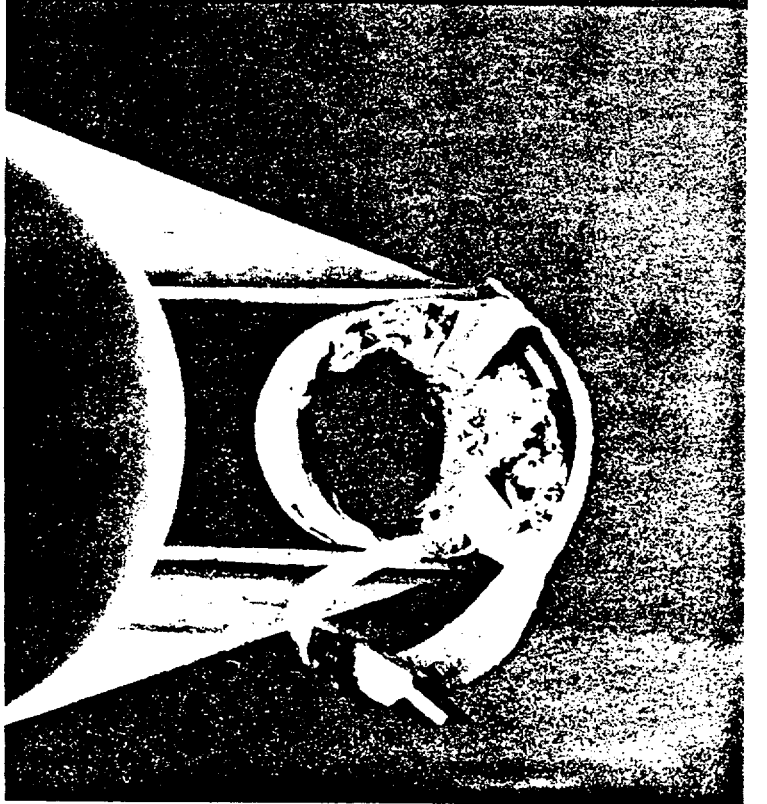
FIGURE 25
VIEW OF LOWER SECTION OF FAILED FUEL ELEMENT
WHEN EXTRACTED FROM HOLE SAW

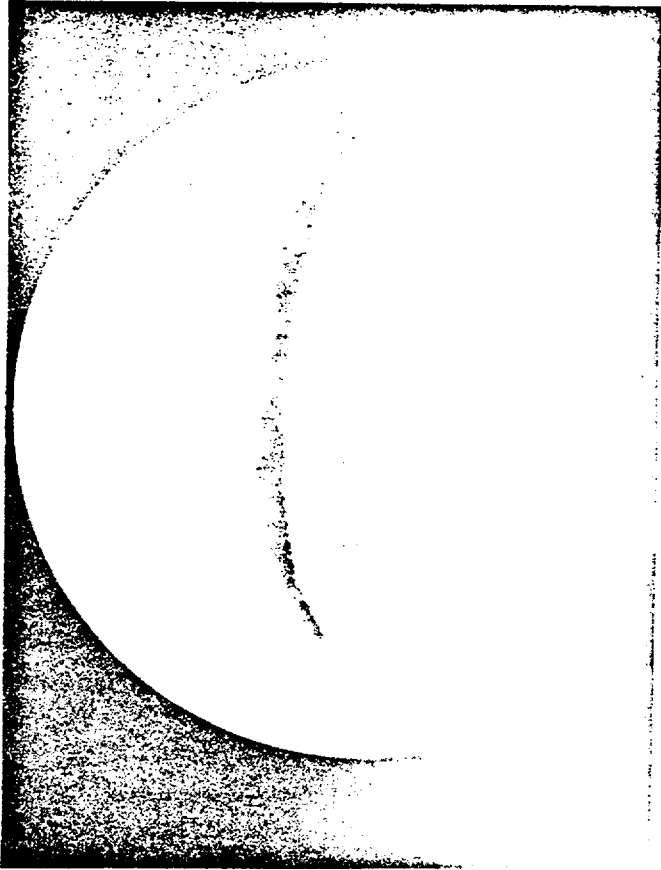
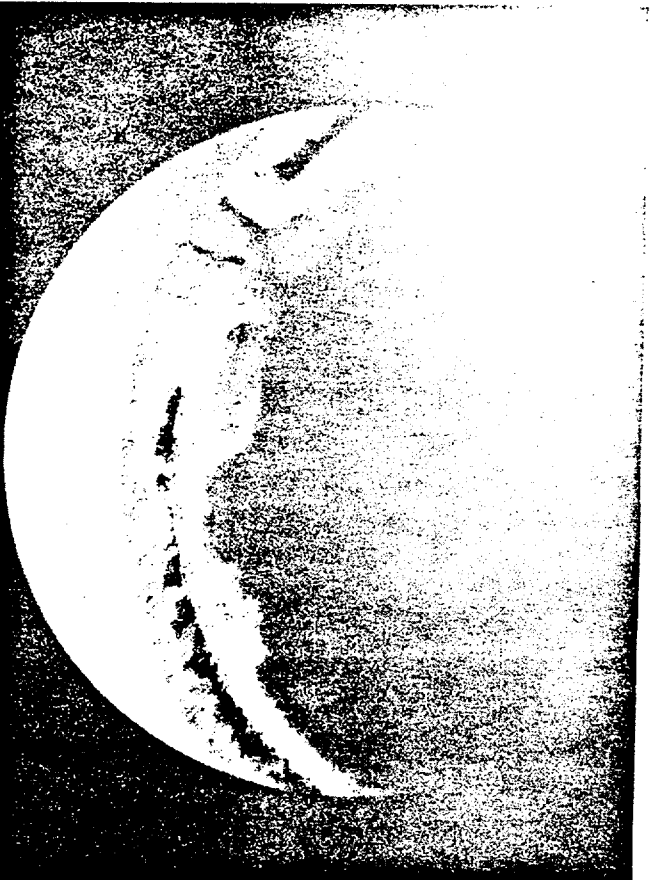
FIGURE 35
FOUR VIEWS OF SECTION 5 1/2" FROM END

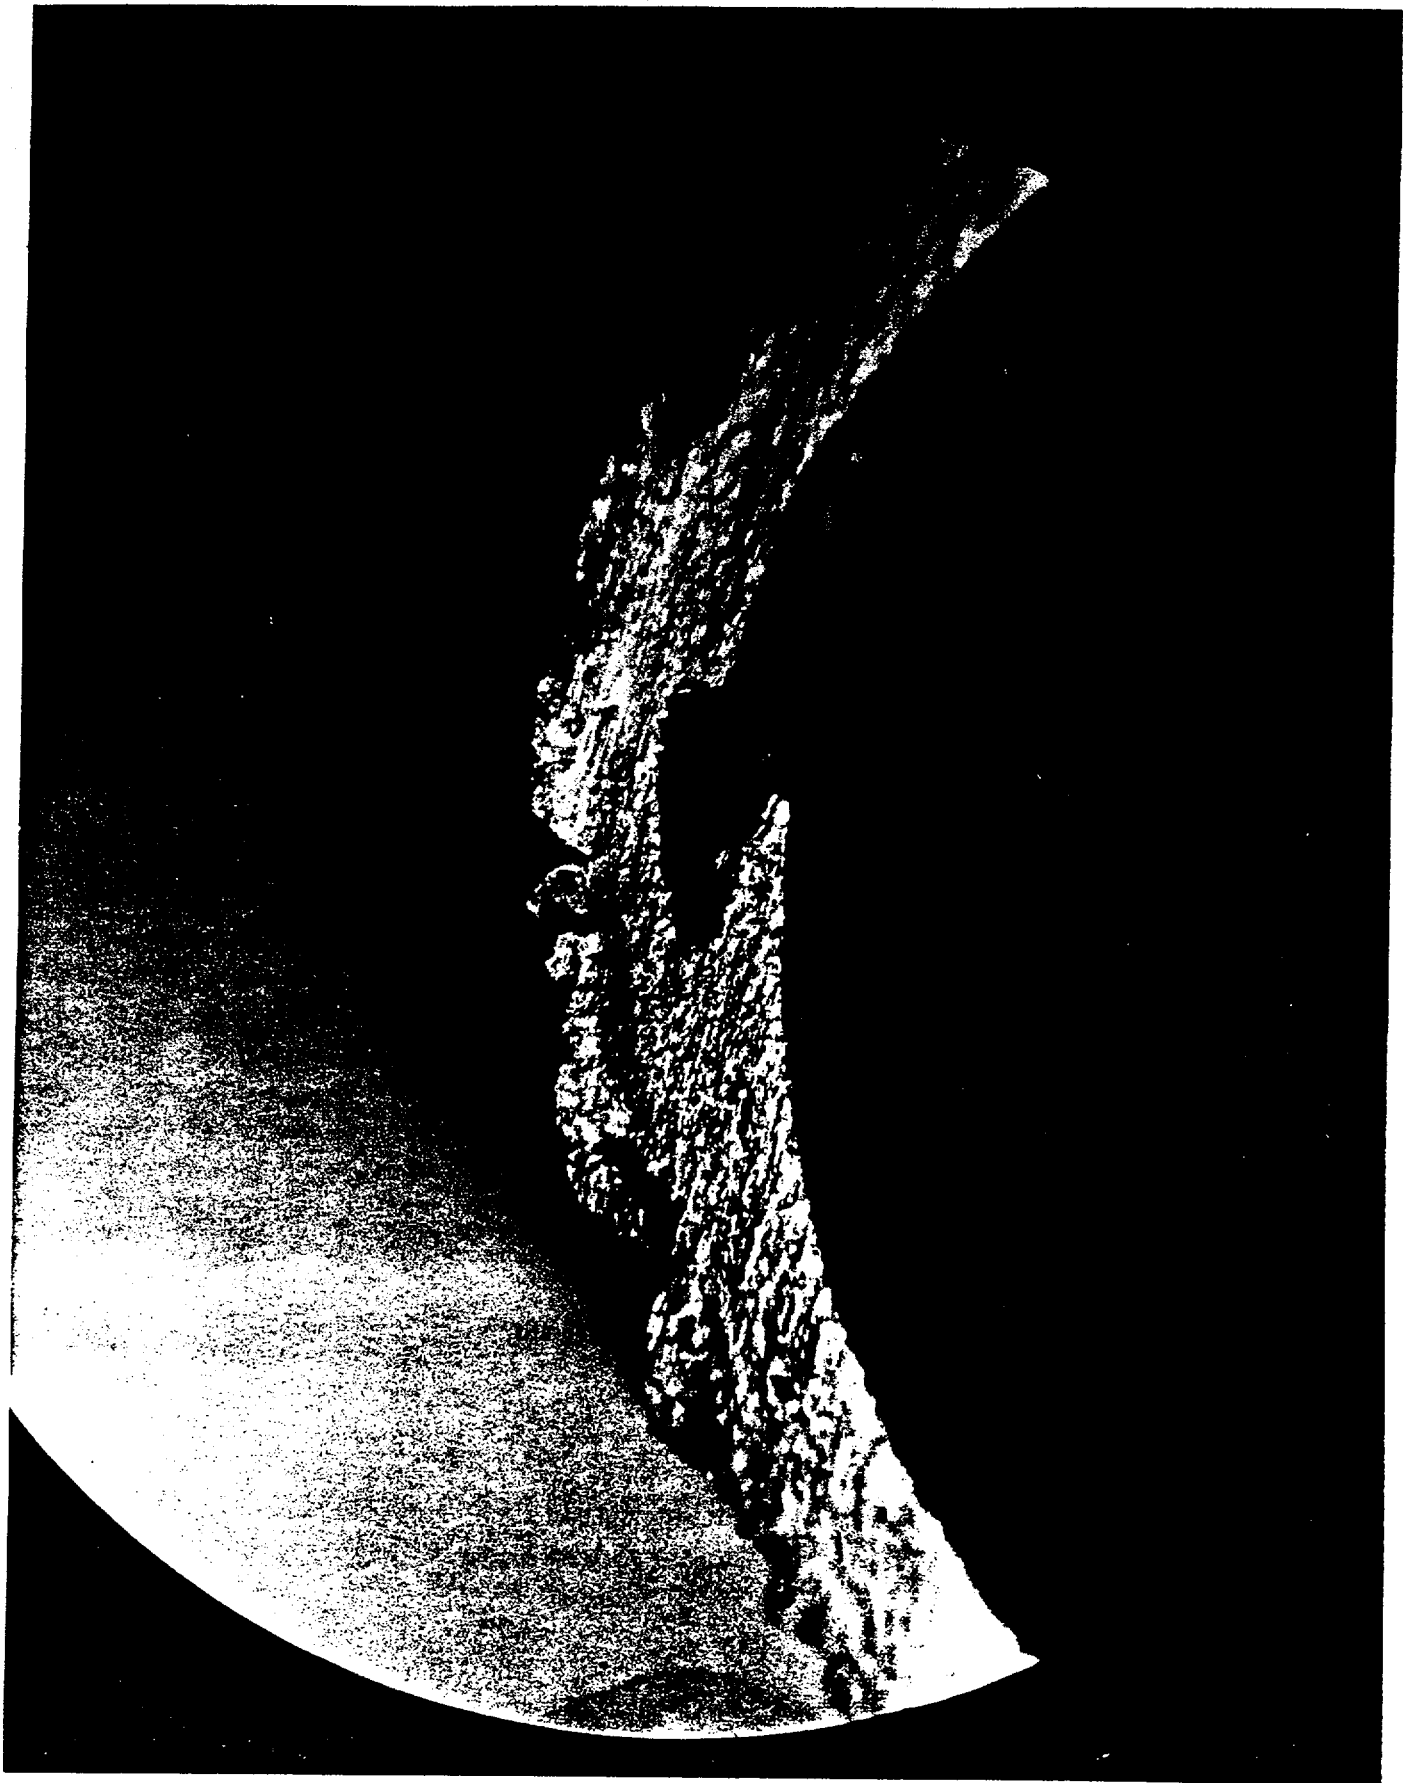
FIGURE 35A
ENLARGED VIEW OF DEFECT PHOTO

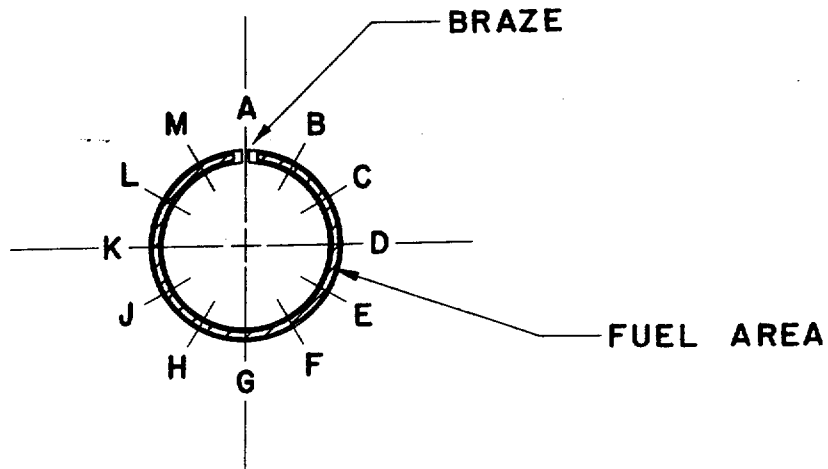
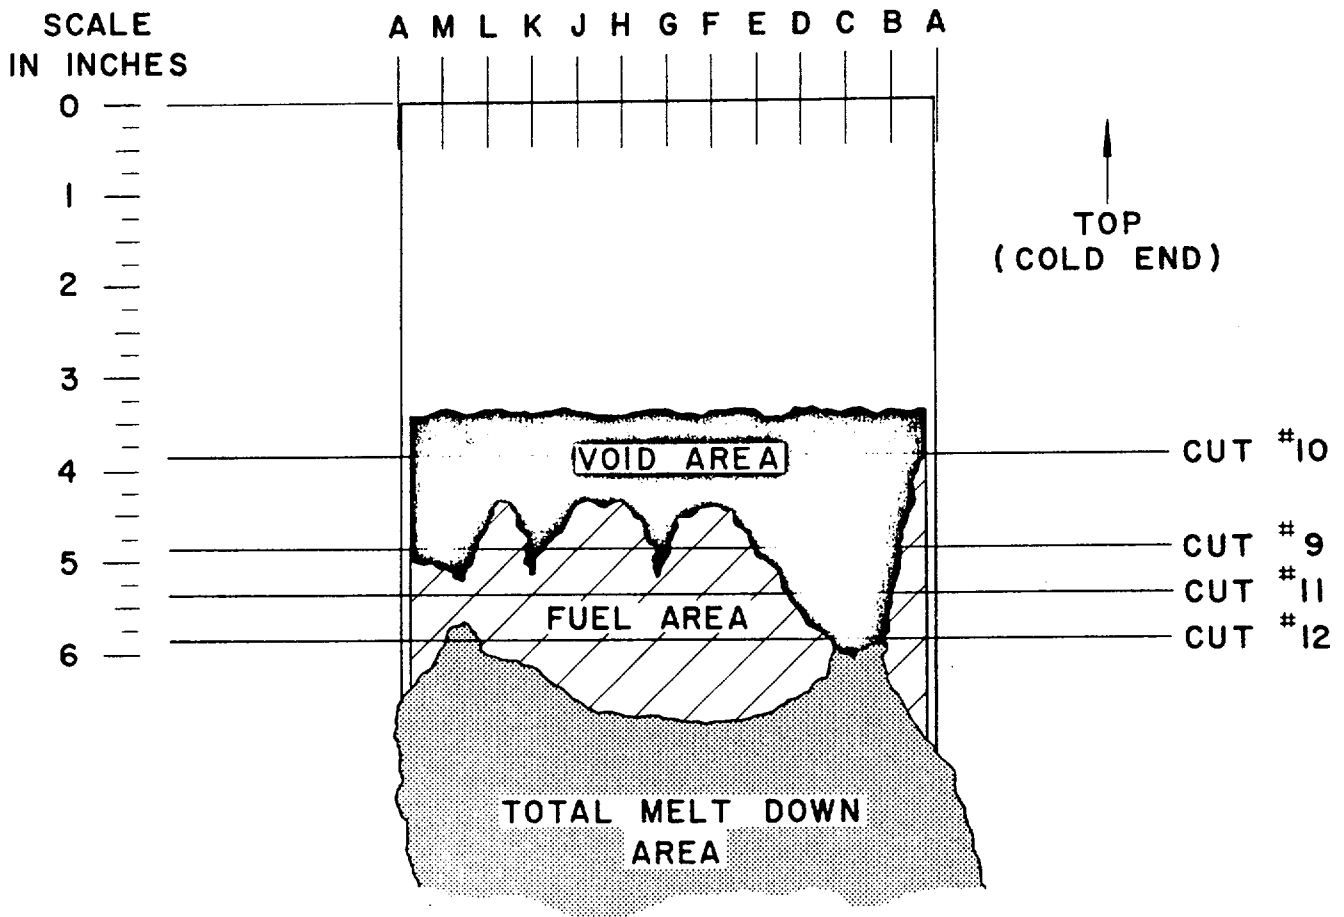
A series of cuts were taken on these tubes. A rather surprising fact was observed that the alloy had run out between the cladding of the center tube all the way to the top portion of the meat. Figure 35 shows photographs of a section taken across this tube approximately 5-1/2 inches from its end. (The top 3 inches are dead aluminum). Although this cut was taken with a hacksaw and is as yet unpolished, it is quite evident that most of the alloy has run out. In external appearance the section seemed sound. Figure 35a is an enlargement of the lower right hand photo of Fig. 35. The small holes observed suggest inhomogeneities in the fuel or poor bonding. The other two tubes when sectioned in the same place were solid. The pattern of the melted run out in the one tube is curious and is presented in Figure 36. The funnel shaped appearance seems to indicate that the tube was hotter at the top than at the bottom, a phenomenon which might have been caused by poor bonding at the element top.

FIGURE 36
 PATTERN OF MELTED RUNOUT (CENTER TUBE)

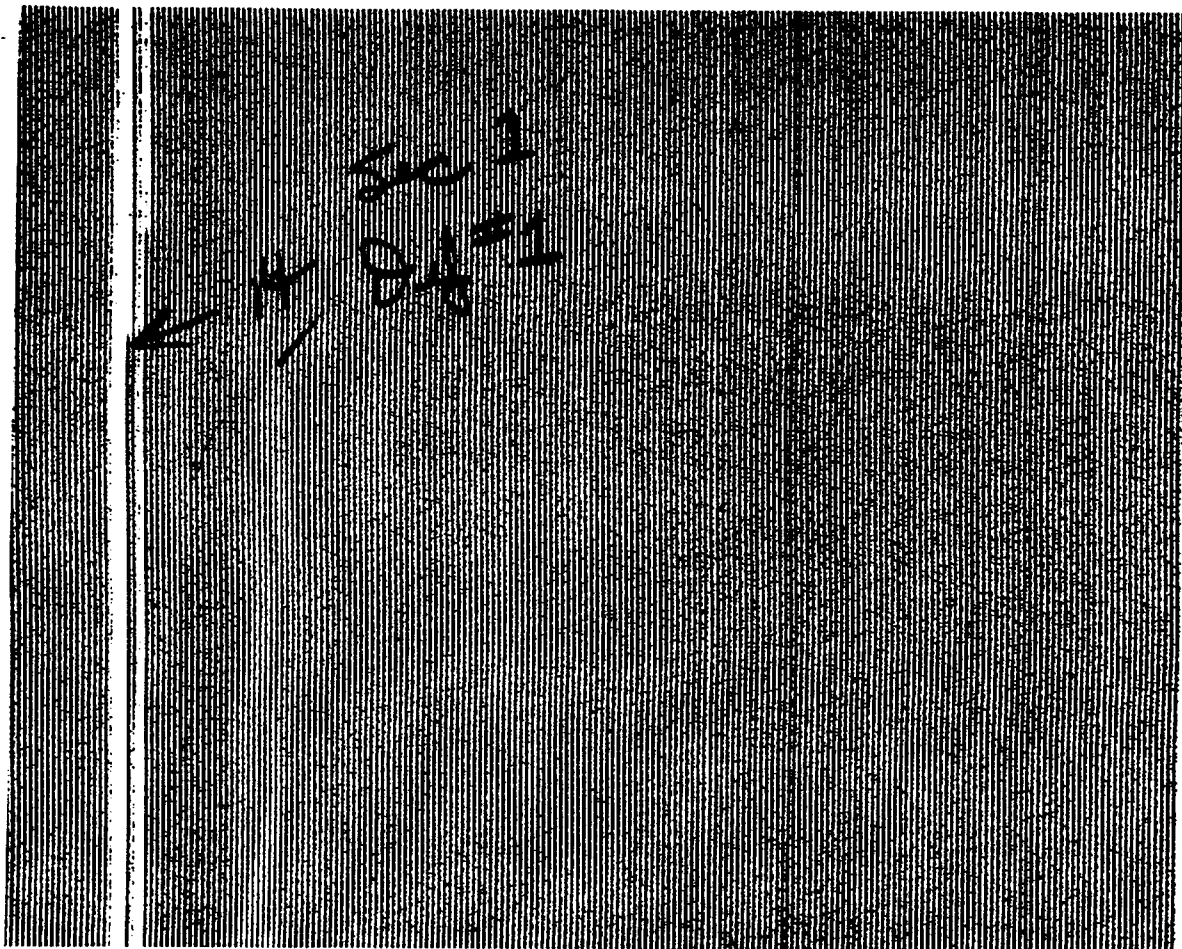
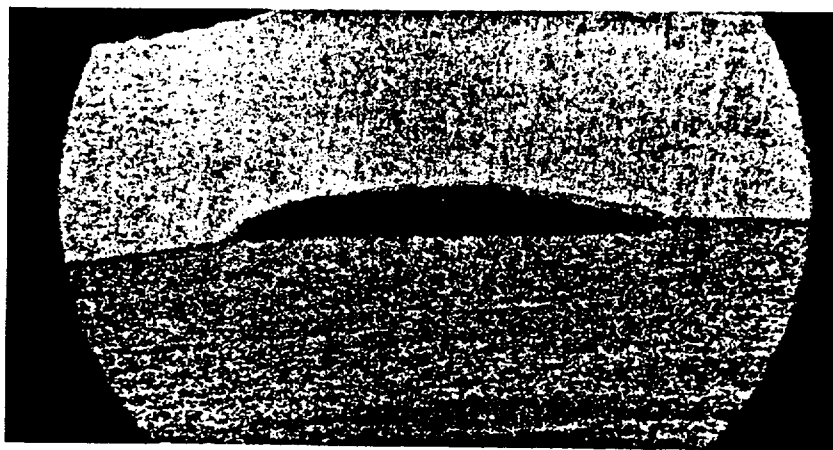
To confirm the ultrasonic inspection method several tubes were sectioned at typical indicated flaw points in the ultrasonic record. Some of these records and the photographs of the sectioned flaws are indicated in Figures 37 and 38. The pictures by no means indicate the worst cases, but as indicated are representative. In each case of a suspected flaw the ultrasonic technique proved infallible and sectioning always produced the defect. All types of defects were discovered including poor bonding, cracks in the fuel, foreign inclusions, and voids. The conclusion reached is that the inspection requirements originally specified were not sufficiently rigid. In view of new tightened specifications this particular batch of fuel was of questionable quality, with over 1464 defects having been found, and with 133 of them over 1/2-inch in size in a sampling of 237 tubes.

FIGURE 38
TYPICAL ULTRASONIC TRACE WITH DEFECT PHOTO
