UNITED STATES
NUCLEAR REGULATORY COMMISSION
WASHINGTON, D.C. 20555-0001

SUBJECT: REVIEW OF RECORDS RELATING TO A DIFFERING
PROFESSIONAL VIEW

<u>NO.</u>	<u>DATE</u>	<u>DESCRIPTION/(PAGE COUNT)</u>
1.	5/23/01	Memorandum to J Dyer from R Landsman, Subject: Differing Professional View Concerning the Startup of the Dry Cask Storage Loading Campaign at Dresden (3 pages)

10.	12/28/01	Memorandum to J Zwolinski et al., from J Grobe, Subject: Differing Professional View Concerning Structural Issues Regarding the Dresden Reactor Building/125 Ton Crane and the Spent Fuel Cask Transfer Facility (5 pages)

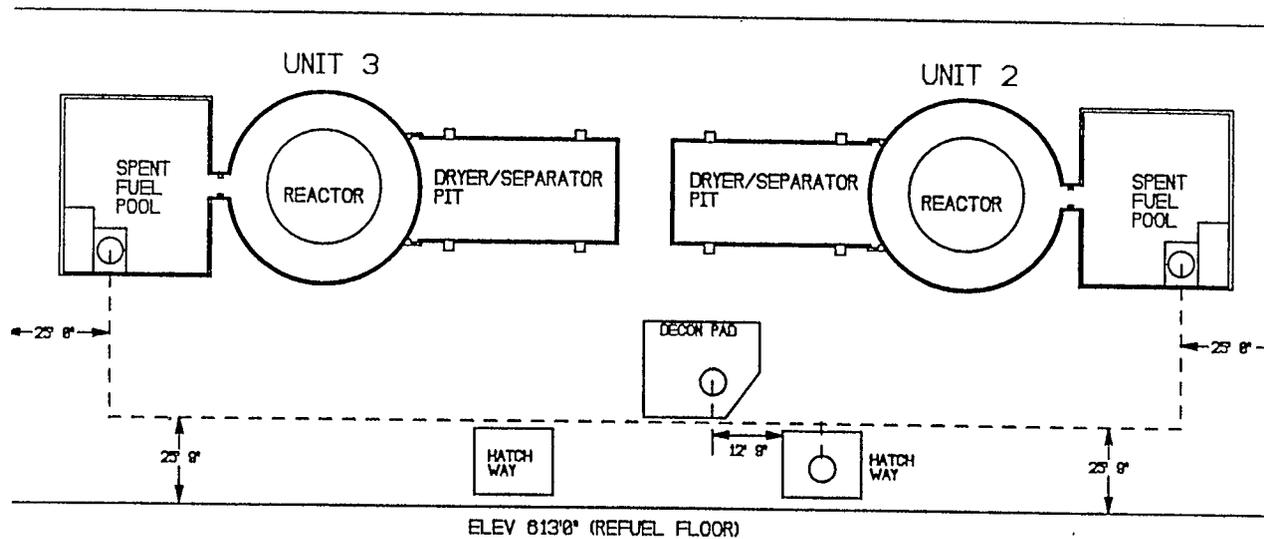
Restricted Mode Path

DRESDEN 2/3 REACTOR BUILDING REDUNDENT CRANE SYSTEM
ALLOWABLE PATHWAY FOR RESTRICTED MODE

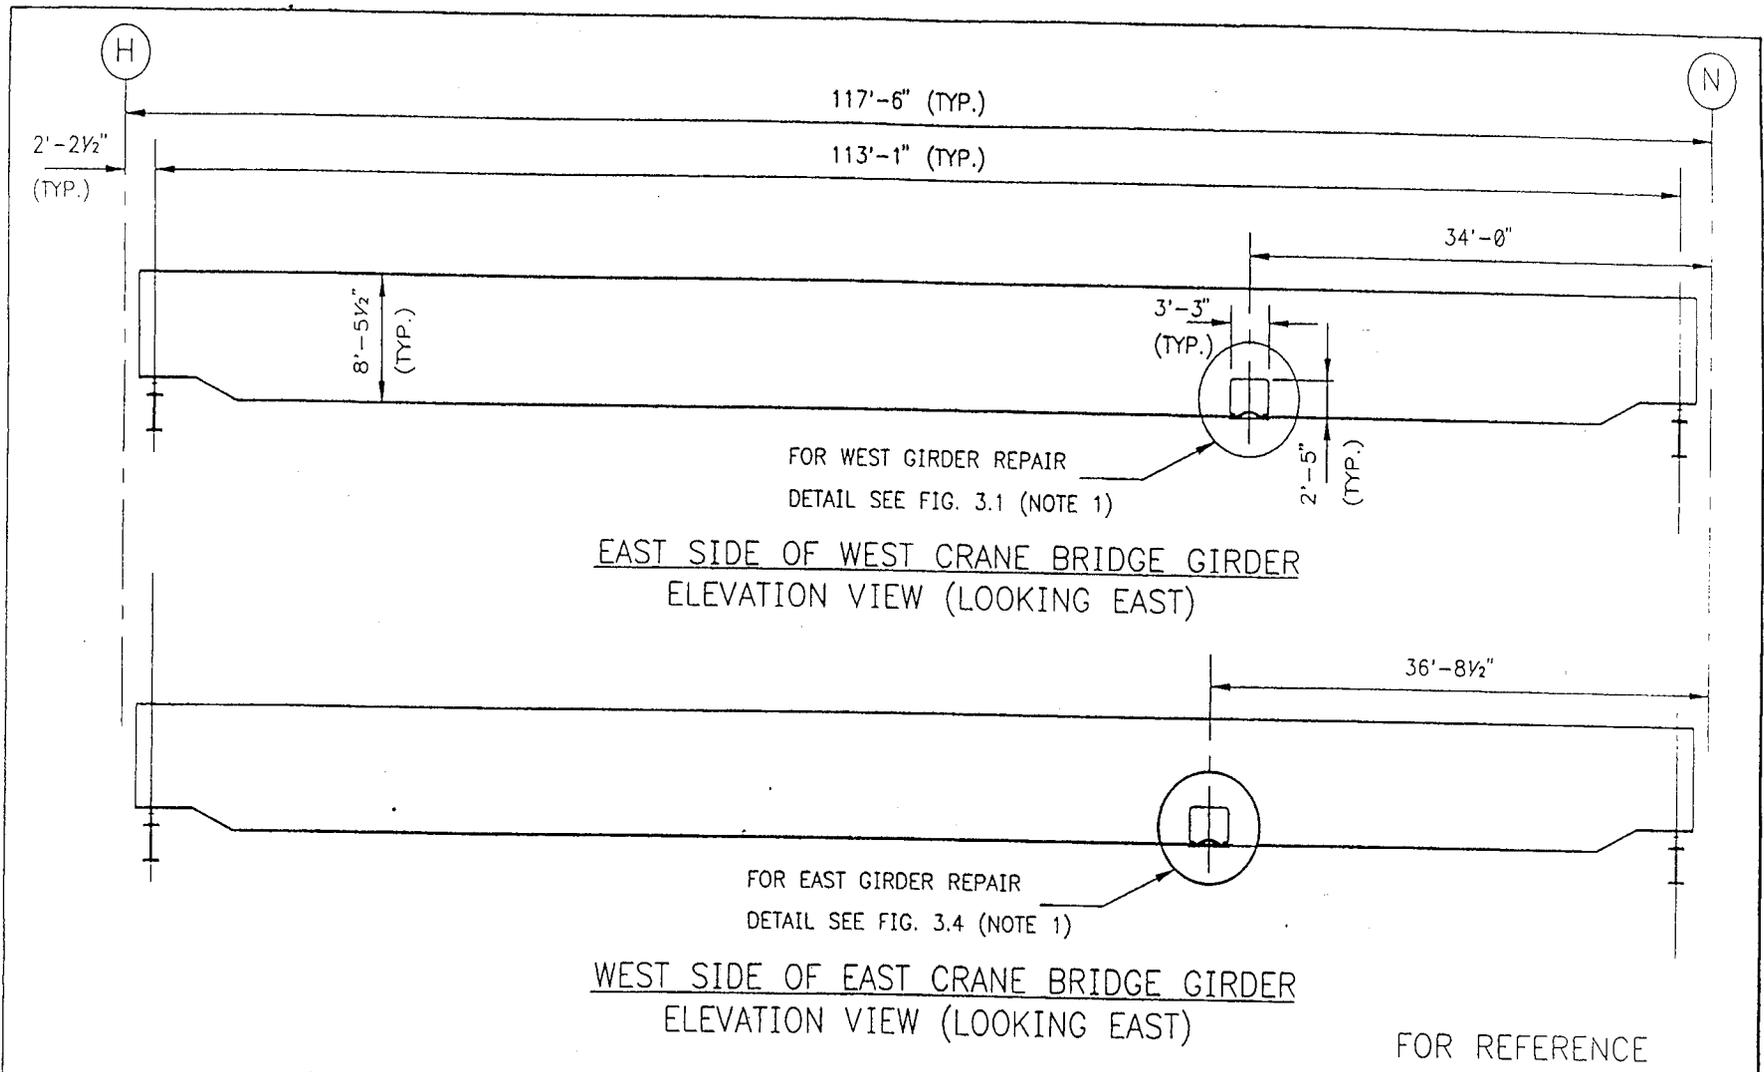
1981 Crane Girder Damage

In 1981, the crane bridge box girders were damaged by impact and compression during an over-hoisting event involving the strongback for the reactor vessel head. The crane girders are built-up box beams approximately 8 ½ feet deep, 2 feet wide, and 113 feet long. The damaged surfaces were confined to the lower portion of the inside webs (buckling) and the inside portion of the bottom flanges (bending) on both the girders approximately 35 feet from one end. The Office of Nuclear Reactor Regulation (NRR) evaluated the licensee's actions to determine whether the crane had been extensively repaired.

- Bottom of girders damaged by a 10 ton lifted load
- Damage affected 2' x 2'2" lower section of inside web and bent bottom flange on each girder (0.3% of total bridge girder surface area)

The licensee's required repairs (to get back to the design basis stress allowables) consisted of a splice plate welded over the cutout portion of the damaged girder webs and welding cover plates to each girder's bottom flange. These repairs were made by the licensee and Nutech was contracted to perform the repair evaluation. On page 3.1 of their repair report, Nutech concluded that the west crane bridge girder damage was so severe that it would be 22 percent overstressed at rated capacity (125 tons) with the damaged area not fixed. Based on 22 percent reduction in load carrying capacity with the damaged section unaccounted for, the NRR staff concluded that the crane would be capable of lifting 100 tons without overstress.

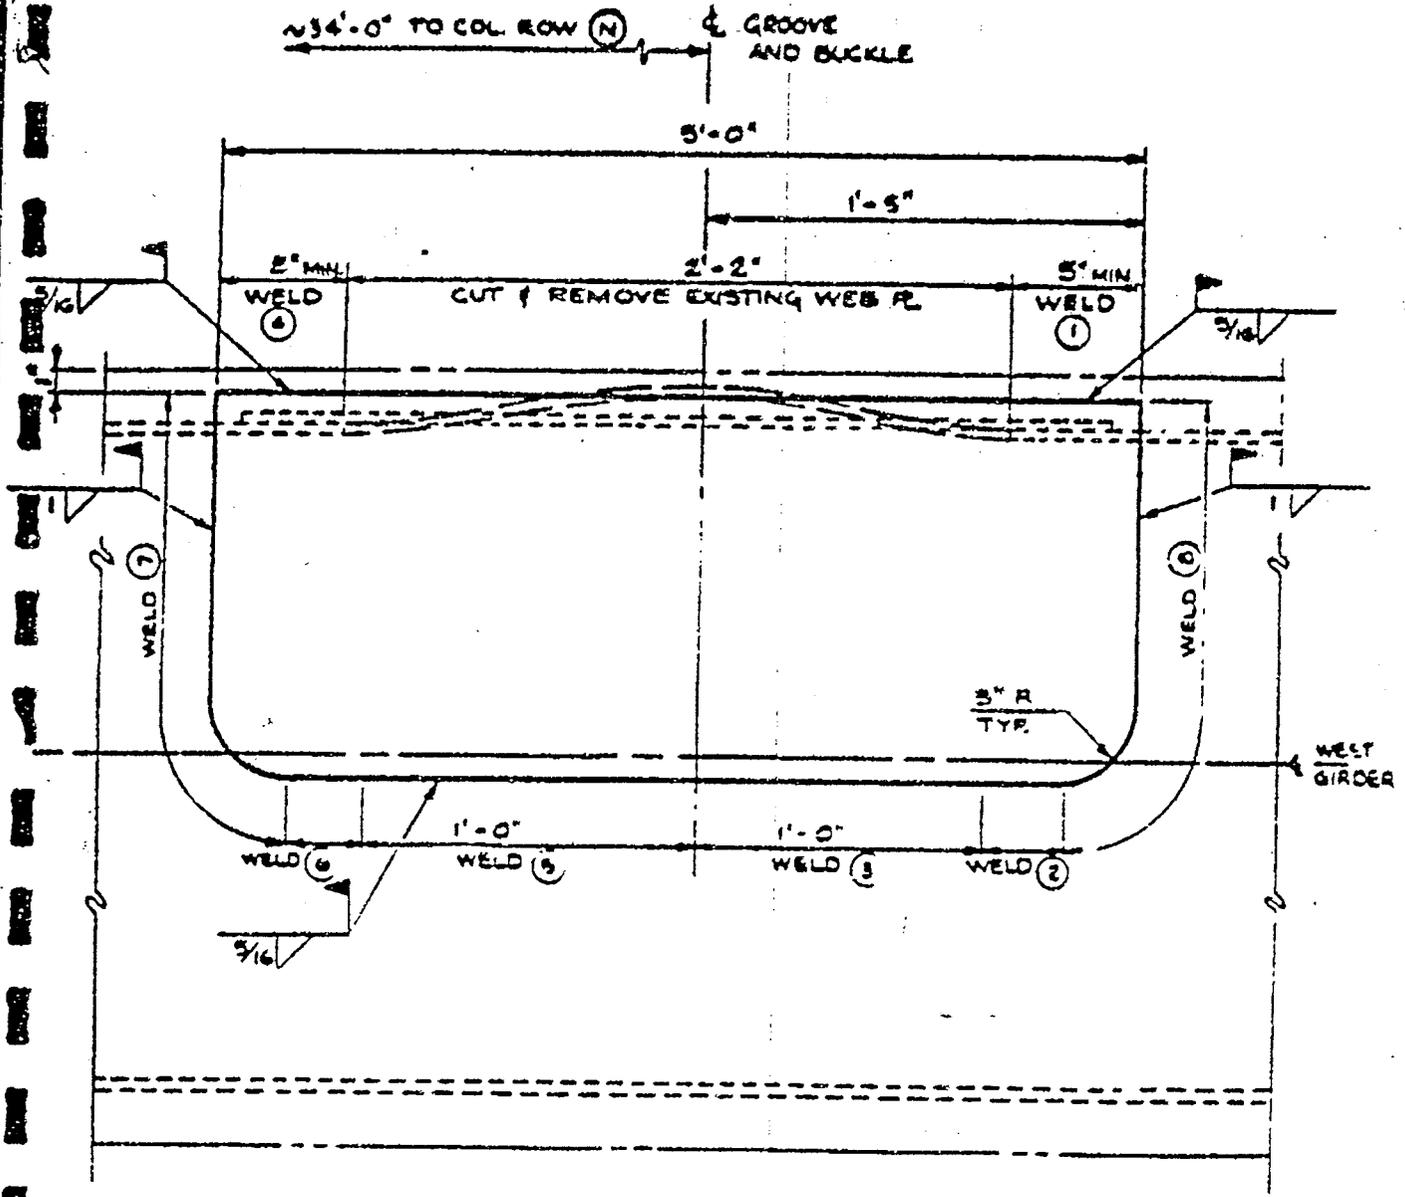
FIG. 3-2

PLAN VIEW(A-A) WEST GIRDER

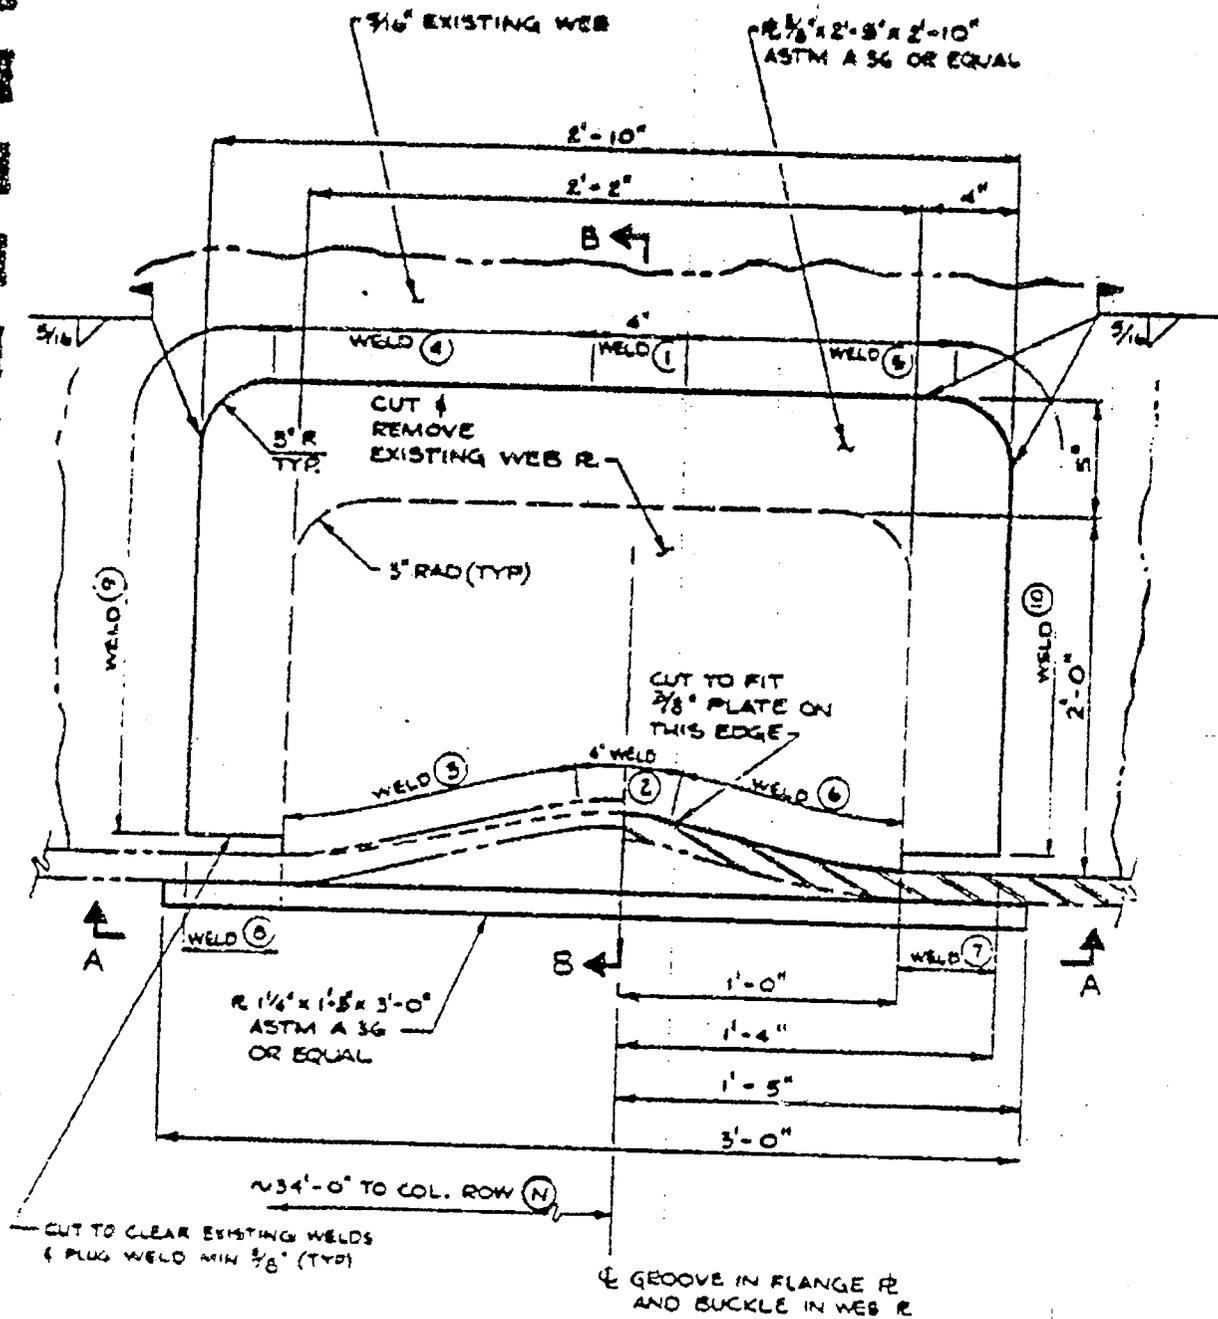
FIG. 3.1

WEST GIRDER REPAIR PLATES
