UNITED STATES
NUCLEAR REGULATORY COMMISSION
WASHINGTON, D.C. 20555-0001

SUBJECT: REVIEW OF RECORDS RELATING TO A DIFFERING
PROFESSIONAL VIEW

<u>NO.</u>	<u>DATE</u>	<u>DESCRIPTION/(PAGE COUNT)</u>
1.	5/23/01	Memorandum to J Dyer from R Landsman, Subject: Differing Professional View Concerning the Startup of the Dry Cask Storage Loading Campaign at Dresden (3 pages)

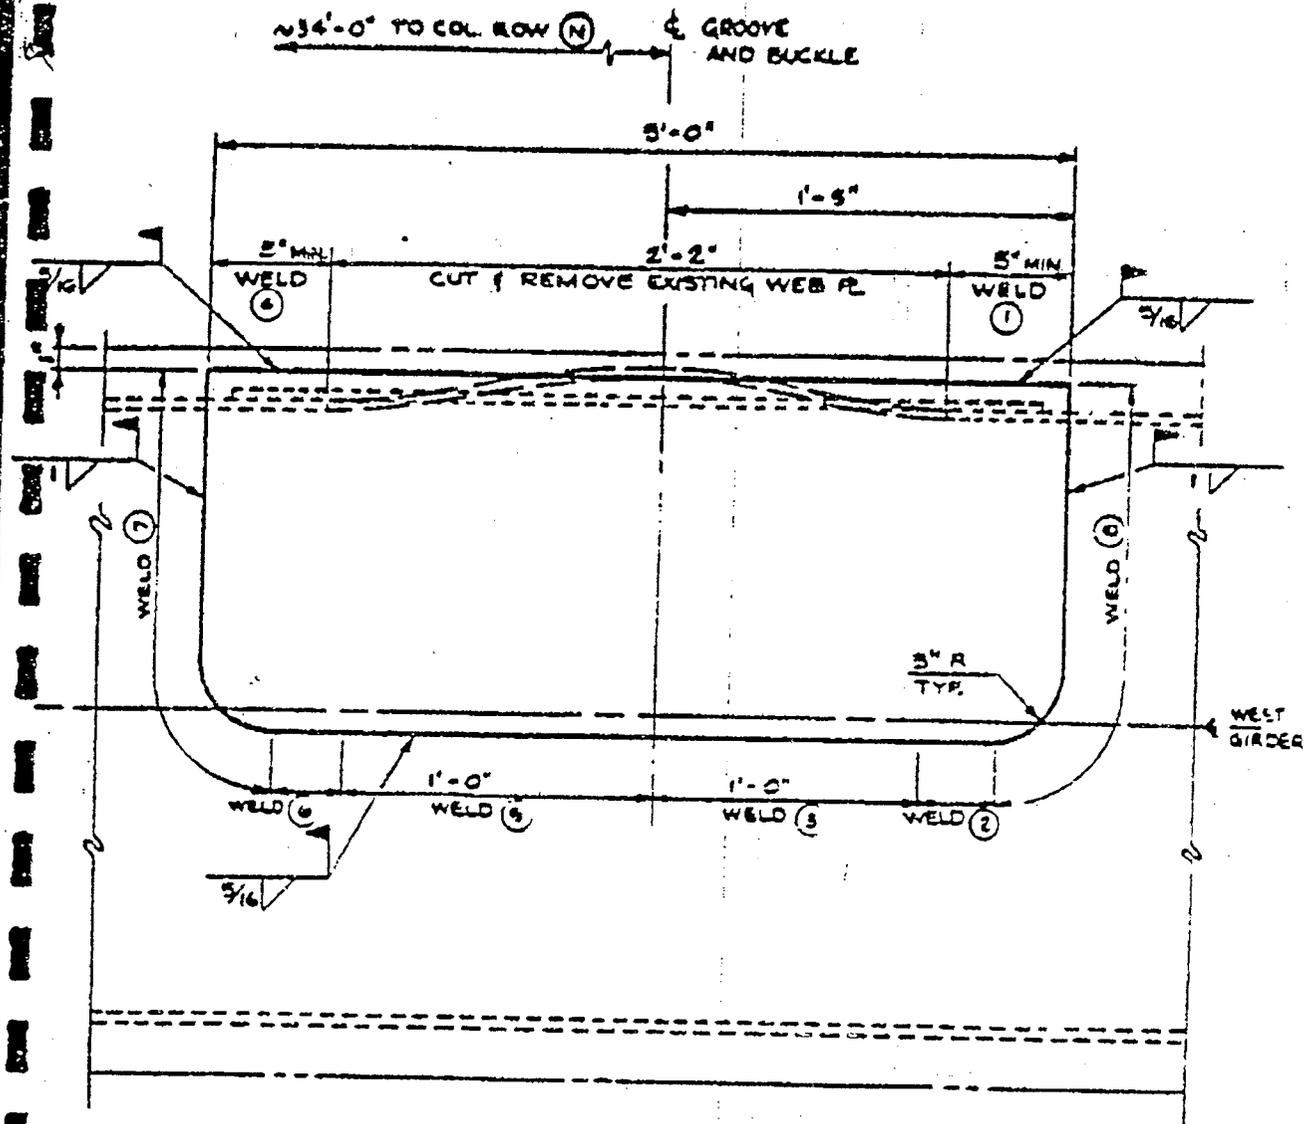
PLAN VIEW(A-A) WEST GIRDER
FIG. 3-2

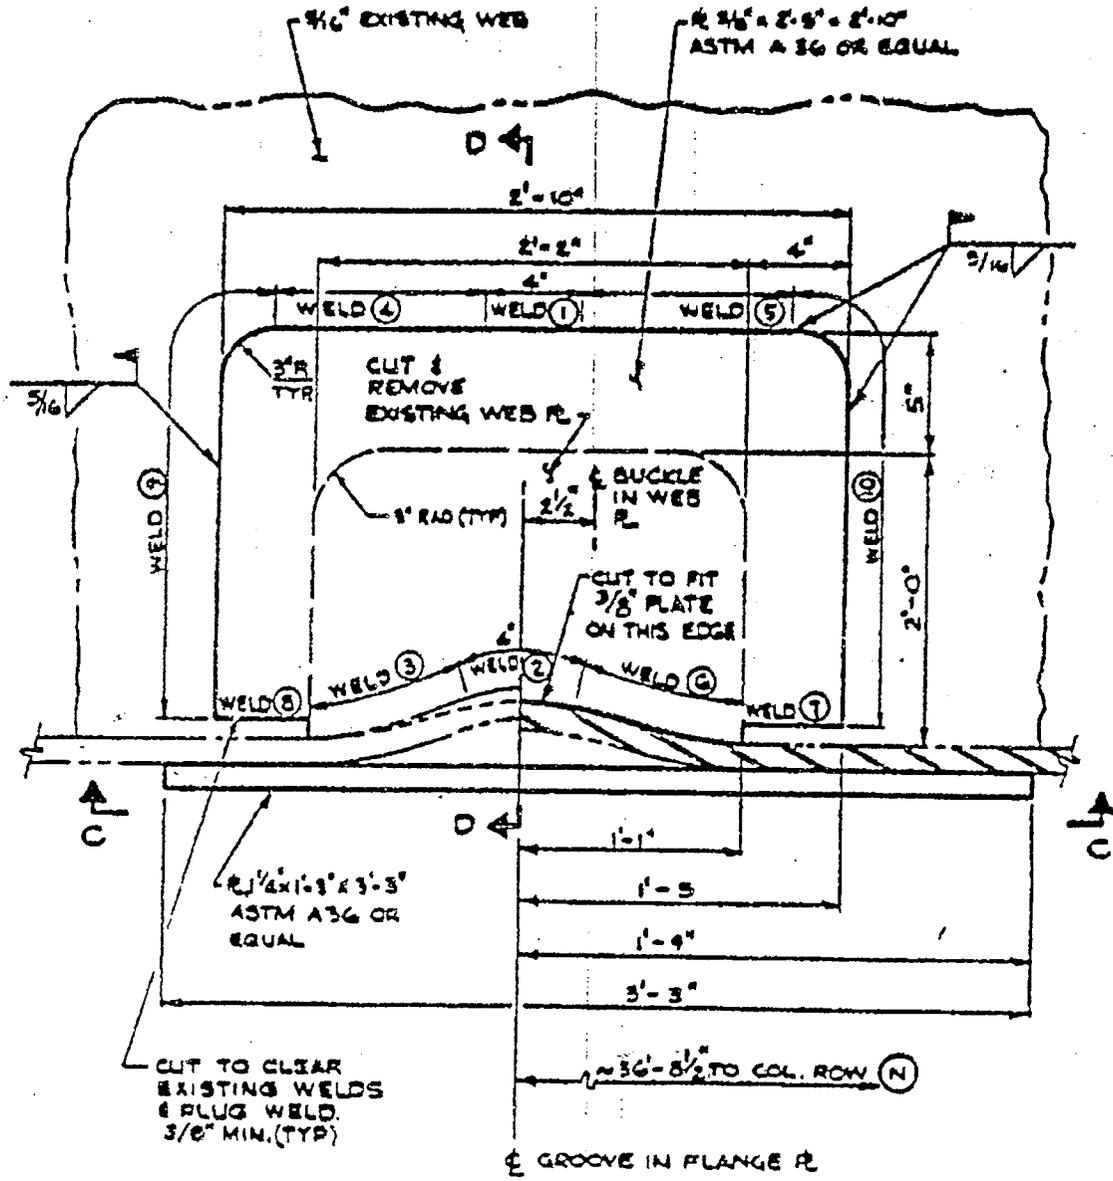
EAST GIRDER REPAIR PLATES
FIG. 3-4

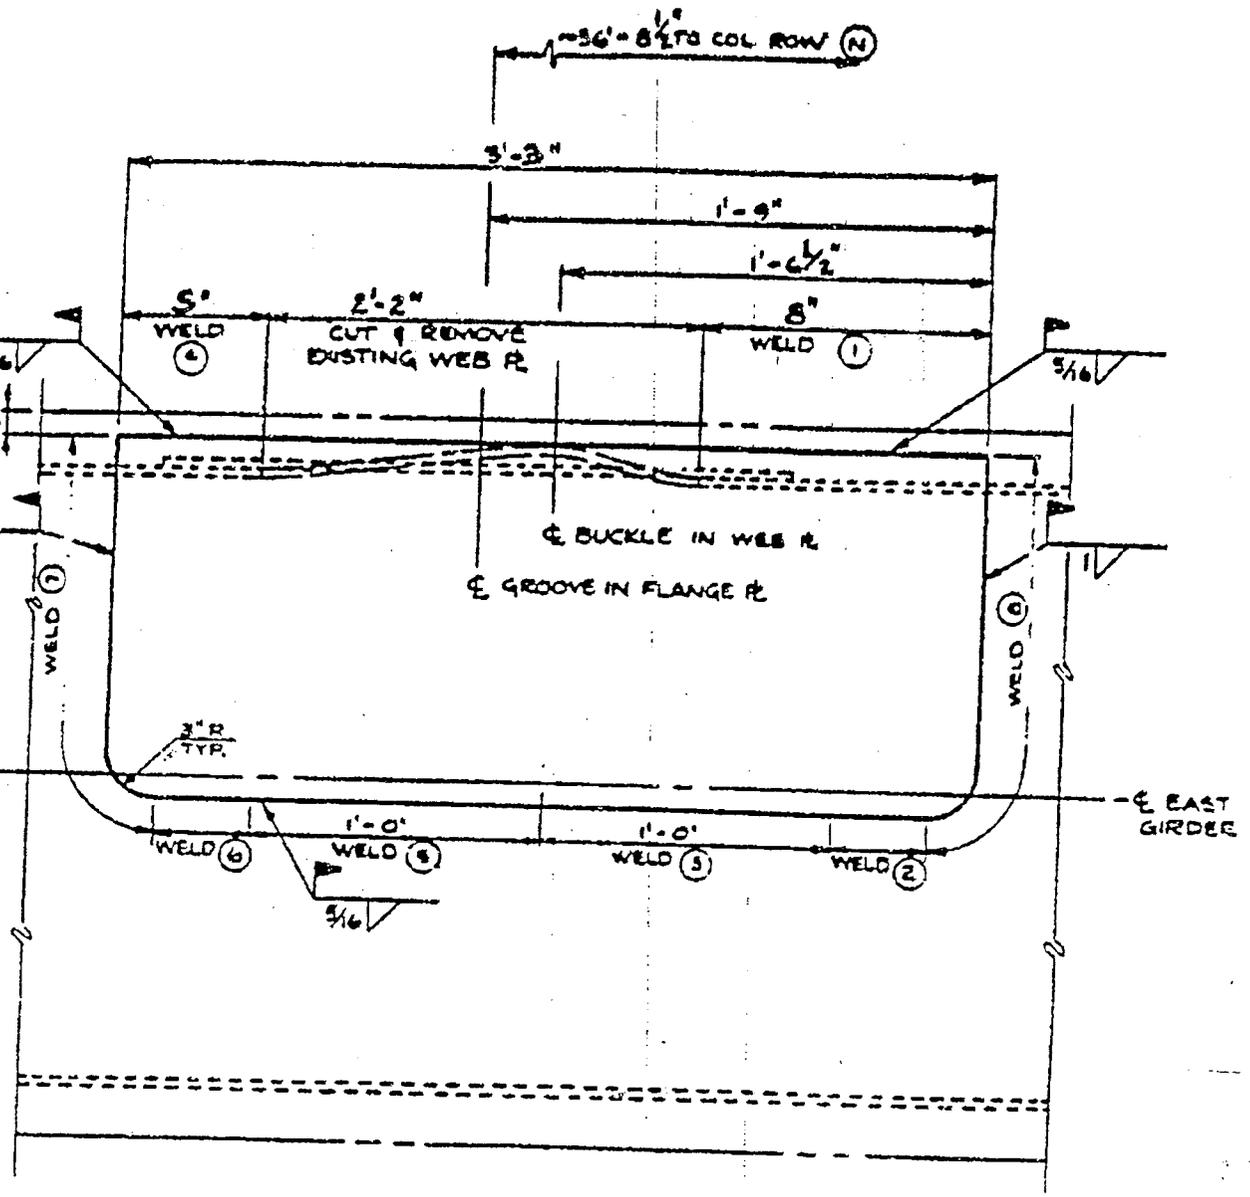
PLAN VIEW (C-C) EAST GIRDER
FIG. 3-5

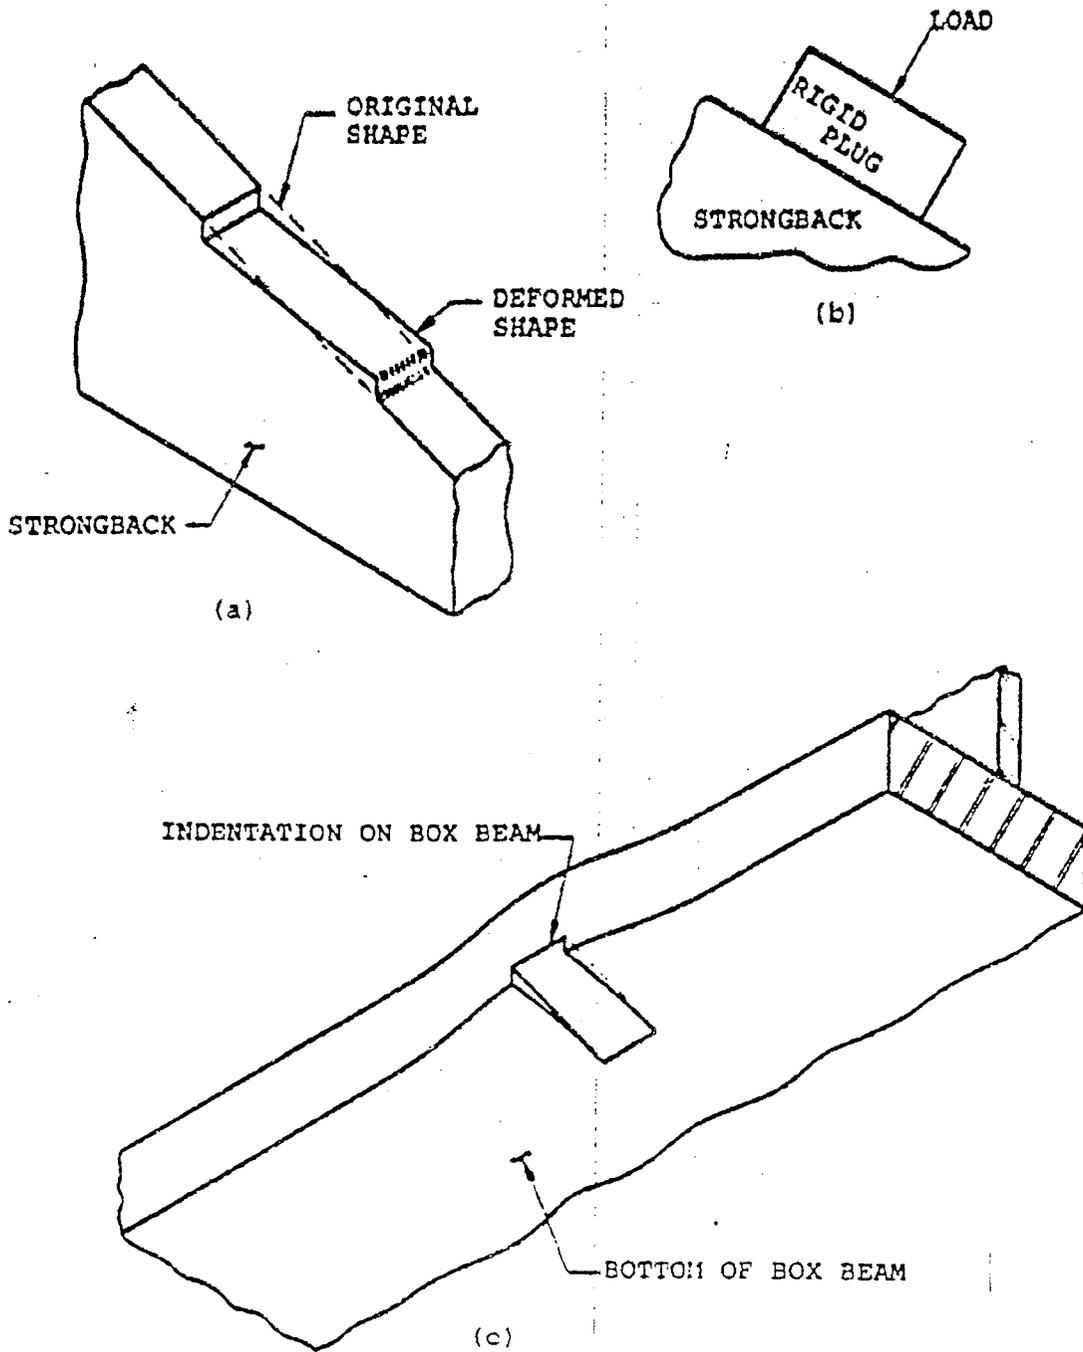
FIGURE 3-7 - MODELS USED TO CALCULATE LIMITING CRANE LOAD
