Docket No. 50-331

Enclosed is a signed original of the "Order for Modification of License" issued by the Commission on May 21, 1975, for the Duane Arnold Energy Center. The Order added a provision to License No. DPR-49 stating that you shall not operate the facility at core power levels exceeding 50% of rated power or core flow rates exceeding 50% of design flow rate without prior written approval by the Director, Office of Nuclear Reactor Regulation. A copy of the Order is being filed with the Office of the Federal Register for publication.

RELATING TO
CHANNEL BOX WEAR
IN THE
VERMONT YANKEE NUCLEAR POWER STATION
(Docket 50-271)

AND THE
PILGRIM NUCLEAR POWER STATION
(Docket 50-293)

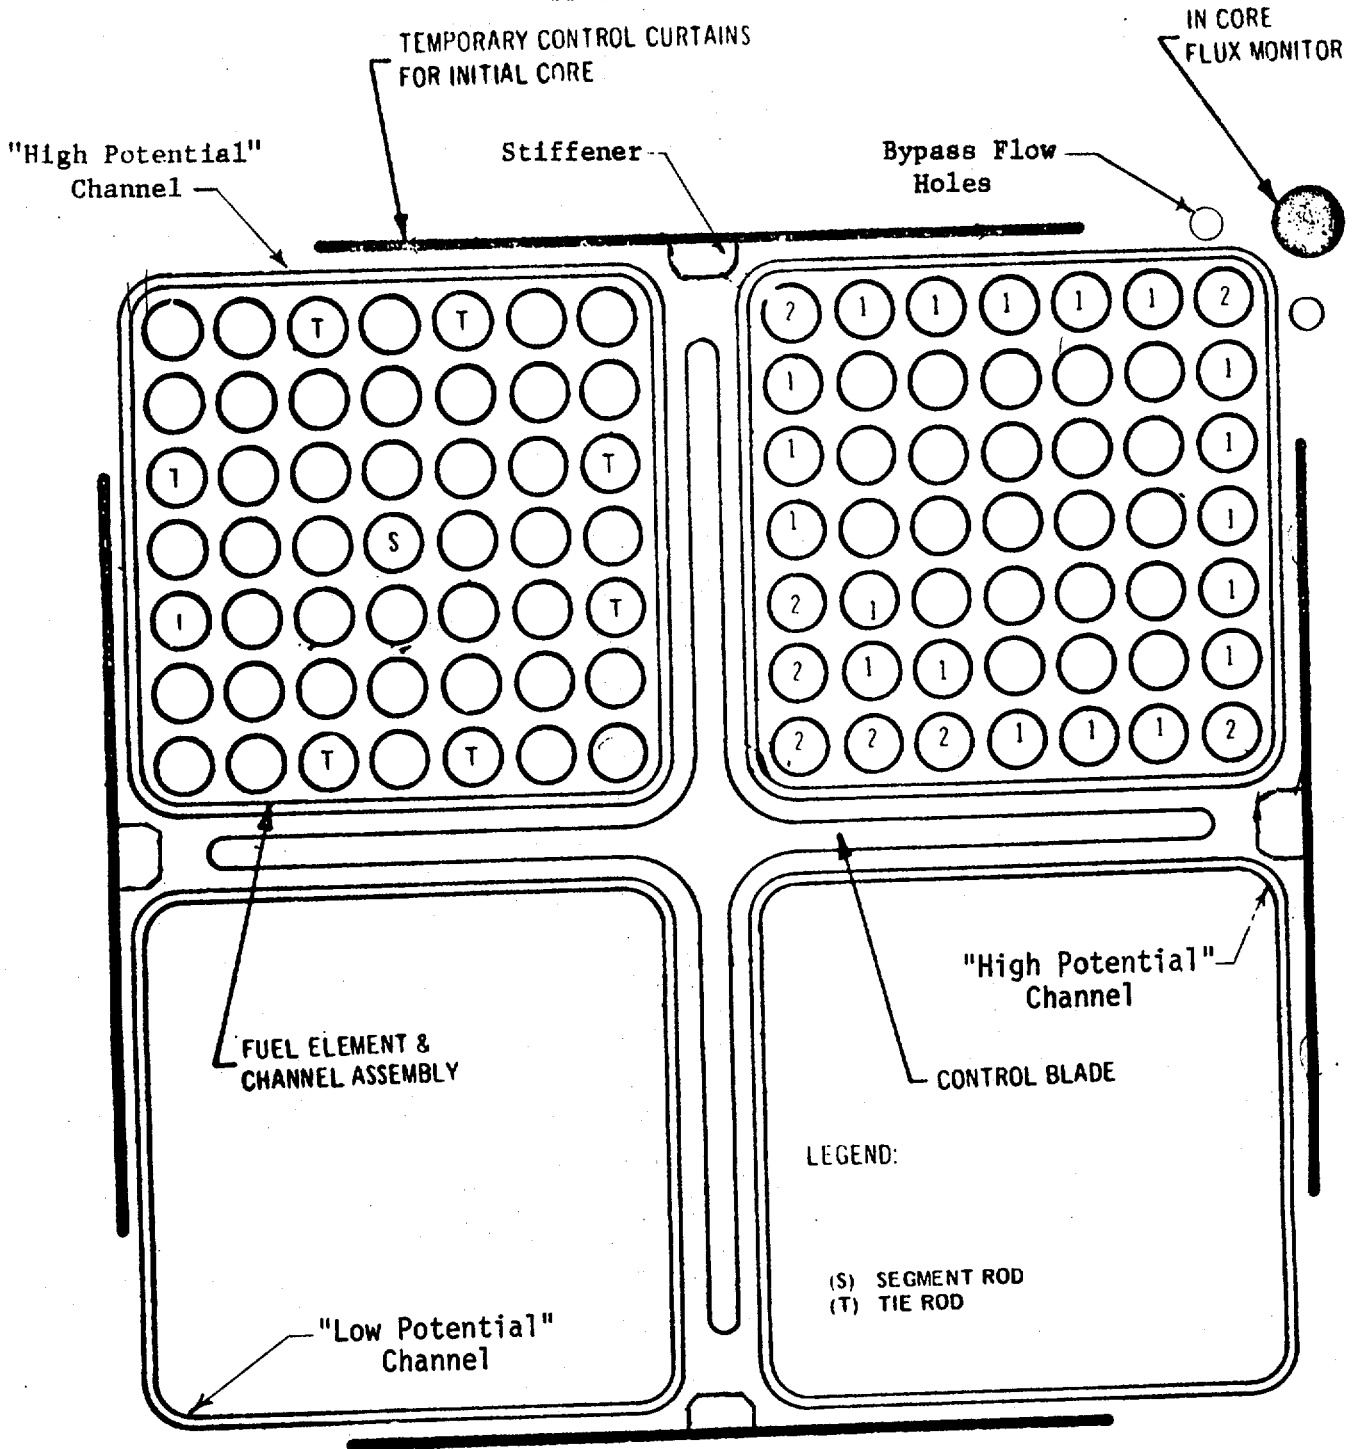
FIGURE 3
TYPICAL CORE CELL

Figure 3 depicts a cross-section of a fuel cell containing all of the elements discussed above. This particular arrangement, combining bypass flow holes with temporary control curtains, is found

in only two operating U.S. reactors, the Vermont Yankee Nuclear Power Station and the Pilgrim Nuclear Power Station. The KKM reactor in Switzerland is the only other facility which contains both of these design features.

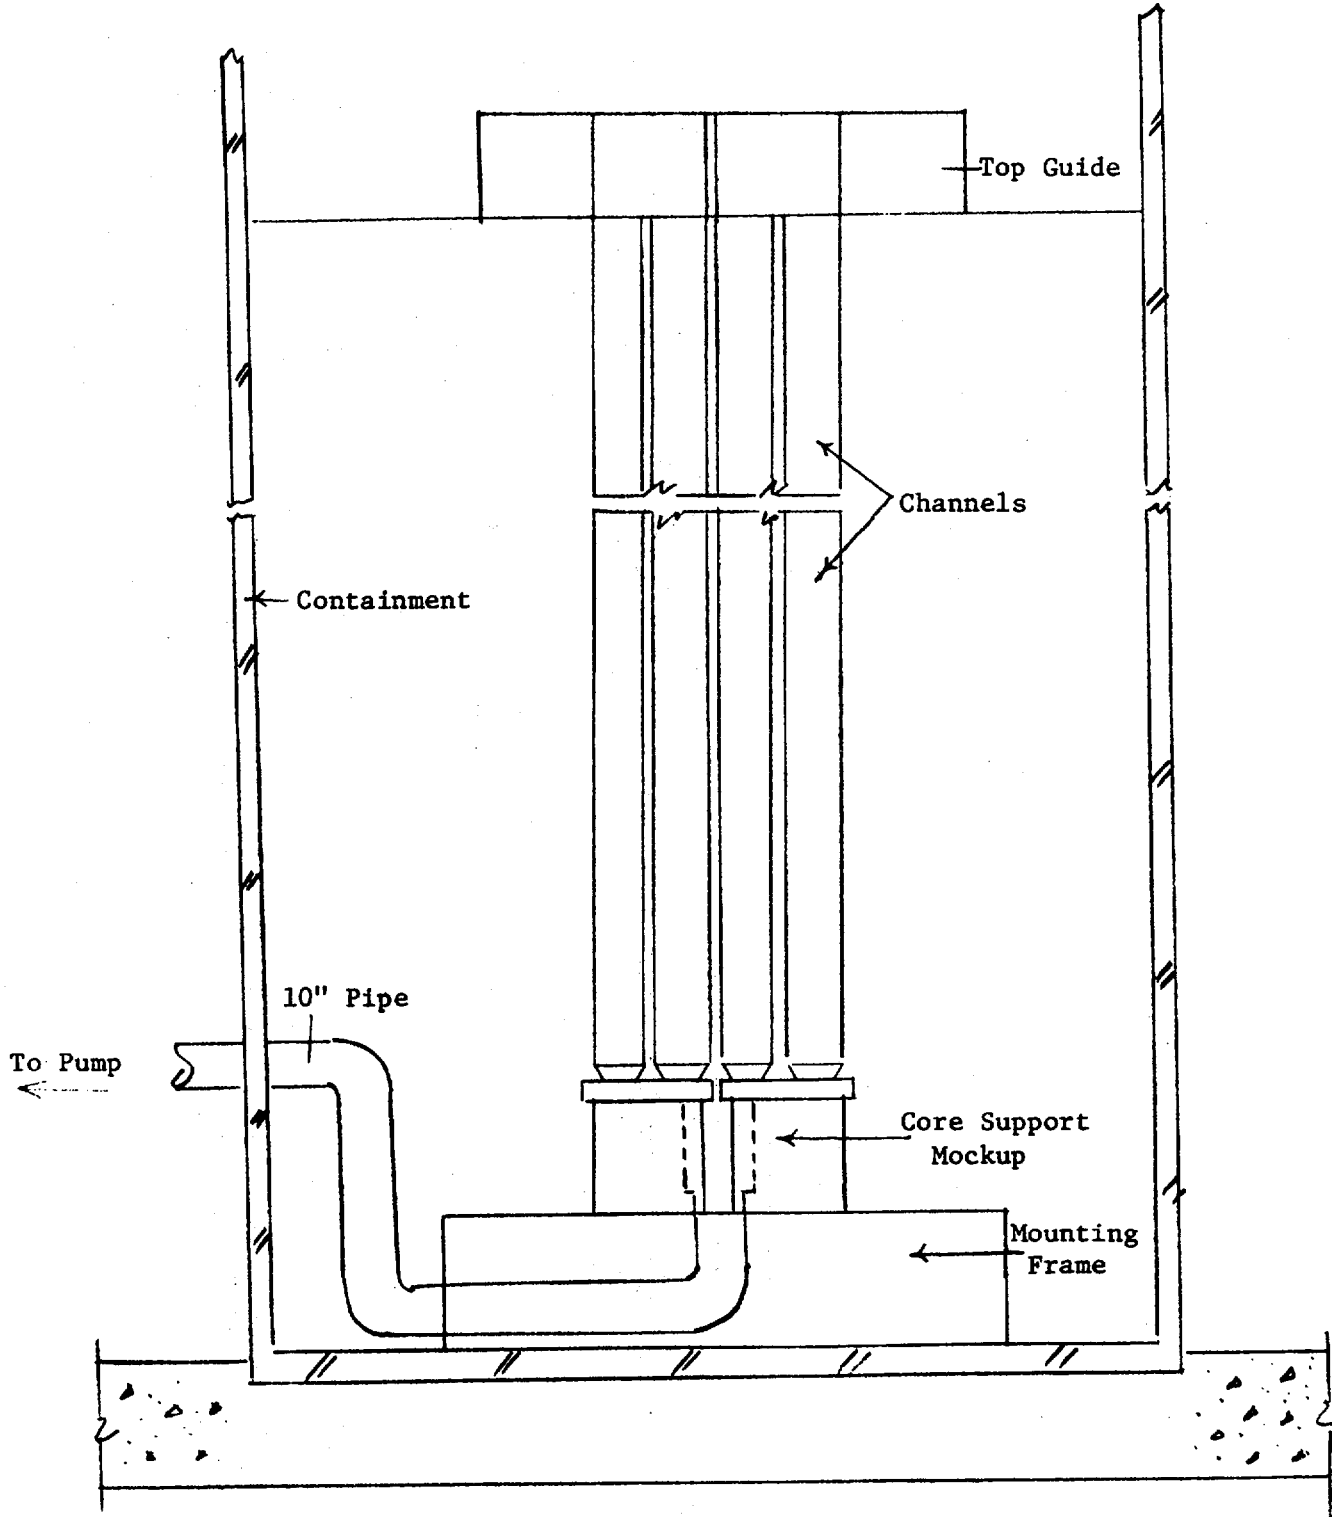
GE FLOW TEST FACILITY ELEVATION

The configuration of control curtains, bypass flow holes and fuel assemblies has been simulated by General Electric in a test facility (Figure 4). The facility consists of twelve fuel assembly channels, four temporary control curtains, and a support plate with four, one-inch-diameter flow bypass holes (Figure 5). A pump and piping provide

Although only preliminary test results are available, both visual observation and the transducer output confirmed that curtain vibration occurs. Visual observation showed the curtains are displaced in a direction opposite from the flow holes. The degree of displacement as well as the amplitude of vibration decreased with decreased bypass flow. No evidence of resonant vibration was observed.
