Docket No. 50-331

DUANE ARNOLD ENERGY CENTER

AMENDMENT TO FACILITY OPERATING LICENSE

Amendment No. 49
License No. DPR-49

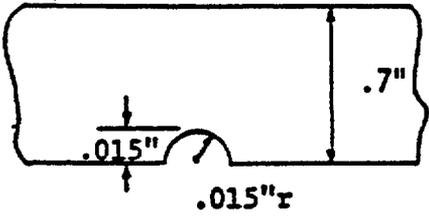
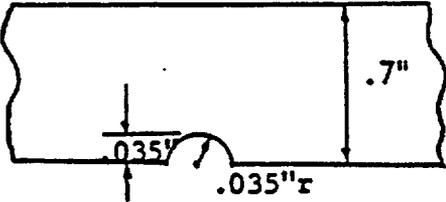
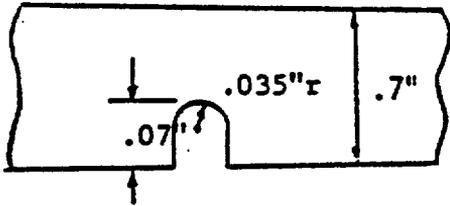
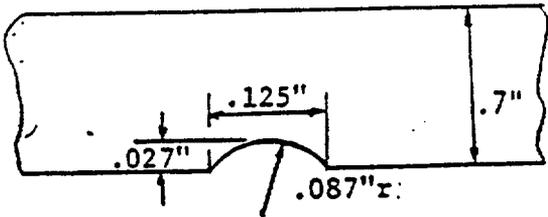
FIGURE 2: Analyzed Notch Configurations at Root of Safe End to Piping Weld (Weld #6)

Although there were differences of opinion regarding the detailed weld root geometry and conditons as determined from interpretation of the radiographs, it was agreed that the evidence clearly showed a wide range of conditions existed from weld to weld and even from place to place on some individual welds. Therefore, the licensee characterized the root conditions at weld numbers 2 and 6

(see Figure 1) by assuming and analyzing six different notch configurations (see Figures 2 and 3). These notch configurations were chosen by the licensee to conservatively bound, relative to mechanical strength, the worst root conditions that could be inferred from the interpretation of the radiographic films. The worst-case condition enveloping all the stated variations is a sharp cup-shaped intrusion, with a depth of about 1/10 the wall thickness. This condition is designated as Case E* in the licensee's analyses. There are three possible adverse effects of this assumed worst-case root condition; adequate fatigue life, initiation of stress corrosion cracking, and initiation of brittle or unstable fracture without prior warning. These three possible effects are discussed below.
