DUANE ARNOLD ENERGY CENTER

AMENDMENT TO FACILITY OPERATING LICENSE

Amendment No. 49
License No. DPR-49

On January 8, 1979, the Nuclear Regulatory Commission (NRC) issued a Safety Evaluation Report (SER) pertaining to the safe-end cracking that occurred at the Duane Arnold Energy Center (DAEC) on June 17, 1978 and to the repair program initiated by the licensee to replace the damaged safe-ends with safe-ends of an improved design. This SER was transmitted to the Iowa Electric Light and Power Company by a letter also dated January 8, 1979.

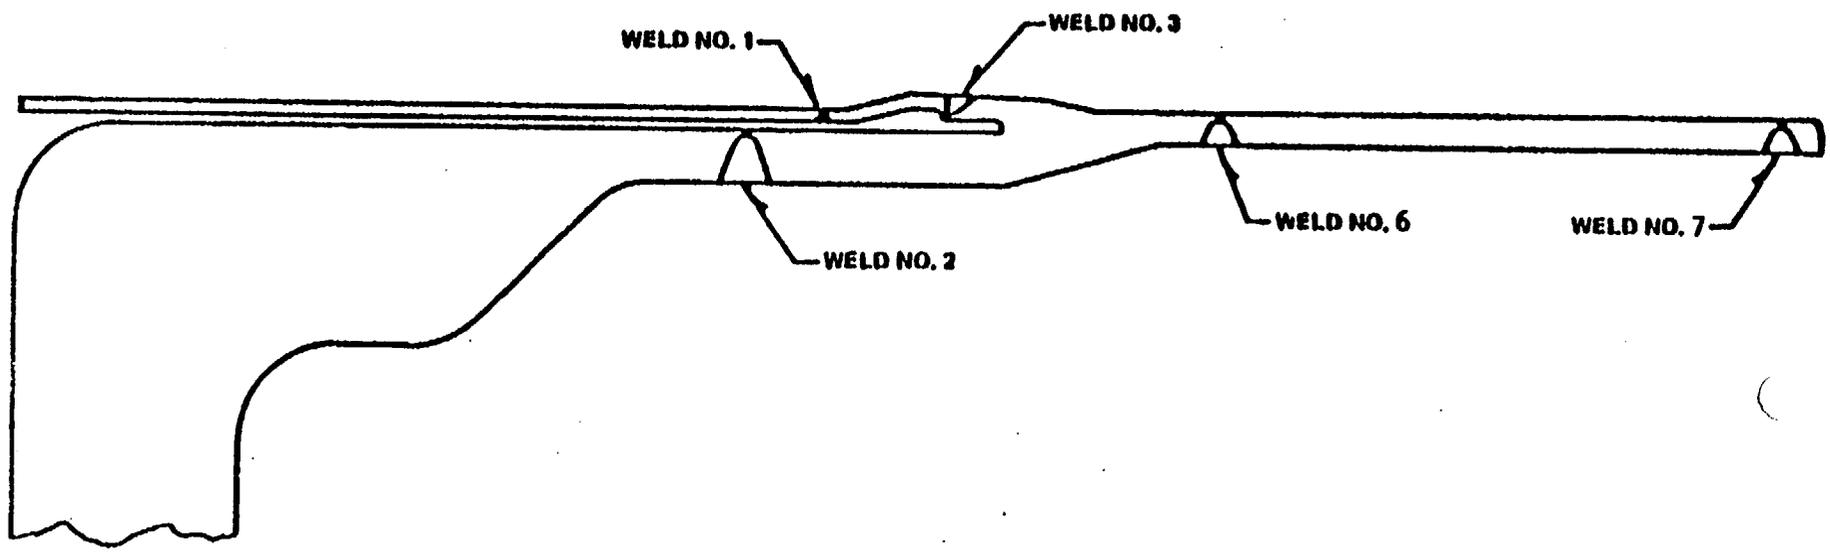
FIGURE 4.6-1

Although there were differences of opinion regarding the detailed weld root geometry and conditons as determined from interpretation of the radiographs, it was agreed that the evidence clearly showed a wide range of conditions existed from weld to weld and even from place to place on some individual welds. Therefore, the licensee characterized the root conditions at weld numbers 2 and 6

(see Figure 1) by assuming and analyzing six different notch configurations (see Figures 2 and 3). These notch configurations were chosen by the licensee to conservatively bound, relative to mechanical strength, the worst root conditions that could be inferred from the interpretation of the radiographic films. The worst-case condition enveloping all the stated variations is a sharp cup-shaped intrusion, with a depth of about 1/10 the wall thickness. This condition is designated as Case E* in the licensee's analyses. There are three possible adverse effects of this assumed worst-case root condition; adequate fatigue life, initiation of stress corrosion cracking, and initiation of brittle or unstable fracture without prior warning. These three possible effects are discussed below.

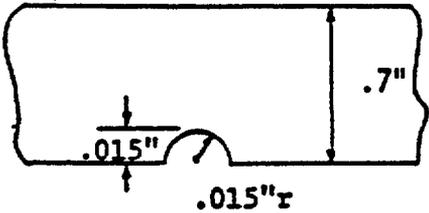
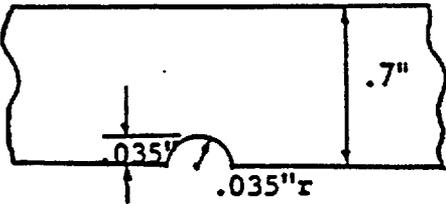
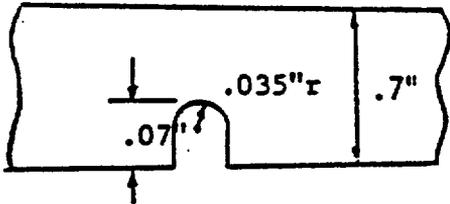
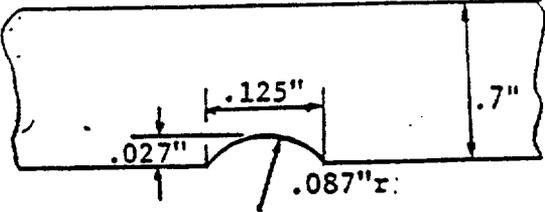
FIGURE 2: Analyzed Notch Configurations at Root of Safe End to Piping Weld (Weld #6)

Because there were concerns that the weld root irregularities could be severe enough to act like crevices to initiate stress corrosion cracking, the licensee performed a stress corrosion crack growth rate analysis. In this analysis he assumed that stress corrosion cracks would be initiated, even though the worst case root condition postulated is not nearly as severe a crevice as was present in the original design. The results of these analyses show that the crack growth rate in terms of fractional depth through the wall as a function of time would be slower than in the old design.

Although the staff has reservations regarding the bases for the stress corrosion crack growth predictions submitted by the licensee, we conclude that even if stress corrosion cracking should initiate at local spots around the circumference, crack propagation would be no faster than the original stress corrosion cracks, and most likely will be slower, because the nominal stress levels at welds 2 and 6 are lower than those at the cracked section of the original safe ends.
