DUANE ARNOLD ENERGY CENTER

AMENDMENT TO FACILITY OPERATING LICENSE

SAFETY EVALUATION BY THE OFFICE OF NUCLEAR REACTOR REGULATION

SUPPORTING AMENDMENT NO. 47 TO LICENSE NO. DPR-49

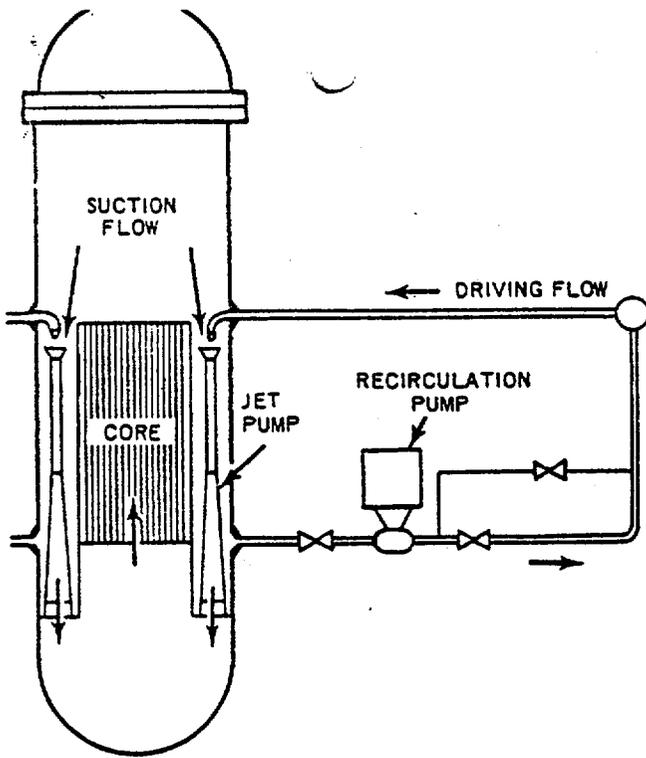
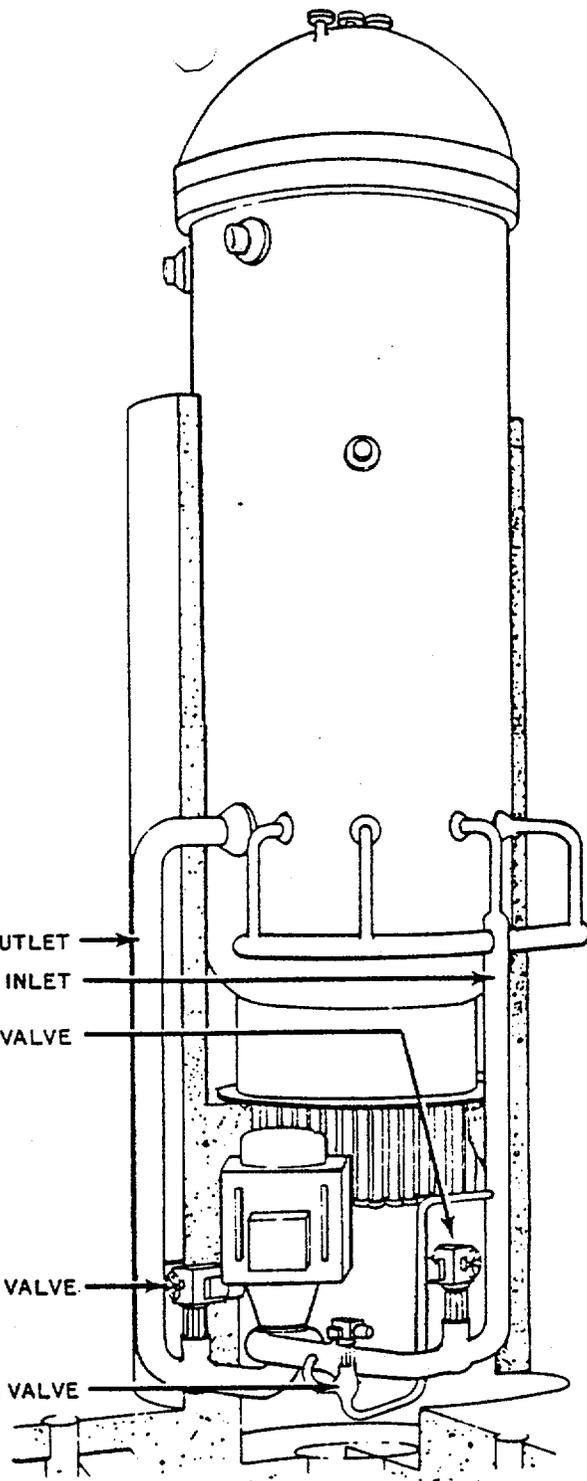
Figure -1

The modification consists of replacing the existing eight cracked recirculation inlet nozzle safe-ends with redesigned safe-ends and thermal sleeve adapters. The safe-ends were fabricated from SB-166 (Alloy 600) material.** They function as transition pieces between the stainless steel reactor recirculation piping and the carbon steel reactor vessel nozzles, and as attachment points for the internal thermal sleeves, that carry the recirculation flow to the jet pump risers (see Figure 1).
