Donald C. Cook Nuclear Plant Unit 1
RESPONSE TO
NUCLEAR REGULATORY COMMISSION BULLETIN 2002-01
REACTOR PRESSURE VESSEL HEAD DEGRADATION AND
REACTOR COOLANT PRESSURE BOUNDARY INTEGRITY

D. C. COOK 1
REACTOR VESSEL HEAD PENETRATION INSPECTION
FINAL REPORT

**D.C. Cook 1
Reactor Vessel Head Penetration Inspection
Final Report**

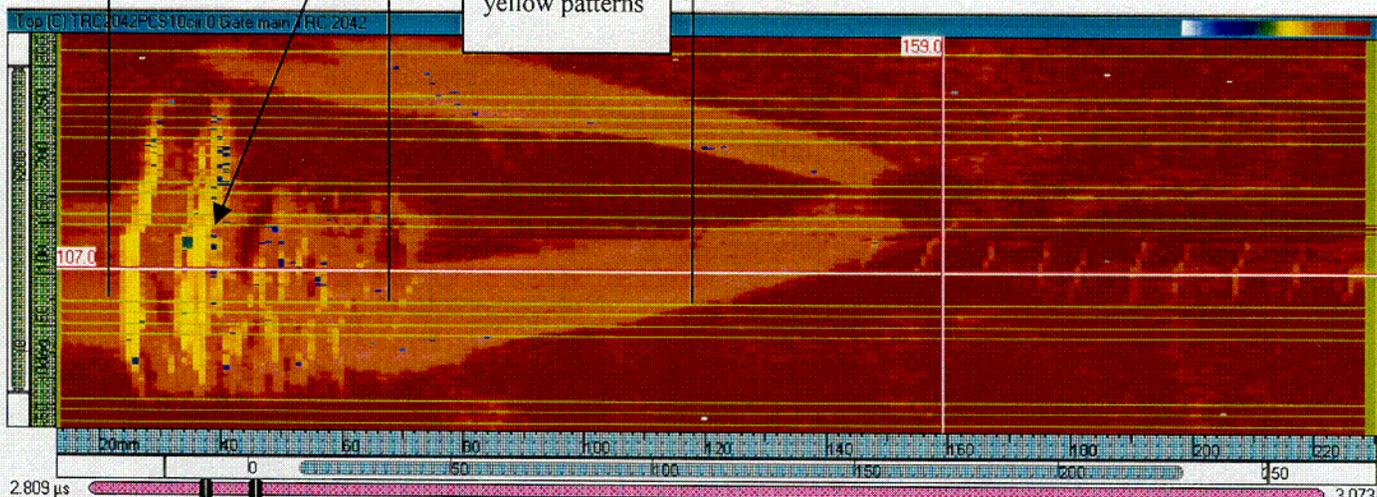
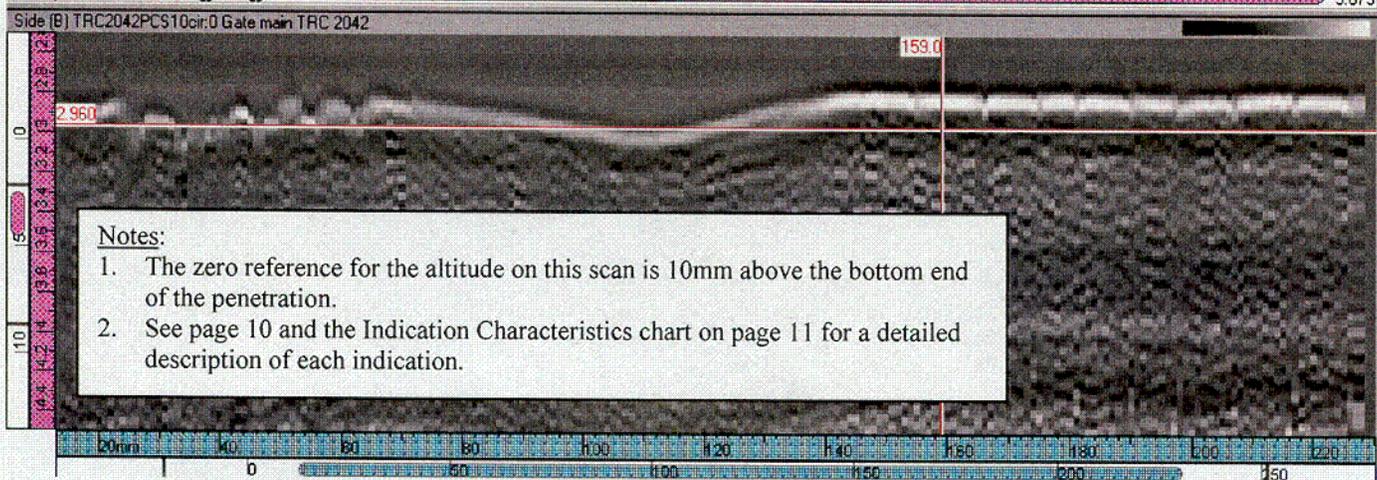
Penetration #62 PCS10 Circ Results

Penetration 62 contained 21 separate circumferentially oriented indications on the inside diameter of the tube above and below the J-groove weld. The depth of the indications ranged from less than 1 millimeter (0.039 inch) to 1.5 millimeter (0.059 inch). The circumferential extent ranged from 26° - 297°. Thirteen of the indications were located above the weld and were less than 1mm in depth with a circumferential extent ranging from 26° - 58°. Eight indications were located below the weld with the depth at one spot of 1.5 millimeter (all other indications are 1 millimeter), with a circumferential extent ranging from 111° - 297°. The indications appeared to have relative uniform spacing between them (see Attachment 2, Page 12). There was no loss of back wall signal or crack tips identified for any of these indications. These indications were dispositioned as being results of the original fabrication process.

Results of these supplementary examinations indicate no evidence of primary water stress corrosion cracking in any of the 79 reactor vessel head penetrations. One penetration, #62, has indications on the penetration tube inside diameter surface that appear to be associated with the manufacturing process. These indications are circumferential in orientation and most have depths less than 1.0 mm.

The characteristics of the indications are listed in the following table and shown in the attached graphic. The indications do not appear to be crack-like, but likely a result of the manufacturing process.

Below Weld
Indications 21 to 14

Above Weld
Indications 13 to 1

Indications are
between the
yellow patterns
