Kewaunee Nuclear Power Plant
N490, State Highway 42
Kewaunee, WI 54216-9511
920-388-2560

Docket 50-305
Operating License DPR-43
Kewaunee Nuclear Power Plant
Reportable Occurrence 2002-002-00

LICENSEE EVENT REPORT (LER)

TITLE (4)
Technical Specifications Required Shutdown: CCW System Leak Could Not Be Repaired Within LCO

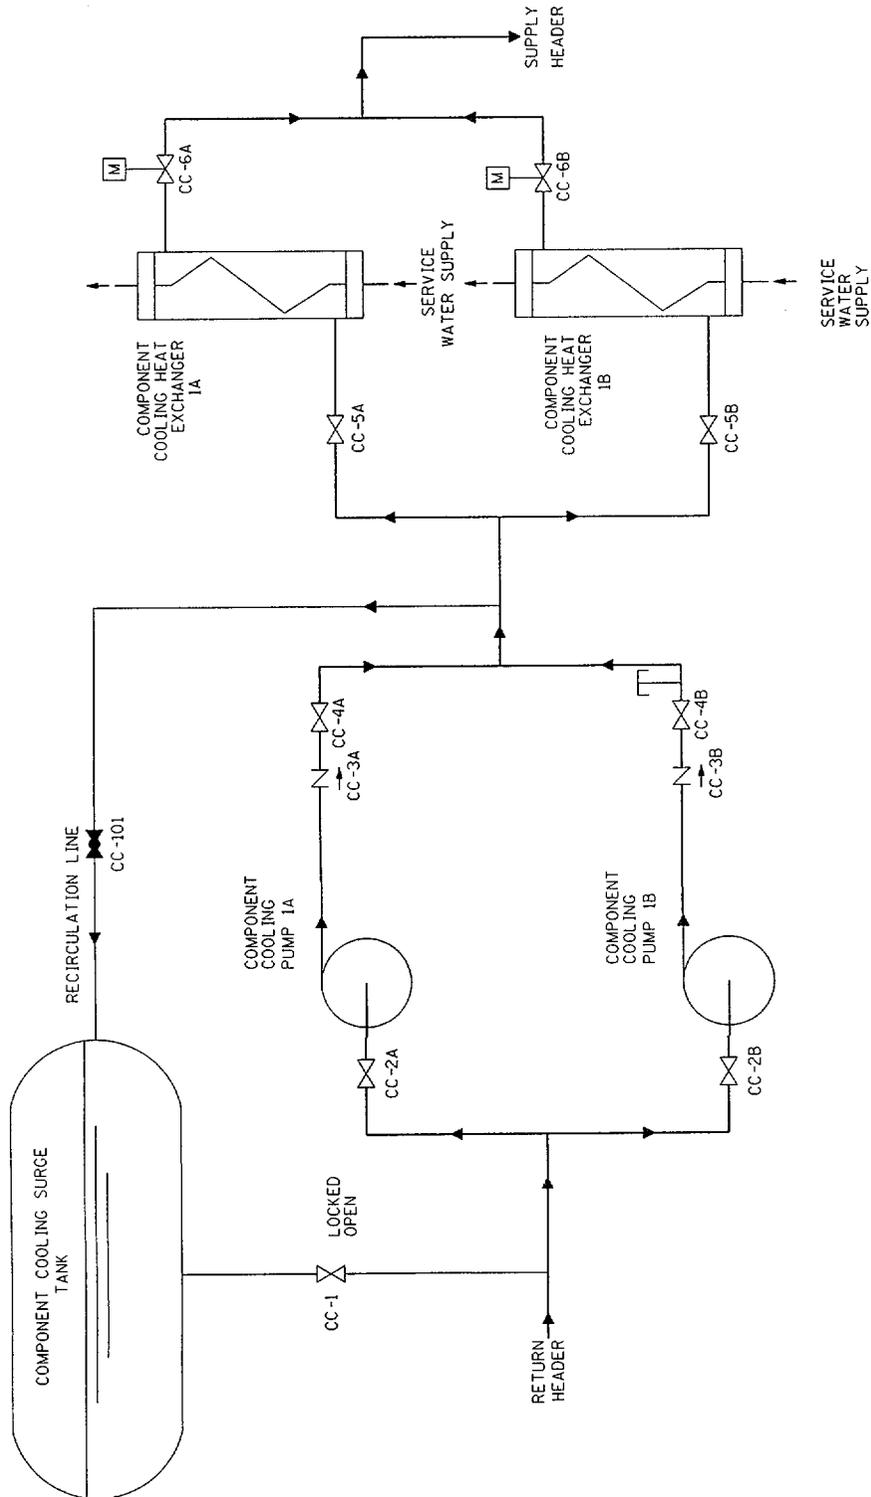
Figure 1: Simplified CCW Sketch

As stated in the Kewaunee Updated Safety Analysis Report (USAR) Section 9.3, the CCW system consists of two CCW pumps, two CCW heat exchangers, a CCW surge tank [TK], cooling lines to various components to be cooled, and associated piping, valves, and instrumentation (see Figure 1). CCW piping to various components is arranged in parallel flow circuits. During normal operation, the CCW pumps and heat exchangers are operated as needed to accommodate the heat removal loads. One pump and one heat exchanger can provide 100% heat removal capability during normal operation. Two pumps and two heat exchangers are used to remove the residual and sensible heat during plant shutdown. If one of the pumps or one of the heat exchangers is not operable, safe shutdown of the plant is not affected; however, the time for cooldown is extended.
