July 11, 2002
NL-02-099
IPN-02-060

SUBJECT: Indian Point 2 and 3 Nuclear Power Plants
Docket Nos. 50-247 and 50-286
License Nos. DPR-26 and DPR-64
"Supplement to 15-Day Response for NRC Bulletin 2002-01"

**SUPPLEMENT TO 15-DAY RESPONSE TO
NRC BULLETIN 2002-01
FOR INDIAN POINT UNIT 2**

FOR INDIAN POINT UNIT 3

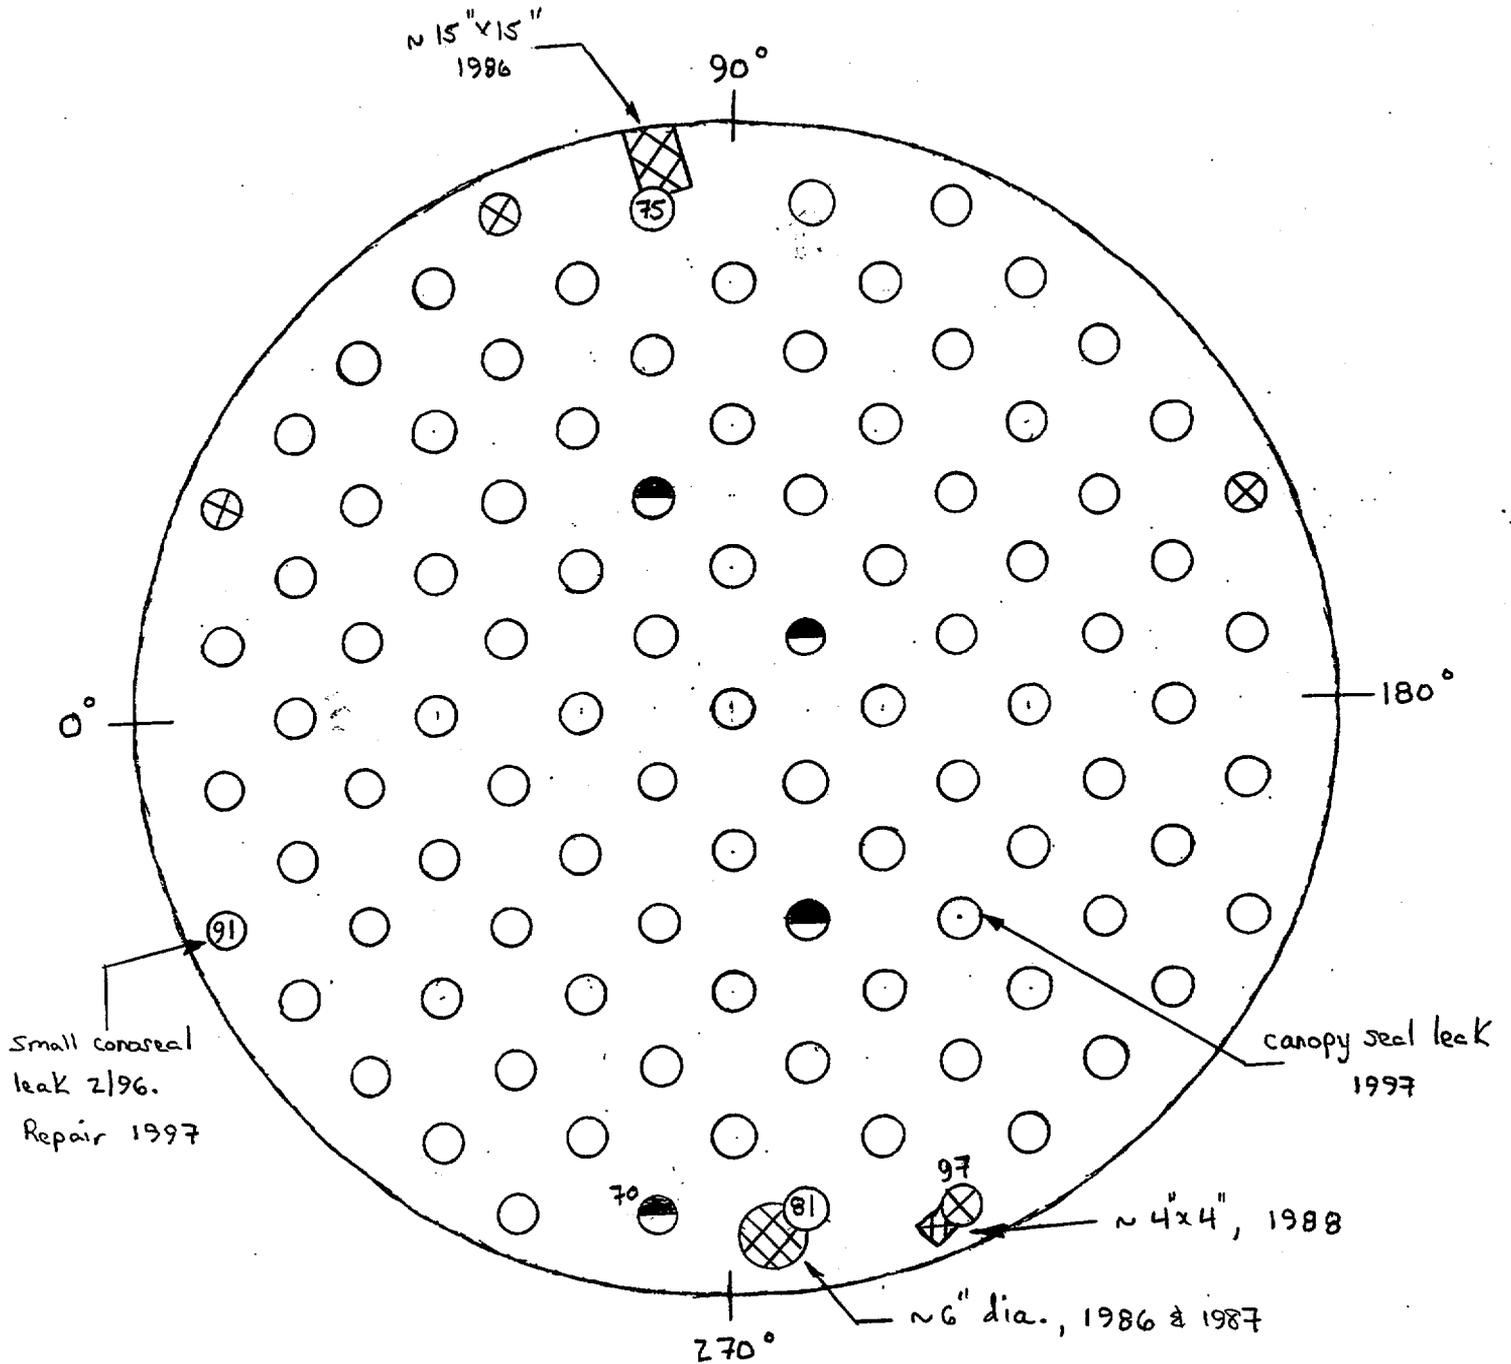
FIGURE I
 UNIT 2 REACTOR VESSEL HEAD
 LEAK LOCATIONS AND INSULATION REMOVAL

Removal of insulation and inspection of the bare metal was performed as described below. Locations are shown on Figure I.

- 1986: Approximately 6 inch diameter section removed between nozzles 70 and 81.
Approximately 15 inch x 15 inch section removed adjacent to nozzle 75.
- 1987: Same location as 1986, between nozzles 70 and 81.
- 1988: Approximately 4 inch x 4 inch section removed adjacent to nozzle 97.

In all above cases, no boron accumulation on the vessel head or degradation of base metal was observed, and the head coating (high-temperature aluminum silicate) appeared to be intact. During the 1986 / 1987 inspection and repair efforts, samples of insulation were tested to determine the degree to which the leaking, borated water had penetrated the head insulation. The results of these tests showed that, although the insulation provided some protection against the leaking water contacting the head base metal, some boron was found through the thickness of the insulation, indicating that the insulation is not water tight. However, no visible signs of boron were found on the vessel head.

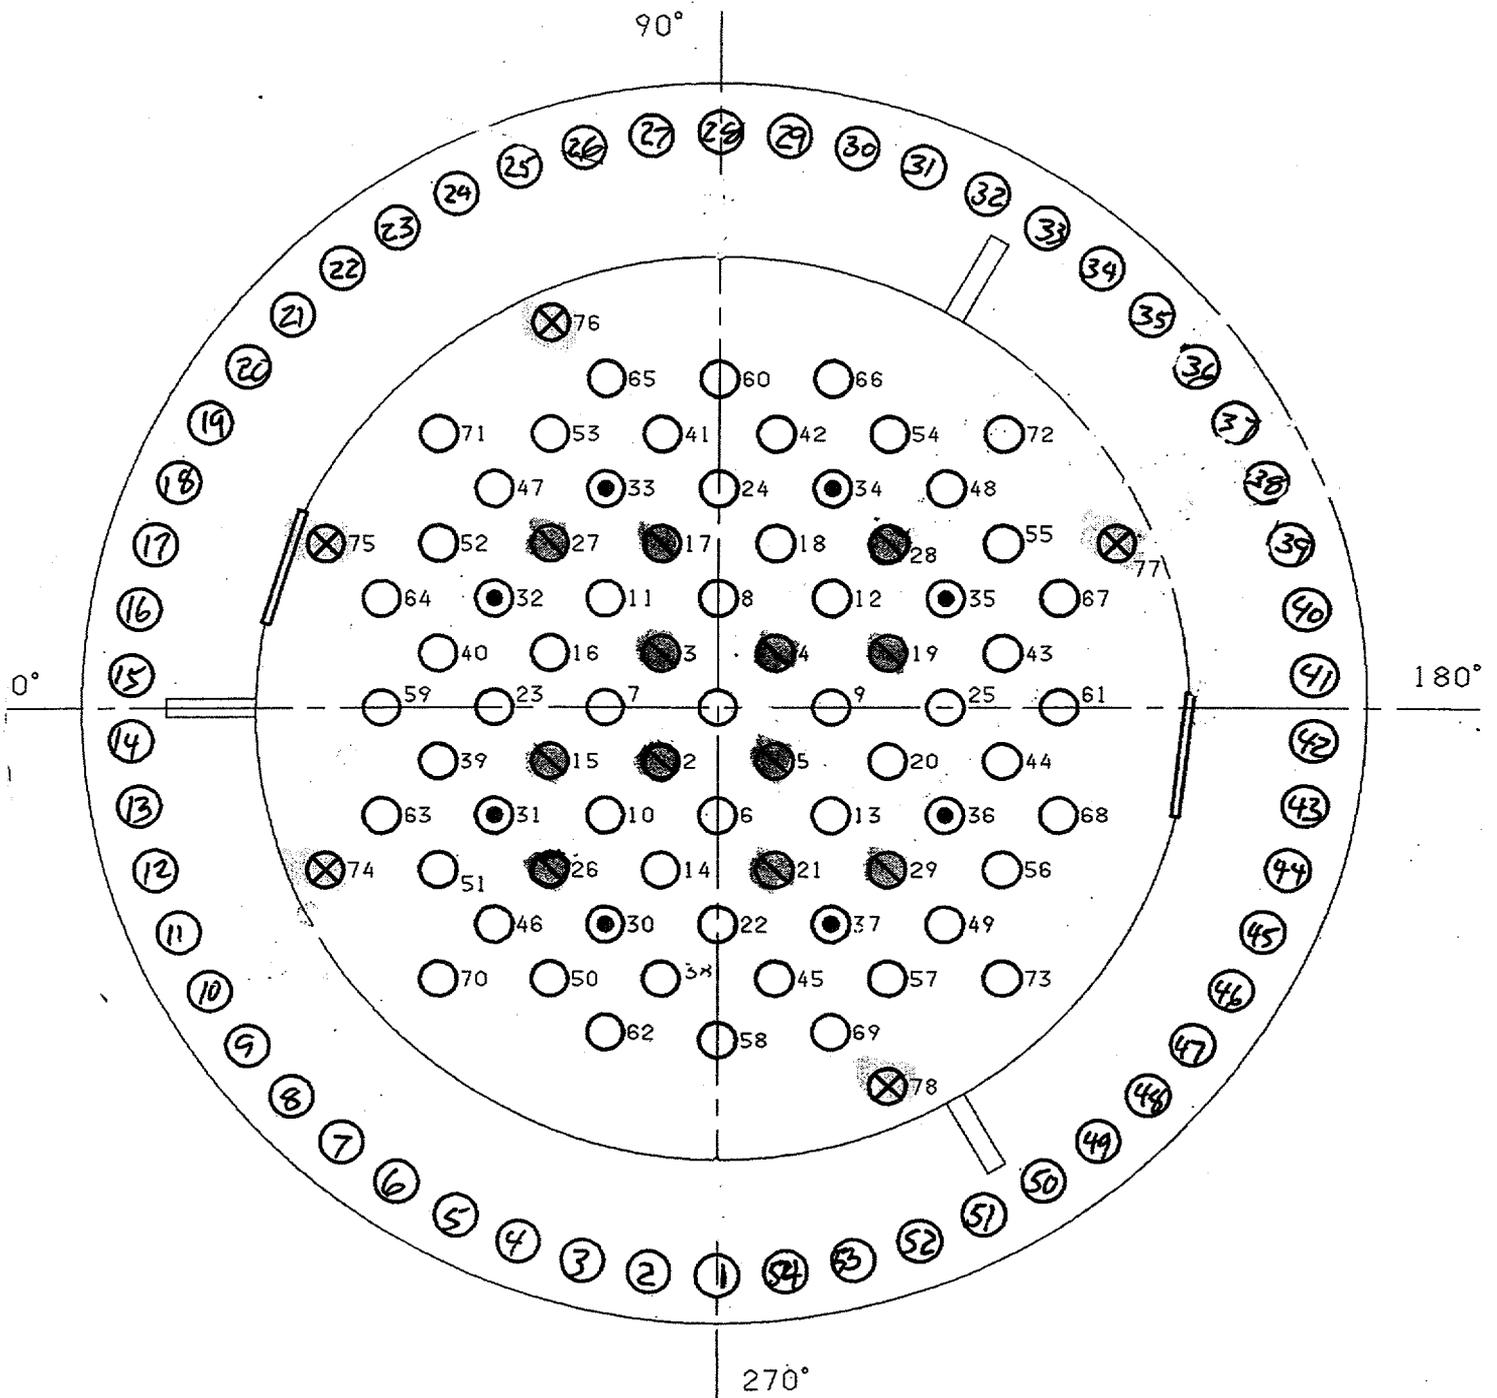
FIGURE II
 UNIT 3 REACTOR VESSEL HEAD
 PENETRATIONS AND CLOSURE STUD LOCATIONS

A plan view of the Unit 3 reactor vessel head is provided in Figure II to show the relative locations of areas described in answers to several of the NRC questions.

Leakage from the canopy seal on CRDM 28 was detected during startup from a scheduled outage in March 1990. A clamp assembly was installed (Work Request 21446) to repair the leak and the wetted insulation over an area approximately 3 feet by 5 feet was removed (Work Request 21284). In addition, a clamp assembly was installed on CRDM 26 (Work Request 21447) because boric acid residue was found on the canopy seal area, although no active leakage was detected. Prior to installing new insulation, the reactor vessel head was cleaned and inspected in the area of removed insulation. No corrosion was noted in the work package documentation.

The Refueling crew inspected the exposed surface of the Reactor Vessel head outside the CRDM shroud assembly per 3PT-R114 during vessel disassembly. At the beginning of R10, the inspection noted boron deposits/streaks around vessel studs #5 through #18, which was documented in the test procedure and in the IP3 corrective action program (Deviation Event Report 99-01968).

During a forced shutdown in September, 1990 boric acid residue was noted on a clamp assembly for conoseal #4 on penetration #77. Work request 23986 was issued to fix this mechanical clamp assembly and the assembly was replaced. As a preventive measure, mechanical clamps were also installed on the canopy seal weld joints for all 5 CET penetrations (74, 75, 76, 77, and 78) and the 10 spare penetrations (2, 3, 4, 5, 15, 17, 19, 21, 27, and 29).

The inspections noted born residue at the location of stud hole #38, which is a different location than refueling outage 10 as noted above.

Inspections were performed and boron deposits were noted at a gasketed joint (conoseal) on the #4 thermocouple penetration (also designated as head penetration #77). This was documented in IP3's corrective action program. This leakage was initially noted on-line (during a leak inspection walk down inside the containment by plant personnel. During RO11, the IP3 ISI engineer, Corporate Metallurgist and system engineer evaluated the areas that showed evidence of boron residue. No degradation of the Reactor vessel was noted. The conoseal was disassembled and repaired during this refueling outage. The conoseal gaskets are normally replaced each refueling as part of the reactor disassembly / reassembly process.
