SUBJECT: Indian Point 2 and 3 Nuclear Power Plants
Docket Nos. 50-247 and 50-286
License Nos. DPR-26 and DPR-64
"Supplement to 15-Day Response for NRC Bulletin 2002-01"

**SUPPLEMENT TO 15-DAY RESPONSE TO
NRC BULLETIN 2002-01
FOR INDIAN POINT UNIT 2**

FOR INDIAN POINT UNIT 3

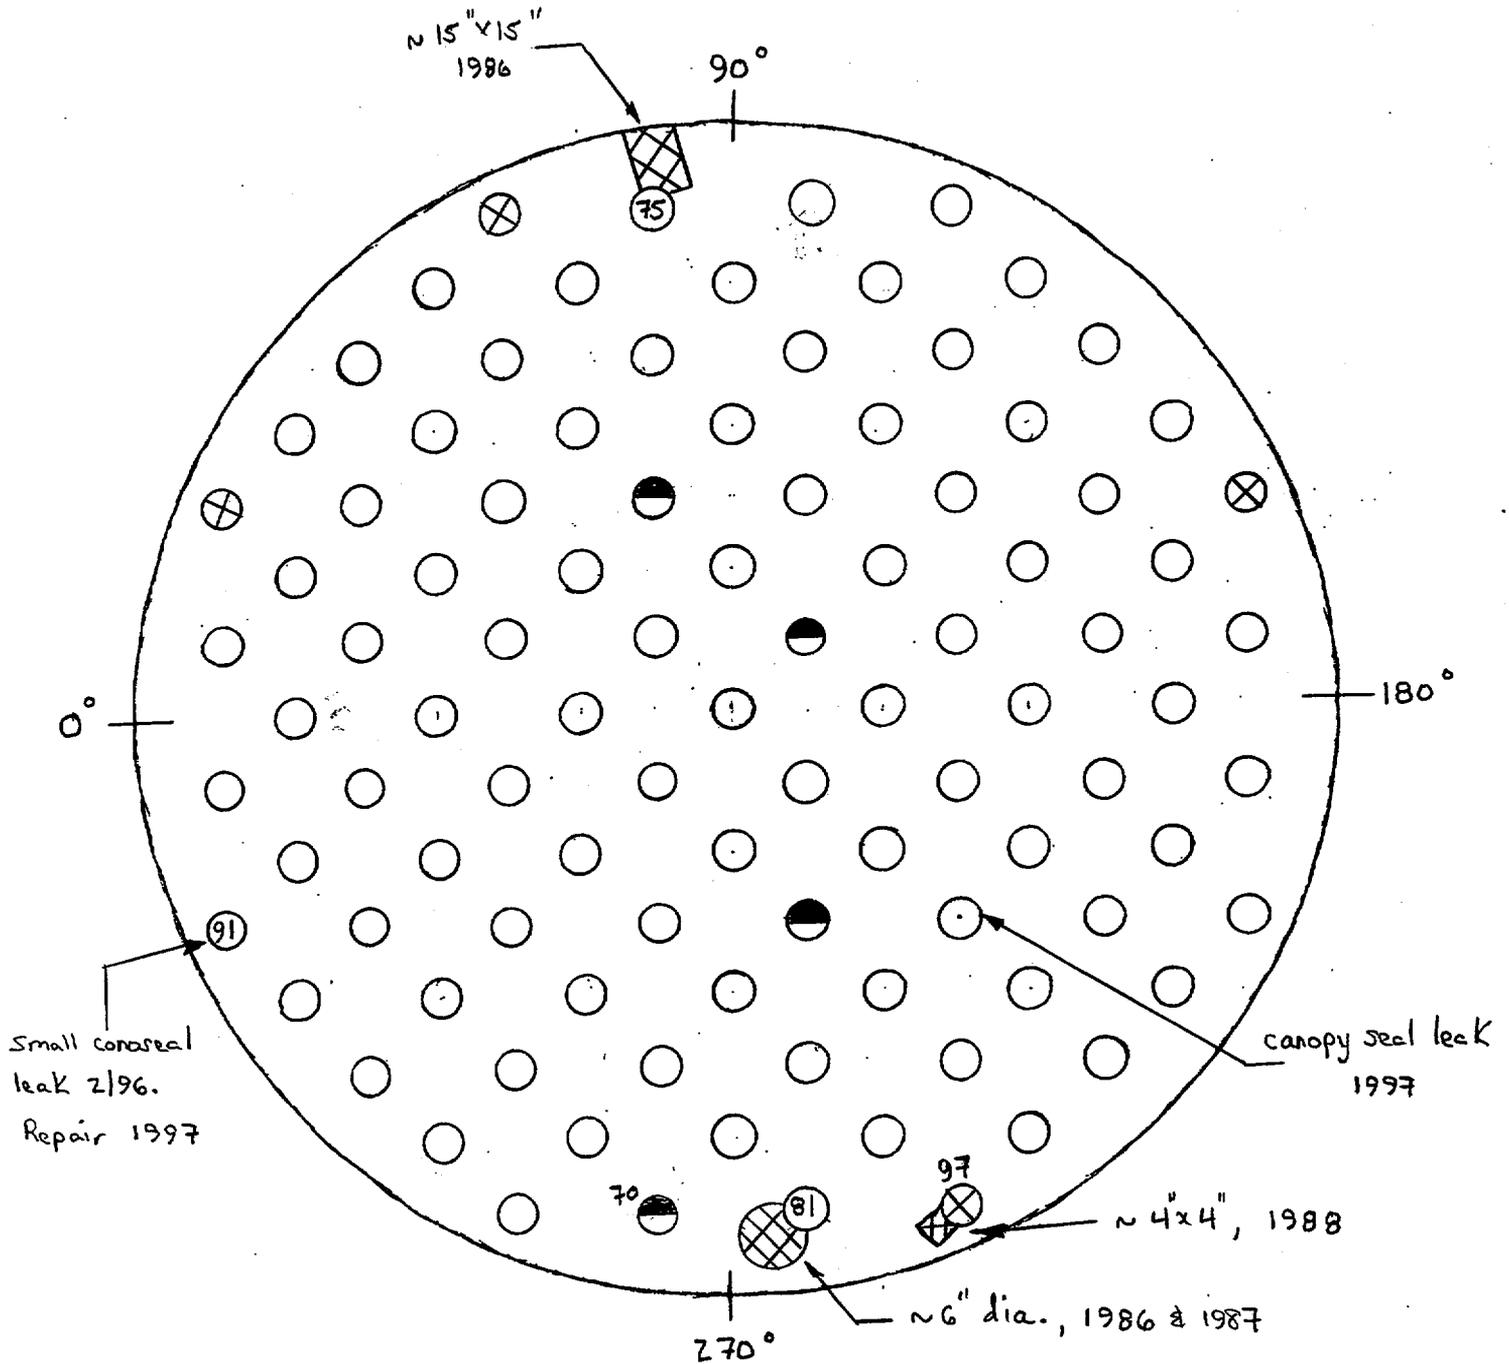
FIGURE I
 UNIT 2 REACTOR VESSEL HEAD
 LEAK LOCATIONS AND INSULATION REMOVAL

Removal of insulation and inspection of the bare metal was performed as described below. Locations are shown on Figure I.

- 1986: Approximately 6 inch diameter section removed between nozzles 70 and 81.
Approximately 15 inch x 15 inch section removed adjacent to nozzle 75.
- 1987: Same location as 1986, between nozzles 70 and 81.
- 1988: Approximately 4 inch x 4 inch section removed adjacent to nozzle 97.

In all above cases, no boron accumulation on the vessel head or degradation of base metal was observed, and the head coating (high-temperature aluminum silicate) appeared to be intact. During the 1986 / 1987 inspection and repair efforts, samples of insulation were tested to determine the degree to which the leaking, borated water had penetrated the head insulation. The results of these tests showed that, although the insulation provided some protection against the leaking water contacting the head base metal, some boron was found through the thickness of the insulation, indicating that the insulation is not water tight. However, no visible signs of boron were found on the vessel head.
