NP-33-02-004-00

LER 2002-004
Davis-Besse Nuclear Power Station, Unit No. 1
Date of Occurrence – May 23, 2002

TITLE (4)
Containment Isolation Closure Requirements for RCP Seal Injection Valves MU66A-D

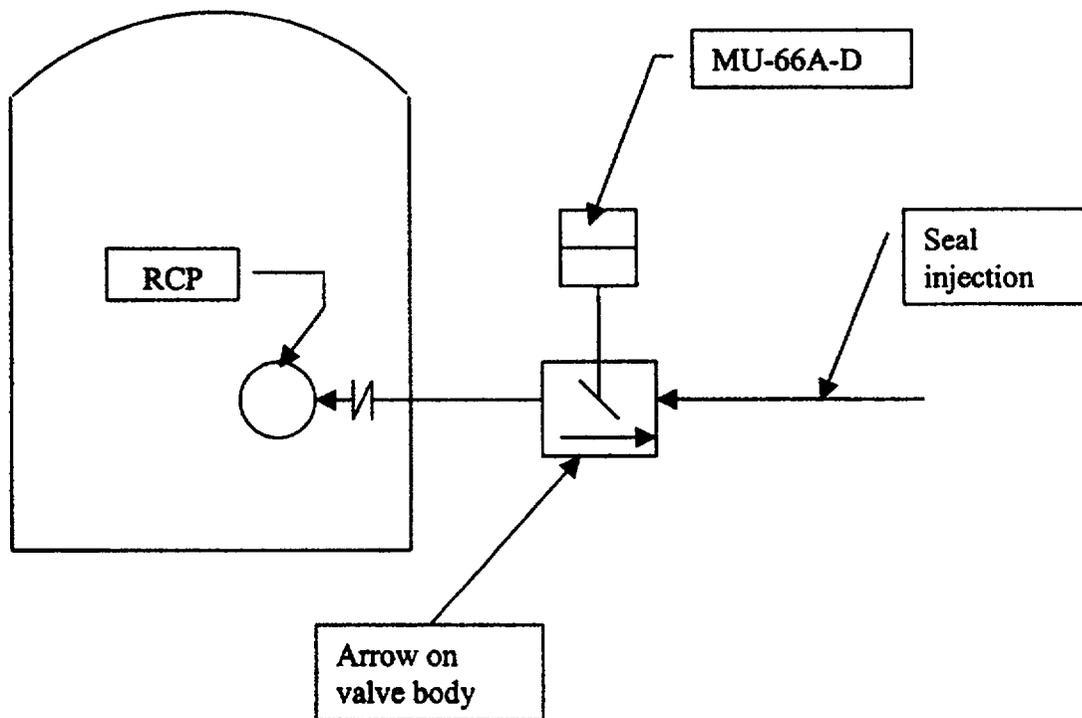
Figure 1

As described in USAR Section 9.3.4.3.3, the four RCP Seal Injection lines each contain a check valve inside containment and a solenoid actuated pneumatic valve outside containment in order to meet the containment isolation provisions of 10 CFR 50, Appendix A, GDC-55. Configuration of valves MU66A-D to meet their design bases assumes system flow under the valve disk during normal operation. During the postulated accident condition, the design bases assume RCS pressure acting on the top of the valve disk. The as-found configuration, shown in Figure 1, results in normal and accident system flow to be the converse of the design bases.

As part of the maintenance activity, one of the MU66 valves was disassembled and inspected. Its installed configuration was determined to be inconsistent with design assumptions. For a postulated accident situation resulting in an SFAS Level 3 containment isolation signal with the makeup pump not operating, the valves were intended to be installed such that RCS pressure would act upon the top of the valve disk, thus assisting valve closure when the valve is subjected to full differential pressure. In the as-found configuration, RCS pressure acts upon the bottom of the valve disk, thus acting to open the valve when subjected to full differential pressure.

The cause of the misorientation of the RCP Seal Water Injection Isolation Valves (MU66A-D) and RCP Seal Return Valve (MU38) appears to have resulted from confusion and/or miscommunication during original construction-phase installation of the valves. No documented information could be found related to the actual field instructions for installation of the valves. The valves were manufactured depicting a flow arrow on the body of the valve which would conform to normal generic system flow path for a globe valve (i.e., flow under the valve disk). The flow arrows shown on the installation drawing (pointing away from containment) were apparently intended to depict flow direction from the RCP seals assumed for postulated accident conditions without including any special notes or cautions on the drawing to explain or emphasize the intended valve configuration. The valves were installed such that the flow arrows on the valve bodies were matched to the flow arrows on the installation drawing which resulted in assumed post-accident RCS flow from the RCP seals to be under the disks for all the valves which is contrary to design intent. Documentation during and after plant construction indicates that the valves should be installed such that RCS pressure would act on the top of the valve disk. The installed configuration is inconsistent with this recommendation, USAR Sections 6.2.4 and 9.4.3.3, and the response to USAR Question 9.3.6.

MU66A-D As-Found Orientation

Valve configuration reflects vendor drawing and the installed condition with the normal seal injection flow on top of disc. The design intent was to install the valve in reverse of this configuration with any RCS back-pressure on top of disc.

An AOV Reliability Program is being implemented, in part, to ensure that AOV sizing and setpoints are reviewed to verify and document their adequacy. For valves MU66A-D, MU38, and all other Category 1 and 2 AOVs and their associated components; design basis requirements, including the correct installed orientation, will be established in accordance with the AOV Reliability Program Manual. The requisite engineering documents will be developed to implement any required changes. Any modifications needed to restore these components to their design requirements will be completed prior to plant restart. Post-modification testing will be performed to verify compliance with design bases.

Drawing 7749-M525-37-7 will be reviewed and revised to ensure that the actual configuration and the valve body arrow shown on the drawing are correct. This action is to be completed following the final design configuration determination based on the AOV Reliability Program requirements and prior to plant restart.
