LER 2002-004
Davis-Besse Nuclear Power Station, Unit No. 1
Date of Occurrence – May 23, 2002

TITLE (4)
Containment Isolation Closure Requirements for RCP Seal Injection Valves MU66A-D

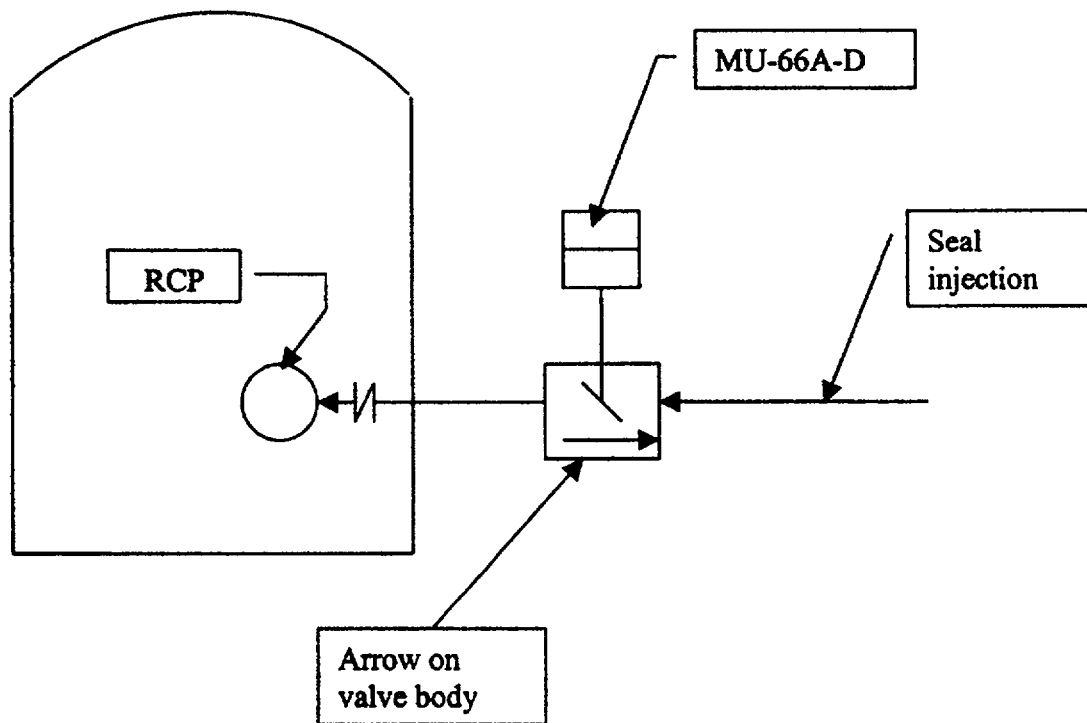
Figure 1

As described in USAR Section 9.3.4.3.3, the four RCP Seal Injection lines each contain a check valve inside containment and a solenoid actuated pneumatic valve outside containment in order to meet the containment isolation provisions of 10 CFR 50, Appendix A, GDC-55. Configuration of valves MU66A-D to meet their design bases assumes system flow under the valve disk during normal operation. During the postulated accident condition, the design bases assume RCS pressure acting on the top of the valve disk. The as-found configuration, shown in Figure 1, results in normal and accident system flow to be the converse of the design bases.

As part of the maintenance activity, one of the MU66 valves was disassembled and inspected. Its installed configuration was determined to be inconsistent with design assumptions. For a postulated accident situation resulting in an SFAS Level 3 containment isolation signal with the makeup pump not operating, the valves were intended to be installed such that RCS pressure would act upon the top of the valve disk, thus assisting valve closure when the valve is subjected to full differential pressure. In the as-found configuration, RCS pressure acts upon the bottom of the valve disk, thus acting to open the valve when subjected to full differential pressure.

MU66A-D As-Found Orientation

Valve configuration reflects vendor drawing and the installed condition with the normal seal injection flow on top of disc. The design intent was to install the valve in reverse of this configuration with any RCS back-pressure on top of disc.

Drawing 7749-M525-37-7 will be reviewed and revised to ensure that the actual configuration and the valve body arrow shown on the drawing are correct. This action is to be completed following the final design configuration determination based on the AOV Reliability Program requirements and prior to plant restart.
