Subject: June 13, 2002, Visit to the Church Rock, New Mexico, UMTRCA Title II Site

June 13, 2002, Visit to the Church Rock, New Mexico, UMTRCA Title II Site

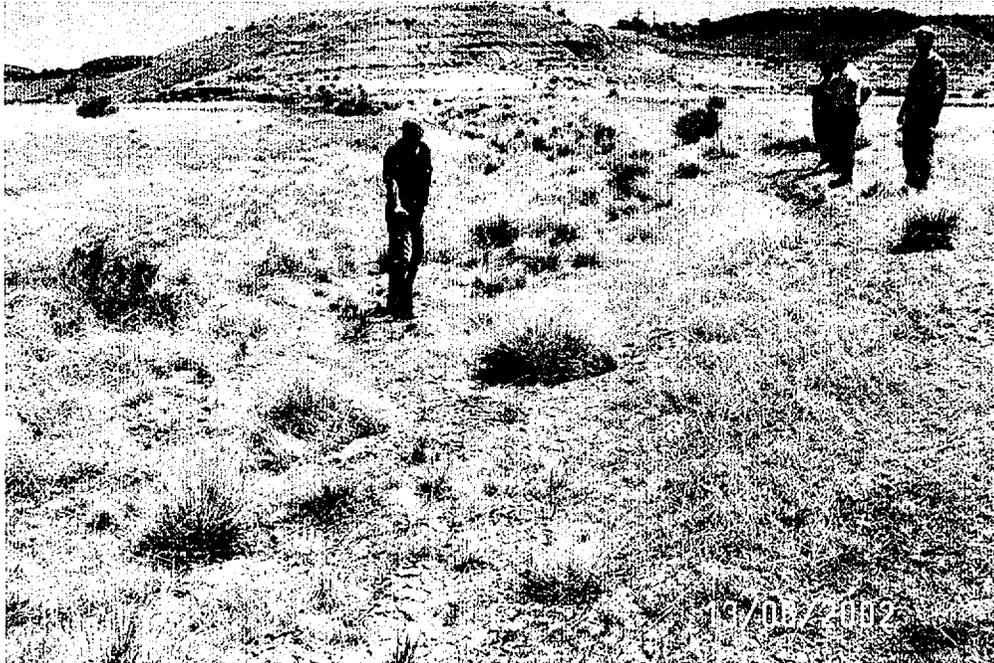
Figure 3

The drainage channels on the cover are shallow u-shaped features that slope gradually to the northwest. Soil has filled the channels in some areas so that about 2/3 of the cross-section has been lost, Figure 3. Flushing of the soil from the channel by a storm event is unlikely because of the minimal channel slope and the soil stability provided by vegetation growing in the soil. The source of the soil appears to be both wind-blown as well as cover runoff. As the channels are dammed with sediment or dunes, concentrated flows may divert across the top of the cell causing gullying through the riprap, radon barrier and tailings. Failure of the channel walls may occur when sheet flow from the cover runs down the side slope of the channel and begins moving the 1.5-inch riprap. Headcutting through the radon barrier into the tailings could result.

On the basis of this and previous visits, I feel that significant annual maintenance at the Church Rock site will be required. The primary costs will be associated with the removal of soil from the cell-top drainage channels and from the north diversion channel to provide sufficient capacity. Removal of material from the drainage channels will be a delicate, labor-intensive operation as the 1.5-inch riprap channel liner can be easily damaged by standard construction equipment. Cleaning of sediment from the north diversion channel and maintenance of the uncompacted roadway embankment will also be necessary after any significant storm event. Unless a risk analysis shows that biointrusion is not a concern, deep-rooted vegetation will be treated with herbicide and burrowing animals killed.

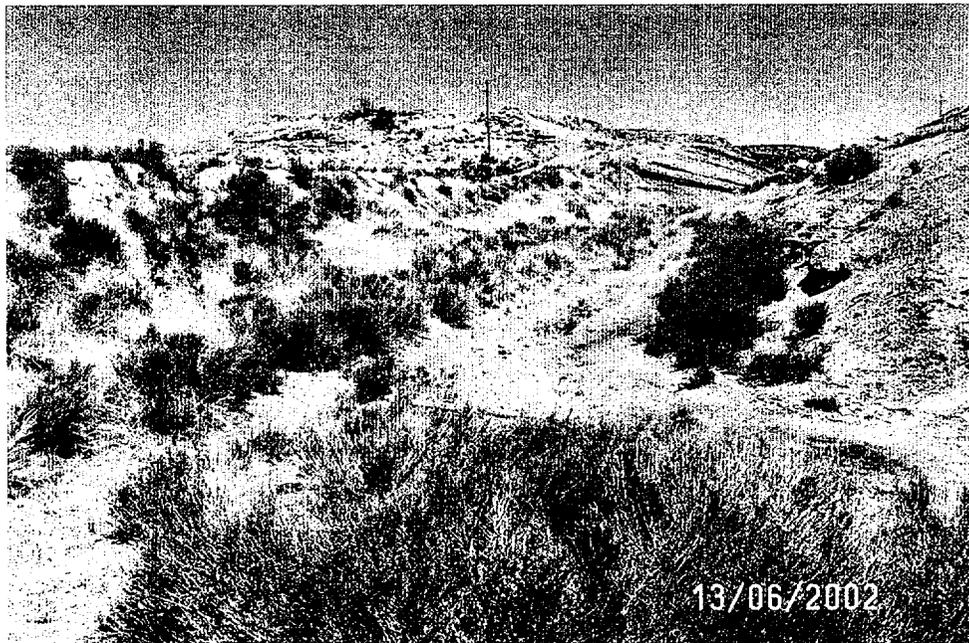
Figure 6

Sediment is filling the north diversion channel Figure 6. The channel captures water from a large drainage area north of the cell and diverts it around the upper end of the cell. The diversion channel has very little slope and the sediment is being stabilized by vegetation. An uncompacted roadway embankment forms the south bank of the diversion channel. The embankment slopes are very steep and are rilling, Figure 7.

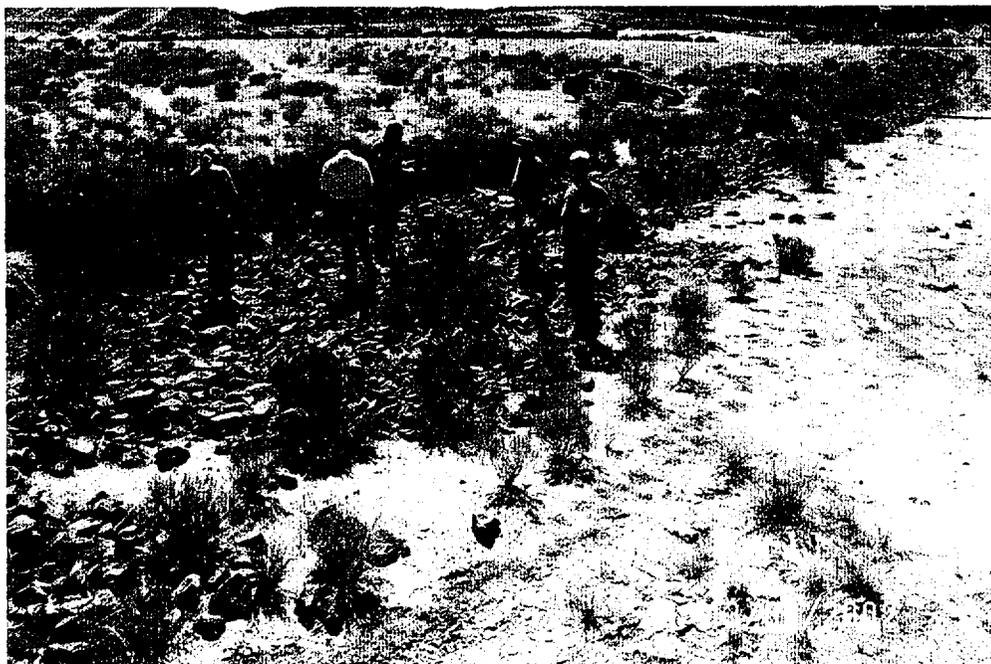
Figure 8

A rock jetty was constructed to prevent the main drainage west of the cell from migrating into the tailing impoundment. Some of the rock from the surface of the jetty has been moved downstream by a storm event, Figure 8. A large gully on the downstream side of the jetty is headcutting toward the jetty.
