Subject: Oyster Creek Generating Station
Facility License No. DPR-16
Docket No. 50-219
Alternative Repair of Control Rod Drive Housing Interface with Reactor Vessel

Enclosure: Oyster Creek Generating Station
Proposed Alternative to ASME Section XI Code Requirements

**OYSTER CREEK GENERATING STATION
PROPOSED ALTERNATIVE TO ASME SECTION XI CODE REQUIREMENTS**

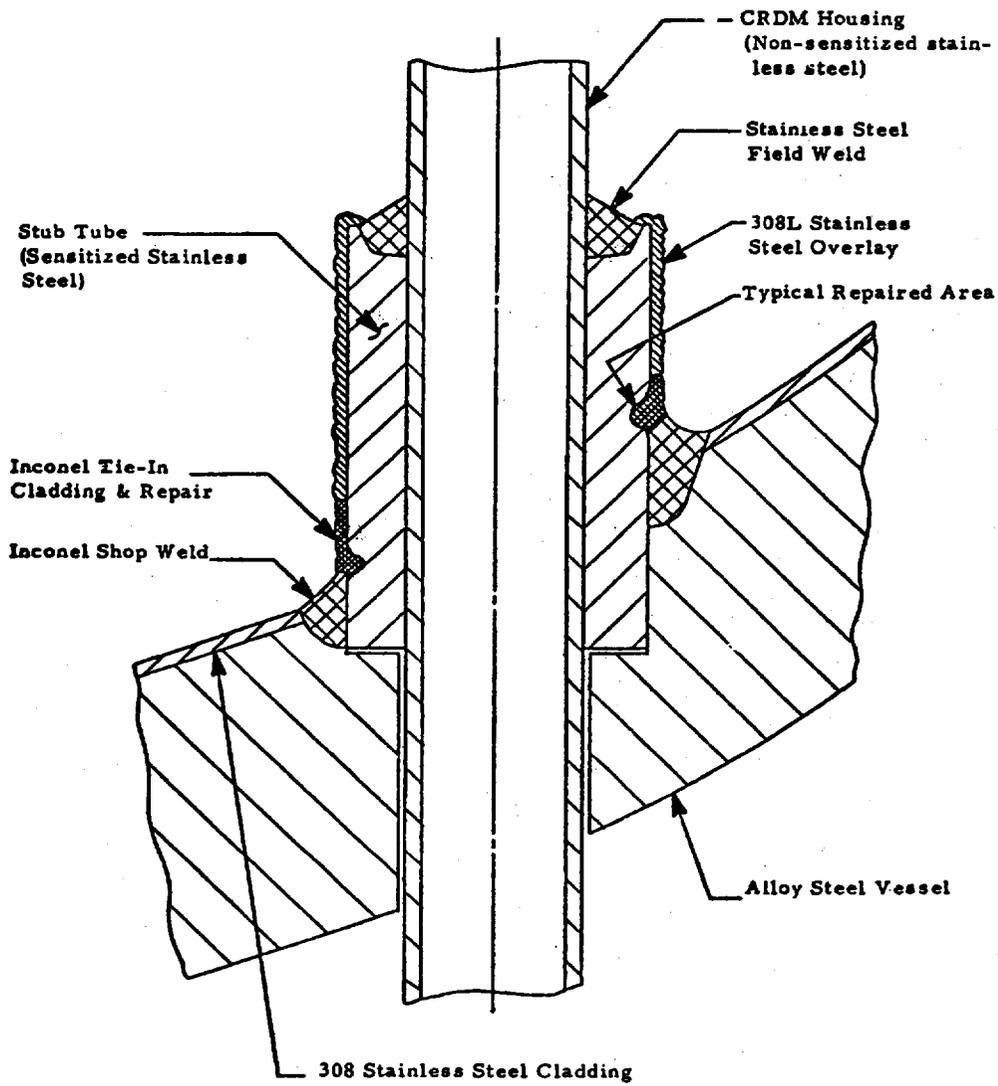
Figure

Although the exact origin of the leak has not been determined, several possibilities exist: these include 1) the stub tube, 2) the stub tube-to-housing weld, or 3) the RPV-to-stub tube weld (see attached figure). AmerGen will remove a control rod guide tube during the 1R19 refueling outage, currently scheduled to commence on October 4, 2002, to gain access to the lower plenum of the RPV. An examination of the bottom head in the area of the stub tubes associated with CRD housings 42-43 and 46-39 will be performed with a remote observation vehicle to support the root cause determination of the leakage. Based upon review of the stub tube repair program during original construction, the most likely cause appears to be related to the stub tube overlay performed by a certain welder.

Although the exact origination of the leak has not yet been determined, several possibilities exist: these include 1) the stub tube, 2) the stub tube-to-housing weld, or 3) the RPV-to-stub tube weld (see attached figure). These components are constructed of stainless steel with the exception of the RPV-to-stub tube weld, which is Inconel. The most likely cause of leakage for these components in this service is crack growth resulting from Intergranular Stress Corrosion Cracking (IGSCC), which is well understood and bounded. All industry experience related to this cracking has shown ample time to react from the time of significant leakage to failure. In addition, prior to performing the repair, the CRD housing is ultrasonically examined to verify its structural integrity in the area to be rolled and at the location of the CRD housing-to-stub tube weld. This examination will include that portion of the housing above and below the stub tube-to-RPV weld.
