Subject: 10CFR21 Reporting of Defects and Non-Compliance -
Engine Systems, Inc. Report No. 10CFR21-0084, Rev. 0

Norgren R18 relieving style pressure regulating valves

Report No. 10CFR21-0084
Rev. 0: July 30, 2002

10CFR21 REPORTING OF DEFECTS AND NON-COMPLIANCE

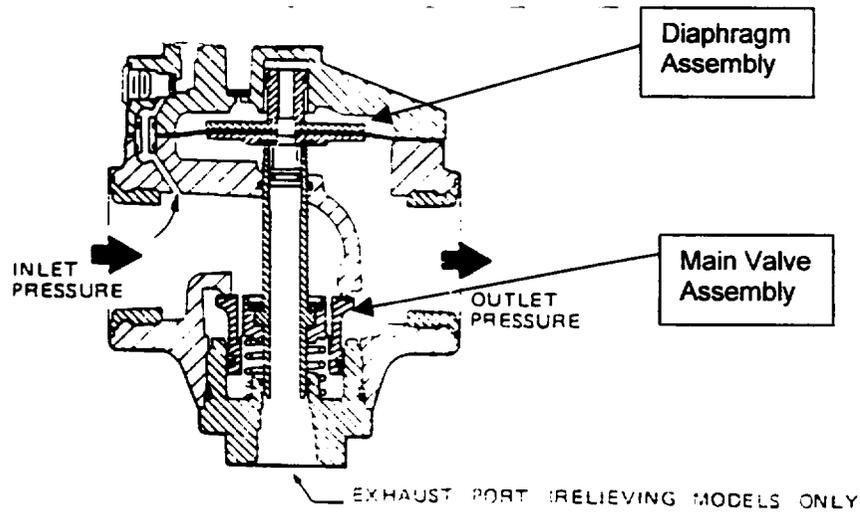
FIGURE 1
Valve Assembly with no flow

C.A. Norgren Company, the manufacturer of the valve, was contacted to evaluate the condition and assist in a resolution. After evaluating the problem Norgren determined that the sudden demand in flow during an engine start caused the main valve to open further than is normally expected. When the air flow is suddenly terminated following the engine start, the resulting backpressure within the valve causes the diaphragm assembly to travel to its maximum upper position and allows its o-ring to separate from the valve tube. The relative positions of the two components causes the main valve to stick in the open position and opens the air relief path through the relieving tube of the regulator. The o-rings around the relief tube and on the diaphragm retainer in addition to the forces generated by the flow through the valve contribute to hold the valve open. As the pressure in the air receiver falls, the forces acting to hold the valve open decrease and the valve returns to its closed position. Refer to figures 1 & 2.

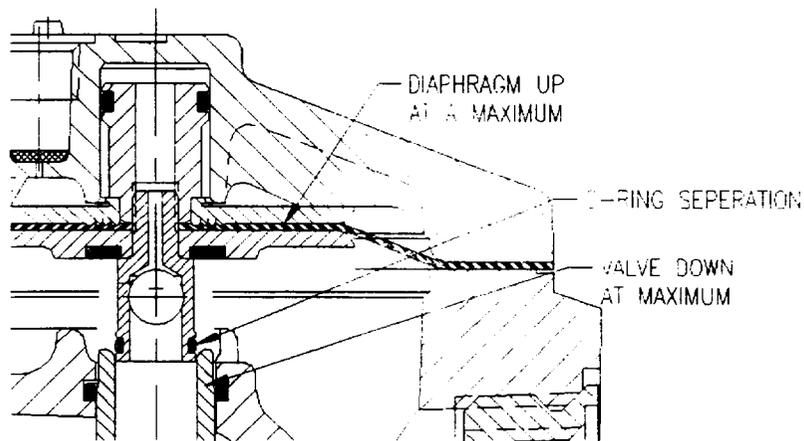
FIGURE 2
Valve Position during event

The first change is to a sub-component of the diaphragm assembly. As seen in Figure 2 the retainer has become separated from the relief tube during sudden backpressure situations causing a resistance to the relief tube returning to the neutral position at no flow. The retainer was extended to ensure the tube cannot come free when the valve and diaphragm are at their furthest separation. Refer to figure 3 depicting the extended retainer installed.

Replace the valve/tube assembly and diaphragm assembly. The part number for the re-designed valve/tube assembly is 5945-60. The part number for the diaphragm assembly is 5945-61.

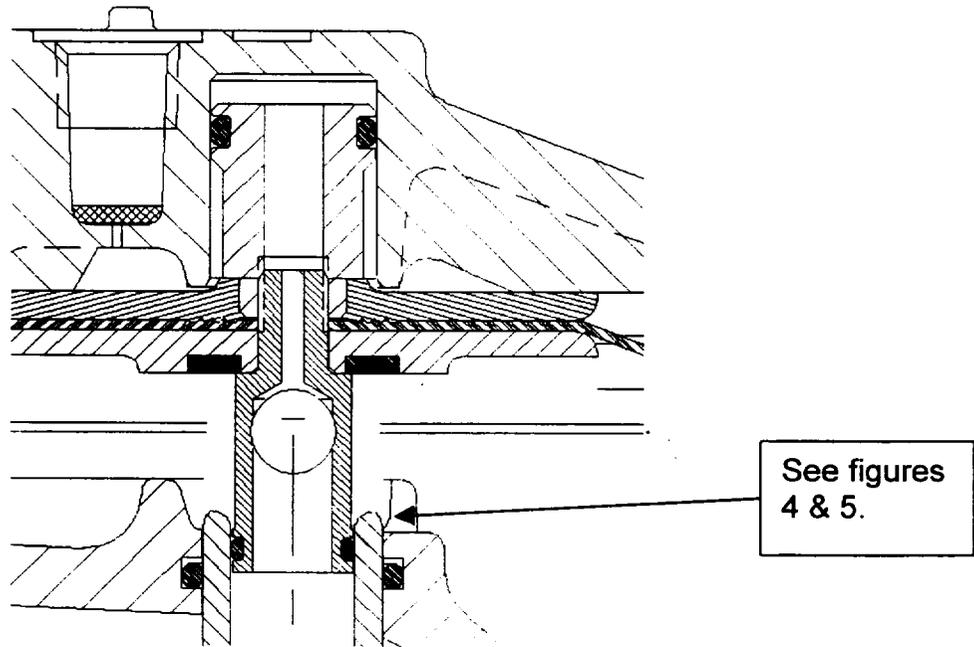
FIGURE 3
Valve with new diaphragm retainer installed

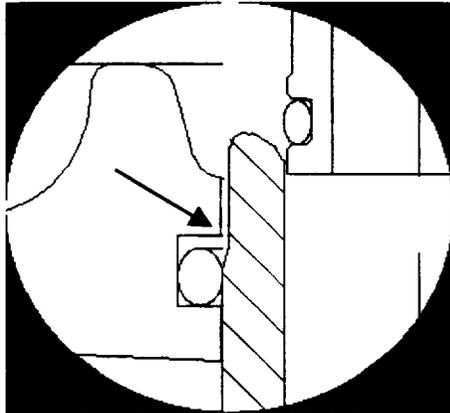
The second change is to the valve tube. As seen in Figure 4, when the valve is open at a maximum, there is room for the o-ring to start extruding from the cavity. When the relief tube tries to return to its normal position, the o-ring provides resistance. The geometry of the valve tube at the o-ring interface was modified to eliminate the smaller diameter on the tube to prevent the o-ring from extruding. Refer to figure 5.

FIGURE 4
Retainer O-Ring in tube

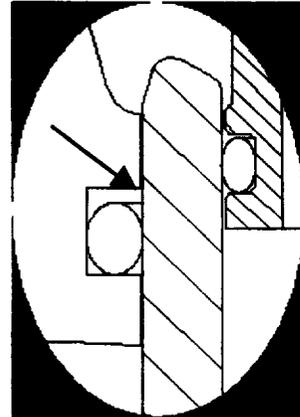
FIGURE 5
Retainer O-Ring in tube
