Subject: LER -2002-003-00 [Reactor Scram 104 on  
June 22, 2002 Due To Loss Of Service Transformer 21]

Grand Gulf Nuclear Station  
Docket No. 50-416  
License No. NPF-29

GNRO-2002/00069

**TITLE (4): Reactor SCRAM Due To Loss Of Service Transformer 21.**

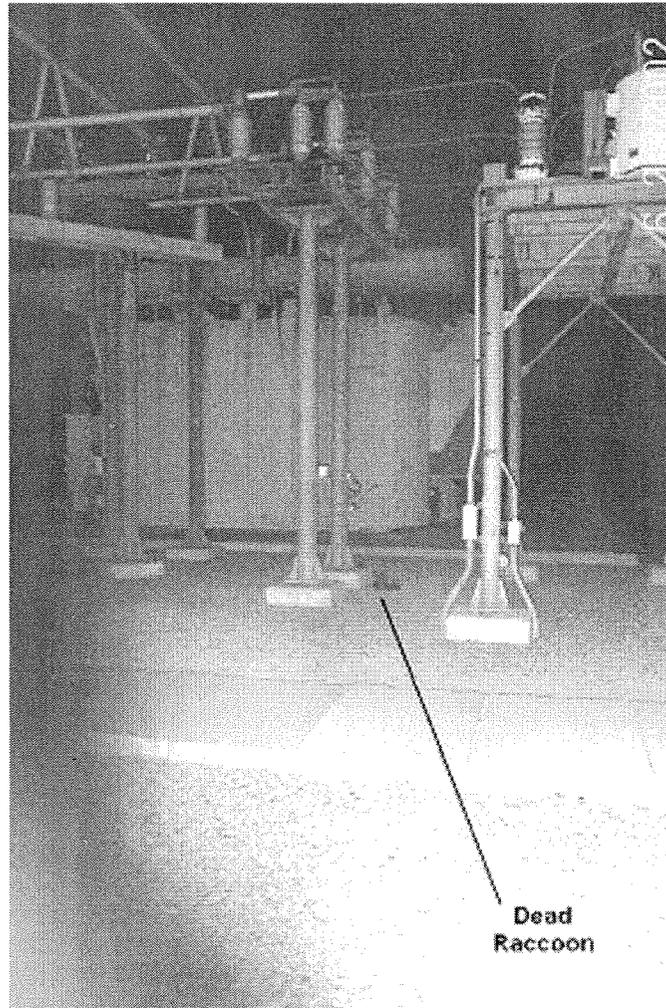
The ground fault was the result of a raccoon bridging the 34.5 KV phase "B" to a grounded stanchion in the vicinity of switch 589-21GT. This switch is a manually operated disconnect switch, located electrically between the secondary of ST21 and the Grounding Transformer for ST21. ST21 is a 500 kV (primary) to 34.5 kV (secondary) transformer. (See Attachments 1, 2 and 3).

**Pictures of dead Raccoon after bridging the 34.5 kV phase "B" to a ground stanchion  
On June 22<sup>nd</sup>, 2002 at Grand Gulf Nuclear Station  
(Attachment 1)**

- a. Service transformer protective relaying was verified to be functioning correctly. Checks were made of the service transformer and related equipment to verify no damage was done to any switchyard components. The service transformer was subsequently re-energized without incident.
