Florida Power
A Progress Energy Company

Crystal River Nuclear Plant
Docket No. 50-302
Operating License No. DPR-72

Subject: LICENSEE EVENT REPORT 50-302/02-001-00

1. FACILITY NAME CRYSTAL RIVER UNIT 3		2. DOCKET NUMBER 05000 302	3. PAGE 1 OF 12									
4. TITLE Automatic Start Of An Emergency Diesel Generator Due To Loss Of The Offsite Power Transformer

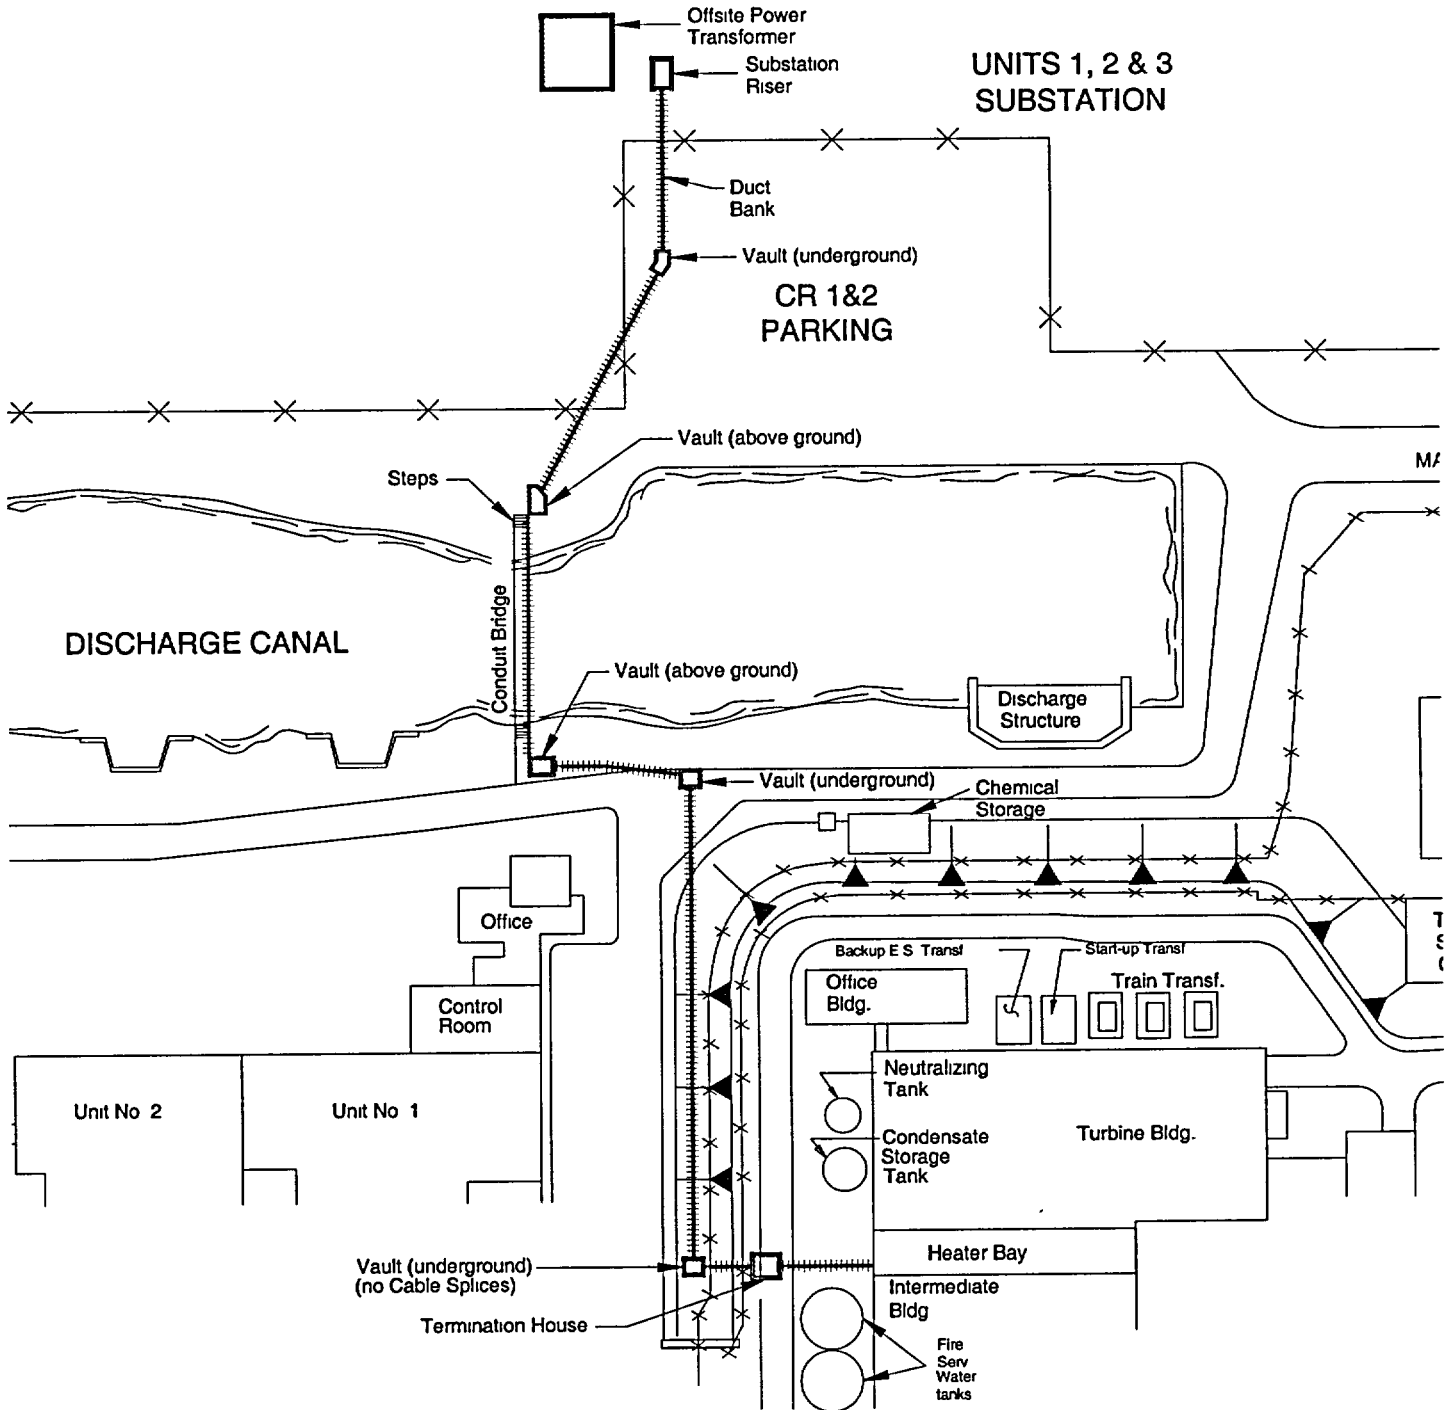
DRAWING #1

The feed from the OPT to the 4160V ES switchgear is a cable run (approximately 1179 feet) in a duct bank from the 230KV switchyard to the termination building (MT-14) on the CR-3 berm. The duct bank is underground for a large portion of the route, exposing the cables to water immersion periodically prior to the June 17, 2002, event. Six three-conductor cables (Kerite, 750 MCM) run from the OPT, through three underground cable vaults (two vaults contain cable splices), two aboveground cable vaults (both contain cable splices), to a termination house (see Drawing #1 – Page 9/12). The cable run continues from the termination house to 4160V ES Bus "A."

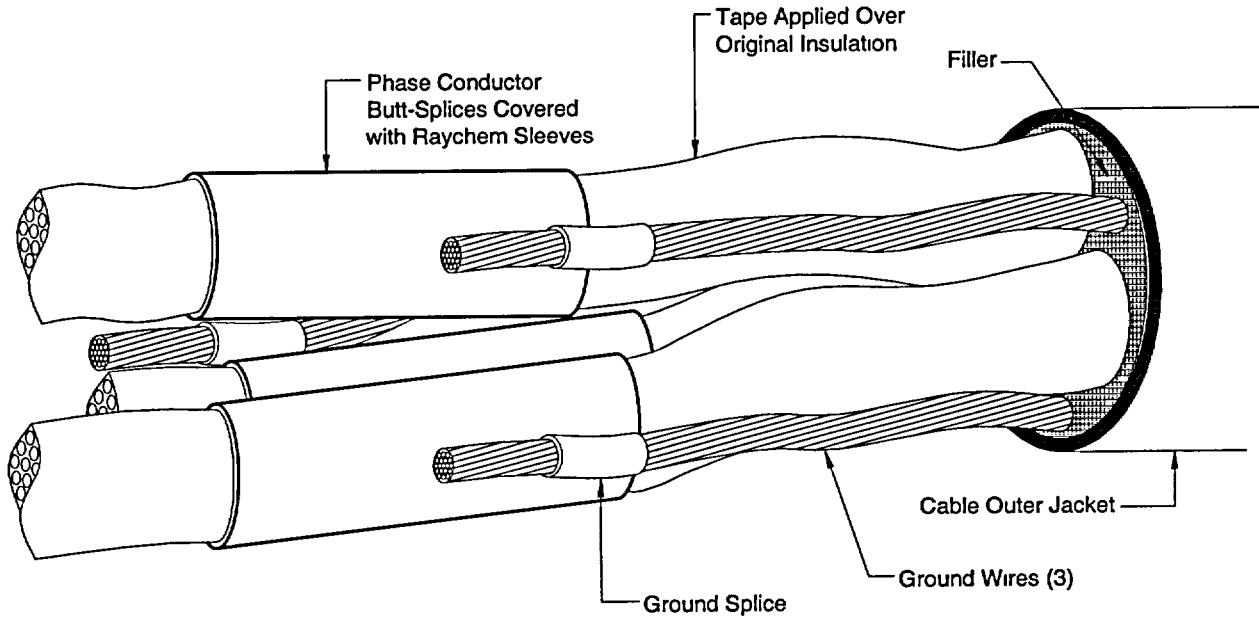
DRAWING #2

A contributing factor under consideration is the as-left configuration of the cables in the vicinity of the splices from the June repairs, where the conductors and the cable grounds are bundled together and covered with a zippered jacket. This configuration actually compressed the uninsulated grounds into the outer surface of the insulation of the conductors, potentially further compromising the insulation. In the unspliced cable sections, a filler material maintains a separation of approximately ¼-inch between the insulated conductors and the grounds. Additionally, during the July repair, water was found within the zippered jackets that had been removed and replaced in June. The water had leached out of the cable filler material after the repairs were made in June.

The cause for loss of the OPT was latent damage from the lightning strike that caused loss of the OPT on June 17, 2002. Upon investigation, Phase B of Cable #4 conductor was found shorted to ground in the CR-1/CR-2 parking lot cable vault. When the Cable #4 splice zippered jacket was opened, approximately 0.5 gallons of water was drained.

During the June event, this cable had an as-found phase-to-ground insulation resistance of 10.4 megohms. After inspection and replacing the zippered jacket, the return to service phase-to-ground insulation resistance was 1.37 megohms. The change in resistance value could have been due to changing the configuration of the ground wire and individual conductors during the installation of the zippered jacket. It could have also been due to pressing the ground wire into the conductor insulation during the installation of the zippered jacket. Changing the configuration of the cable in the zippered jacket could have moved the ground wire closer to a portion of the insulation material degraded by the June lightning strike. The collected water inside the zippered jacket then created a path for tracking through the degraded insulation to the ground wire.

AS-LEFT CABLE
CONFIGURATION
AFTER JULY 20,
2002 EVENT

1. The zippered jackets were removed from the cable splices in both the CR-1/CR-2 parking lot cable vault and the cable vault located near the CR-1/CR-2 gate for this cable run. The exposed conductor insulation and splices were dried and wiped clean. The zippered jackets were not re-installed over the splices in order to prevent water accumulation and to provide separation similar to nominal conductor-to-ground spacing.

Scotch 130C Linerless Rubber Splicing Tape was used to repair and enhance the conductor insulation. A minimum of four half lapped layers of Scotch 130C was applied to the maximum extent possible to the exposed conductor insulation where the zippered jacket was removed from the six Kerite 750 MCM cables (see Drawing #2 – Page 10/12). The insulation properties provided by the tape will ensure that at least 5KV of insulation is available in this section of the cabling and that a minimum separation of approximately ¼-inch between the insulated conductors and the grounds is maintained.
