Florida Power
A Progress Energy Company

Crystal River Nuclear Plant
Docket No. 50-302
Operating License No. DPR-72

Subject: LICENSEE EVENT REPORT 50-302/02-001-00

1. FACILITY NAME CRYSTAL RIVER UNIT 3					2. DOCKET NUMBER 05000 302					3. PAGE 1 OF 12									
4. TITLE Automatic Start Of An Emergency Diesel Generator Due To Loss Of The Offsite Power Transformer

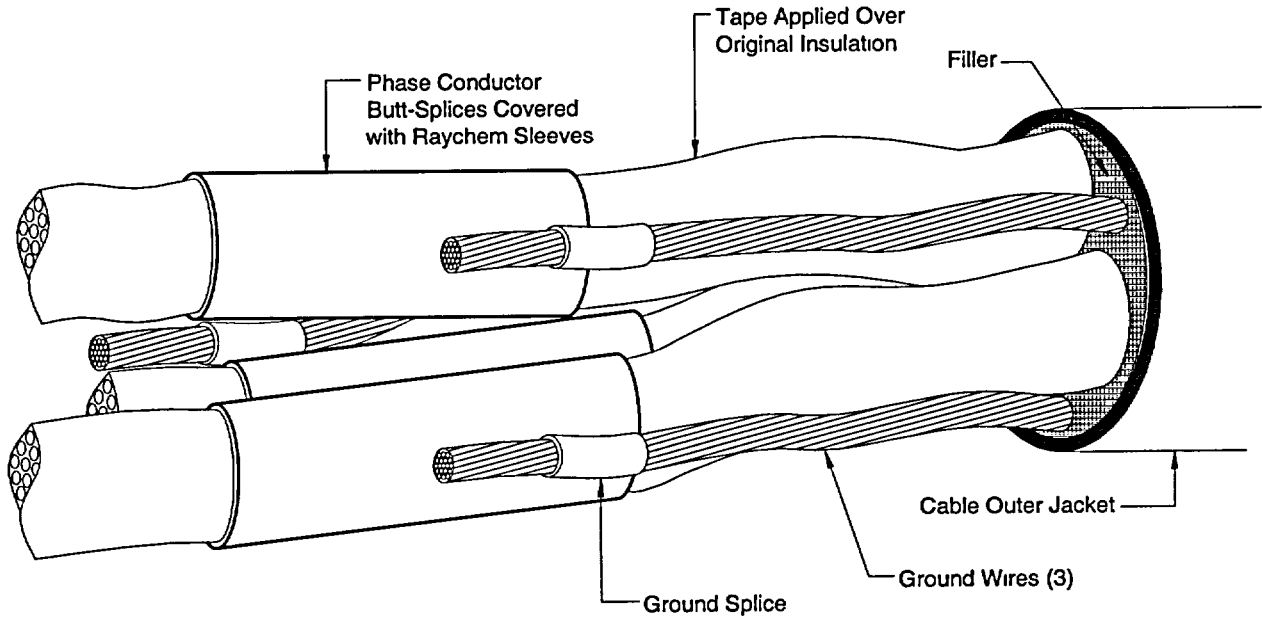
DRAWING #2

A contributing factor under consideration is the as-left configuration of the cables in the vicinity of the splices from the June repairs, where the conductors and the cable grounds are bundled together and covered with a zippered jacket. This configuration actually compressed the uninsulated grounds into the outer surface of the insulation of the conductors, potentially further compromising the insulation. In the unspliced cable sections, a filler material maintains a separation of approximately ¼-inch between the insulated conductors and the grounds. Additionally, during the July repair, water was found within the zippered jackets that had been removed and replaced in June. The water had leached out of the cable filler material after the repairs were made in June.

The cause for loss of the OPT was latent damage from the lightning strike that caused loss of the OPT on June 17, 2002. Upon investigation, Phase B of Cable #4 conductor was found shorted to ground in the CR-1/CR-2 parking lot cable vault. When the Cable #4 splice zippered jacket was opened, approximately 0.5 gallons of water was drained.

During the June event, this cable had an as-found phase-to-ground insulation resistance of 10.4 megohms. After inspection and replacing the zippered jacket, the return to service phase-to-ground insulation resistance was 1.37 megohms. The change in resistance value could have been due to changing the configuration of the ground wire and individual conductors during the installation of the zippered jacket. It could have also been due to pressing the ground wire into the conductor insulation during the installation of the zippered jacket. Changing the configuration of the cable in the zippered jacket could have moved the ground wire closer to a portion of the insulation material degraded by the June lightning strike. The collected water inside the zippered jacket then created a path for tracking through the degraded insulation to the ground wire.

AS-LEFT CABLE
CONFIGURATION
AFTER JULY 20,
2002 EVENT

1. The zippered jackets were removed from the cable splices in both the CR-1/CR-2 parking lot cable vault and the cable vault located near the CR-1/CR-2 gate for this cable run. The exposed conductor insulation and splices were dried and wiped clean. The zippered jackets were not re-installed over the splices in order to prevent water accumulation and to provide separation similar to nominal conductor-to-ground spacing.

Scotch 130C Linerless Rubber Splicing Tape was used to repair and enhance the conductor insulation. A minimum of four half lapped layers of Scotch 130C was applied to the maximum extent possible to the exposed conductor insulation where the zippered jacket was removed from the six Kerite 750 MCM cables (see Drawing #2 – Page 10/12). The insulation properties provided by the tape will ensure that at least 5KV of insulation is available in this section of the cabling and that a minimum separation of approximately ¼-inch between the insulated conductors and the grounds is maintained.
