SUBJECT: NRC INSPECTION REPORT 40-8102/2002201

Report No.: 40-8102/2002201

Facility: ExxonMobil Highland Uranium Mill Site

Location: Converse County, Wyoming

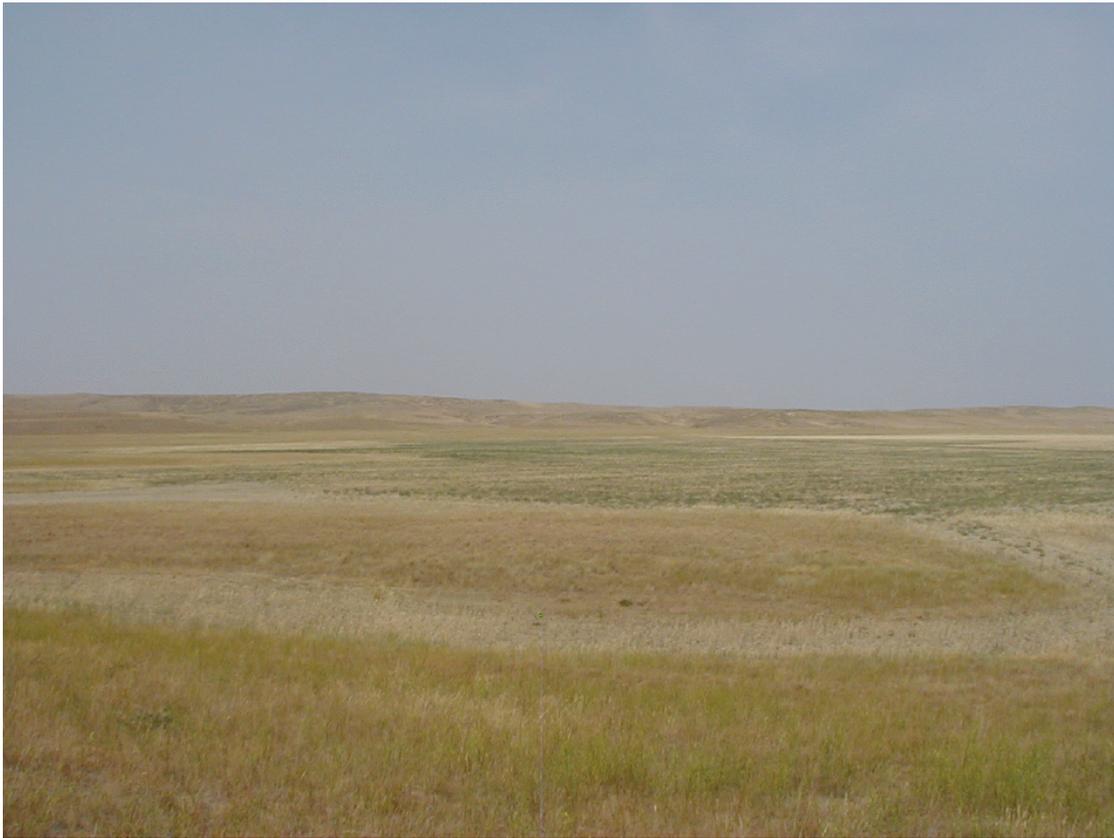
During the site tour, the licensee noted that the settlement area on the tailings impoundment had been filled, and that new settlement monument sites had been established. Additionally, vegetation seeding of the cover and disturbed areas was accomplished in the fall of 2001.

**Exxon Mobil Tailings Impoundment Looking East North East**

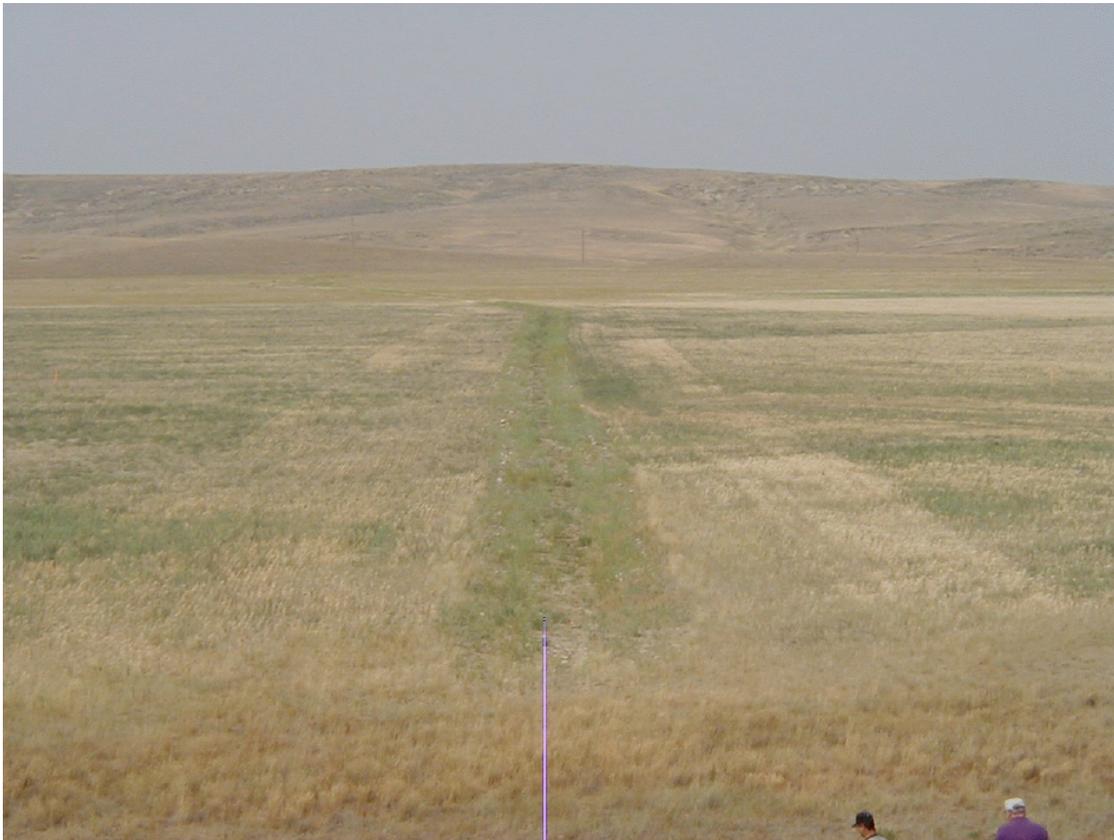
**Exxon Mobil Tailings Impoundment Drainage Ditch Looking North**

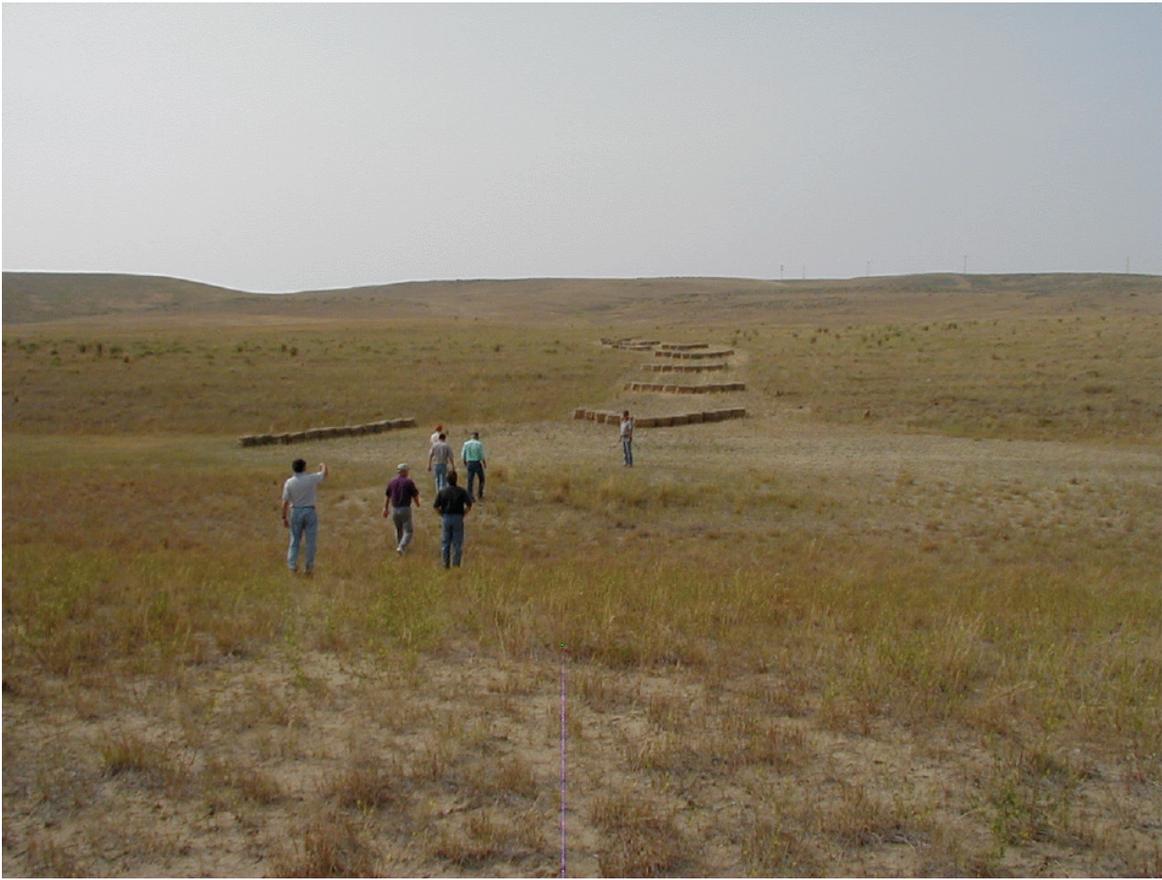
Licensed activities at ExxonMobil's former Highland Uranium Mill site has been accomplished by a contractor. No ExxonMobil personnel were stationed at the site. The ExxonMobil site project manager has visited the site on an as-needed basis. Routine activities at the site included groundwater monitoring, settlement monument monitoring, well maintenance, weed control, and filling in of the settled area on the tailings impoundment. Re-seeding of the reclamation area was completed, and sediment was removed from the main drainage channel.

Exxon Mobil Main Drainage Channel Sediment Removal Area Looking North
