SUBJECT: NRC INSPECTION REPORT 40-4492/2002202

Docket No.: 40-4492  
License No.: SUA-667  
Report No.: 40-4492/2002202  
Licensee: American Nuclear Corporation  
Facility: Former Gas Hills Project  
Location: Gas Hills area, Fremont County, Wyoming  
Inspection Date: July 31, 2002

### American Nuclear Corporation's Gas Hills Project NRC Inspection Report 40-4492/2002202

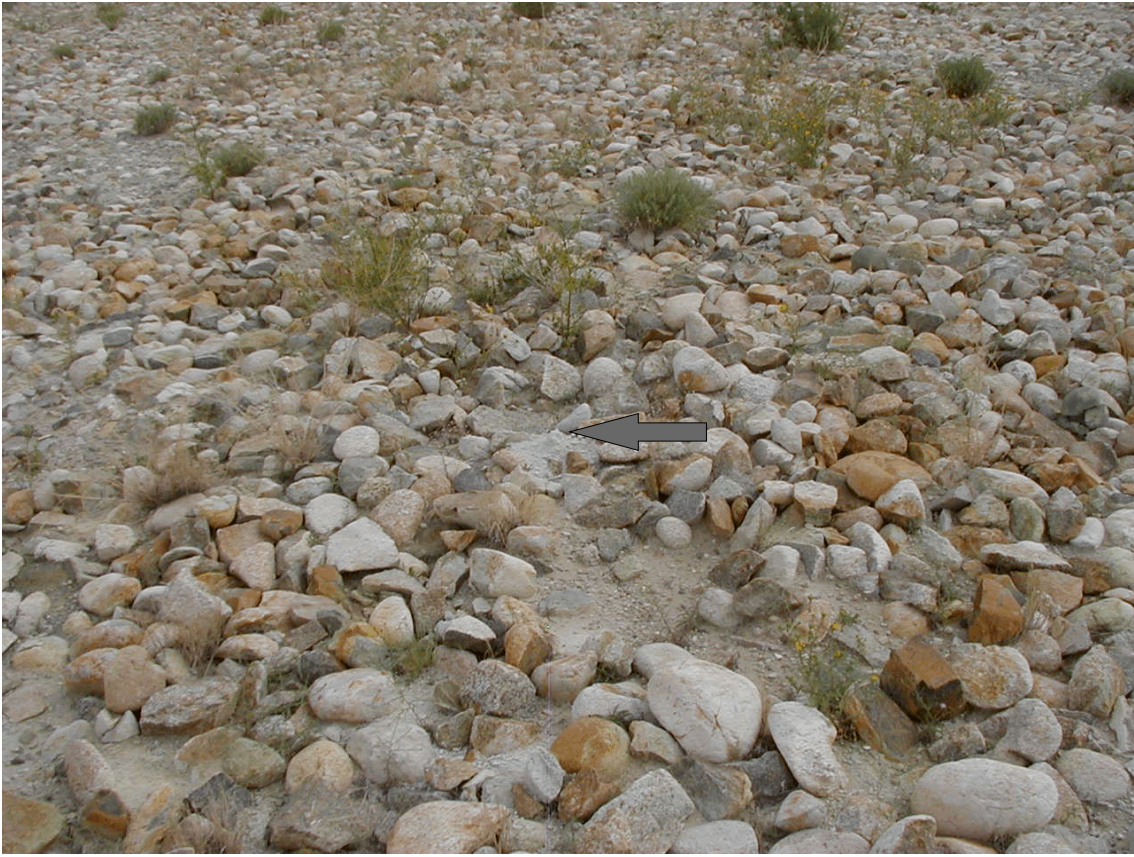
The inspection indicated that there may be problems with the placement and durability of the placed riprap. In addition, gulying was noted near the toe of the No. 2 tailings pile.

Decomposed Rock ANC No. 2 Tailings Impoundment Slope

It was determined that the rock riprap needed to be repaired in several areas of the top and side slopes, and that repairs needed to be accomplished to reduce the gulying at the edges of the impoundment cover. Additional rock will probably be needed for the rock to conform to construction specifications related to the thickness and gradation. A rock toe will also be needed to prevent gully intrusion into the reclaimed side slopes.

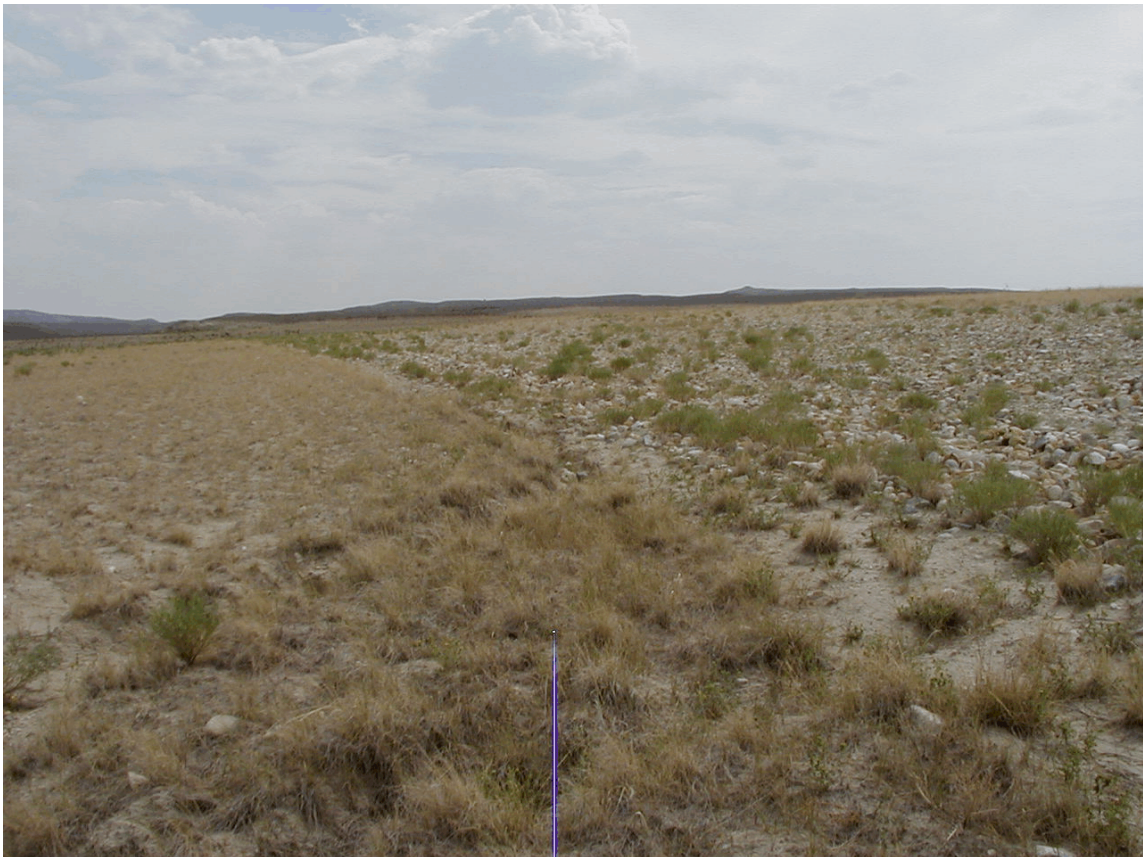
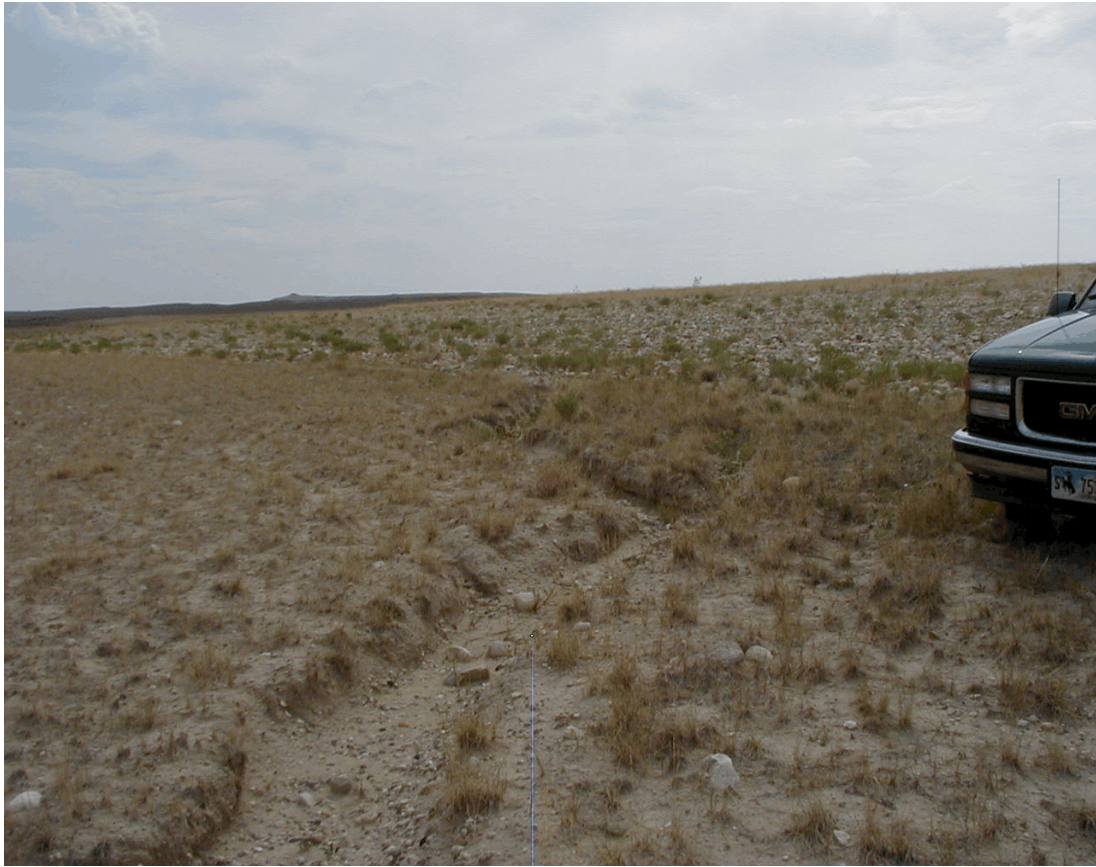
Gullying at edge of ANC No. 2 Tailings Impoundment
