## EXECUTIVE SUMMARY

NAC International, Inc.  
NRC Inspection Report No. 71-0018/96-210 - 72-1015/96-209

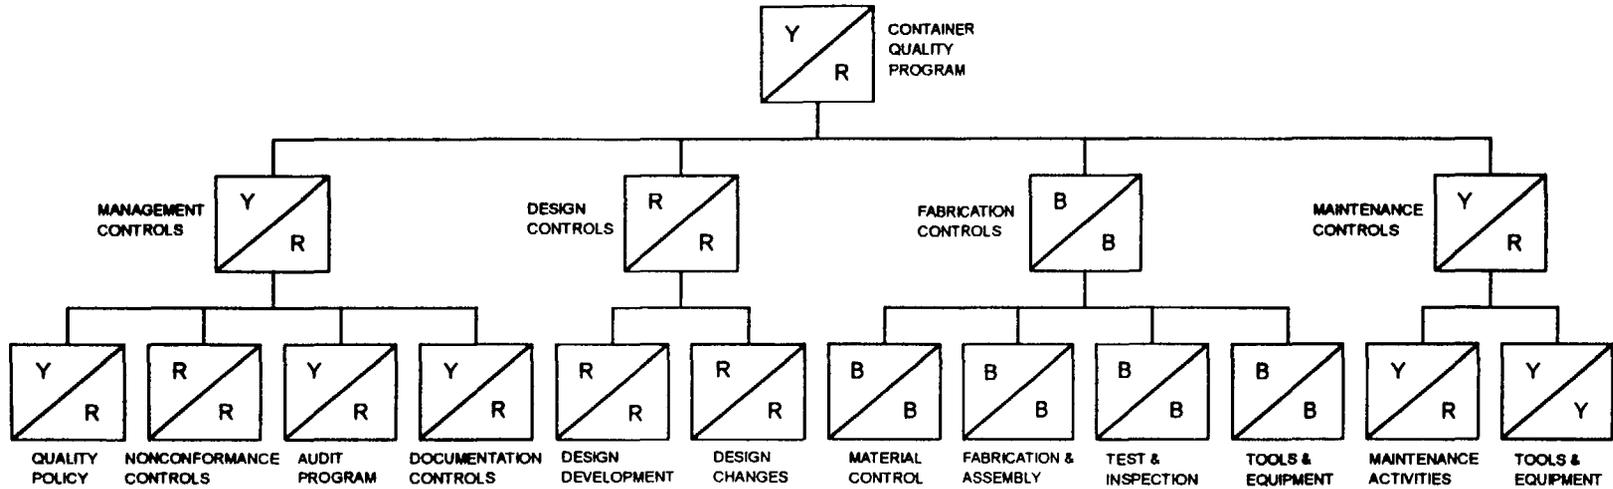
The results of the inspection are shown pictorially in the Inspection Results Summary that follows (Reference NUREG/CR-6314, "Quality Assurance Inspections for Shipping and Storage Containers"). This summary shows that, overall, the QA program described in procedures and instructions meet regulatory requirements. However, the implementation of the NAC QA program does not meet regulatory requirements and application commitments.

## INSPECTION RESULTS SUMMARY
