## Insulation Resistance Measurement Results

NRC FORM 335 (2-89) NRCM 1102, 3201, 3202	U.S. NUCLEAR REGULATORY COMMISSION	<b>1. REPORT NUMBER</b> (Assigned by NRC, Add Vol., Supp. Rev., and Addendum Numbers, if any) <b>NUREG/CR- 6776</b> <b>SAND2002-0447P</b>				
<b>2. TITLE AND SUBTITLE</b>  <b>Cable Insulation Resistance Measurements Made During Cable Fire Tests</b>		<b>3. DATE REPORT PUBLISHED</b>				
		<table border="1" style="width: 100%;"> <tr> <td style="width: 50%;">MONTH</td> <td style="width: 50%;">YEAR</td> </tr> <tr> <td>June</td> <td>2002</td> </tr> </table>	MONTH	YEAR	June	2002
		MONTH	YEAR			
June	2002					
<b>4. FIN OR GRANT NUMBER</b>  <b>Y6037</b>						
<b>5. AUTHOR(S)</b>  <b>Francis J. Wyant</b> <b>Steven P. Nowlen</b>	<b>6. TYPE OF REPORT</b>  <b>Technical</b>					
	<b>7. PERIOD COVERED (inclusive Dates)</b>					
<b>8. PERFORMING ORGANIZATION -- NAME AND ADDRESS</b> (If NRC, provide Division, Office or Region, U.S. Nuclear Regulatory Commission, and mailing address, if contractor, provide name and mailing address)  <b>Sandia National Laboratories</b> <b>P.O. Box 5800</b> <b>Albuquerque, NM 87185-0744</b>						
<b>9. SPONSORING ORGANIZATION -- NAME AND ADDRESS<

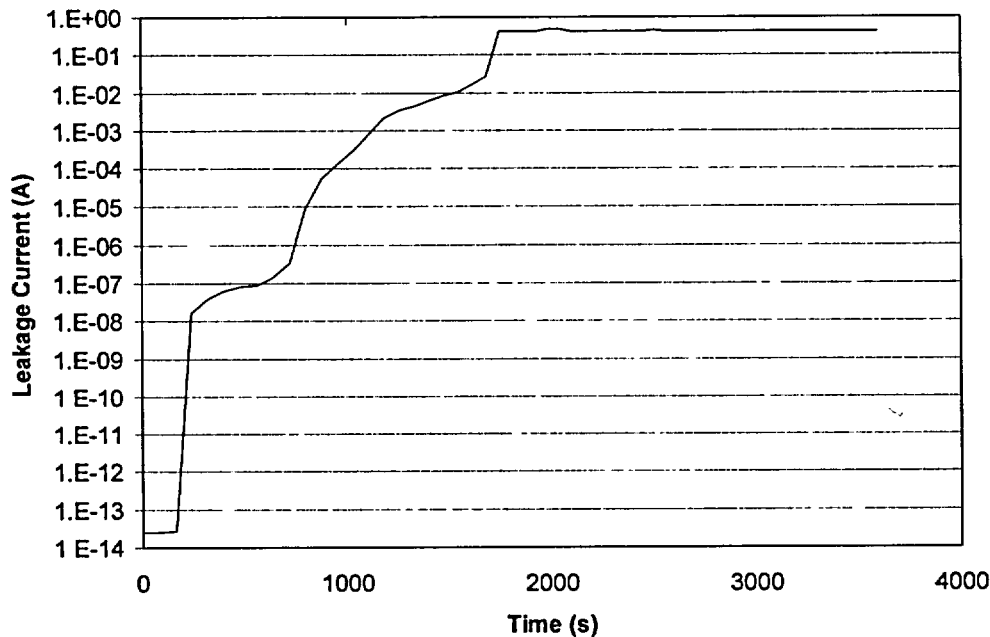
Figure 5-38. Leakage current resulting from IR changes between Conductors 1 and 2 during Test 9.

Based solely on the results of the IR measurements made during Test 9, it appears that the IR cable experienced fire-induced damage that allowed leakage currents high enough to cause device actuation in a DC control circuit. The modes of failure cannot, however, be determined with confidence.

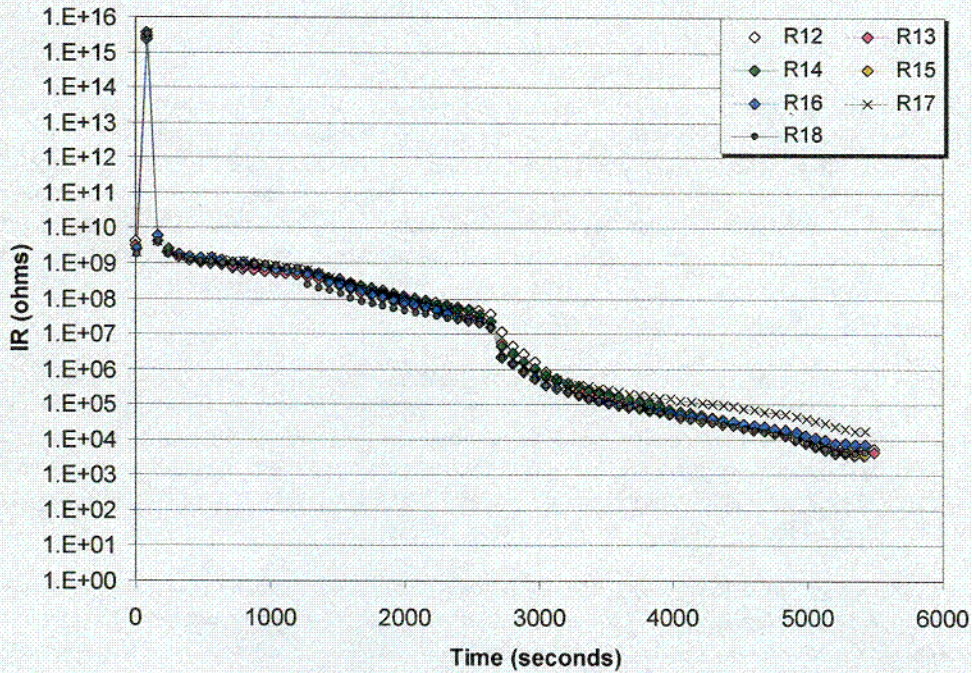
Figure 5-40. Representative conductor-to-conductor IRs obtained during Test 10. This plot shows the IR between Conductor 1 and the other seven conductors in the IR cable bundle.

As shown in the figure, there was a very gradual decrease in IRs between the conductors from start to end of the test run ( $3 \times 10^9$  down to  $1 \times 10^4 \Omega$ ).

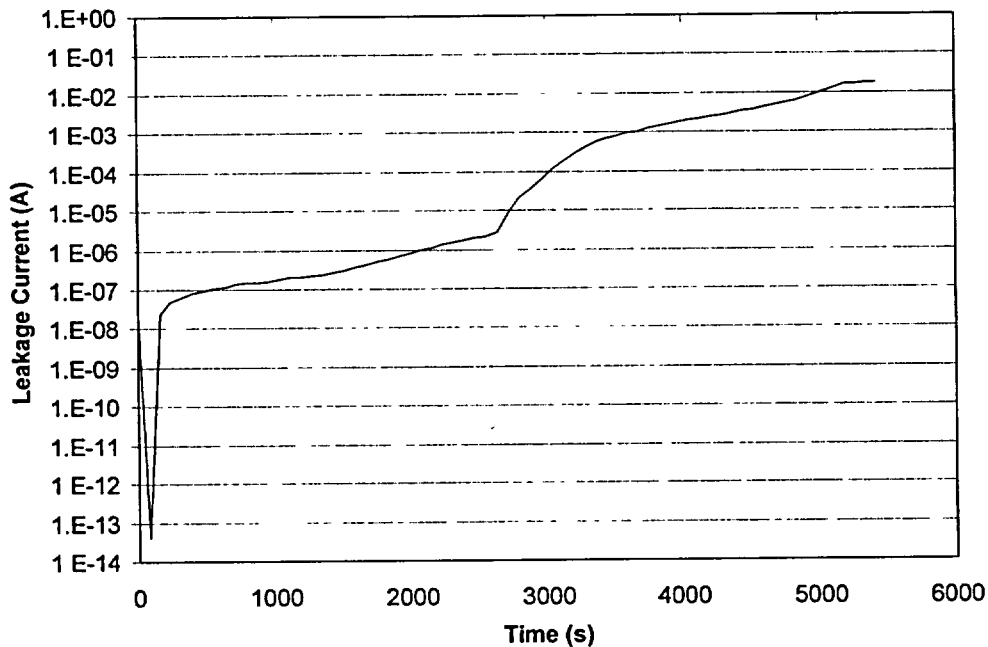
Figure 5-41 plots how the leakage current between Conductors 1 and 2 changed as the test progressed. The peak leakage current appears to be  $\sim 20$  mA between the conductors.

Based solely on the results of the IR measurements made during Test 10, while the cable did show substantial IR degradation, the test appears to have stopped short of actual failure. That is, it does not appear that the IR cable experienced fire-induced damage that would allow leakage current high enough to cause device actuation in a DC control circuit.

Figure 5-41. Leakage current resulting from IR changes between Conductors 1 and 2 during Test 10.

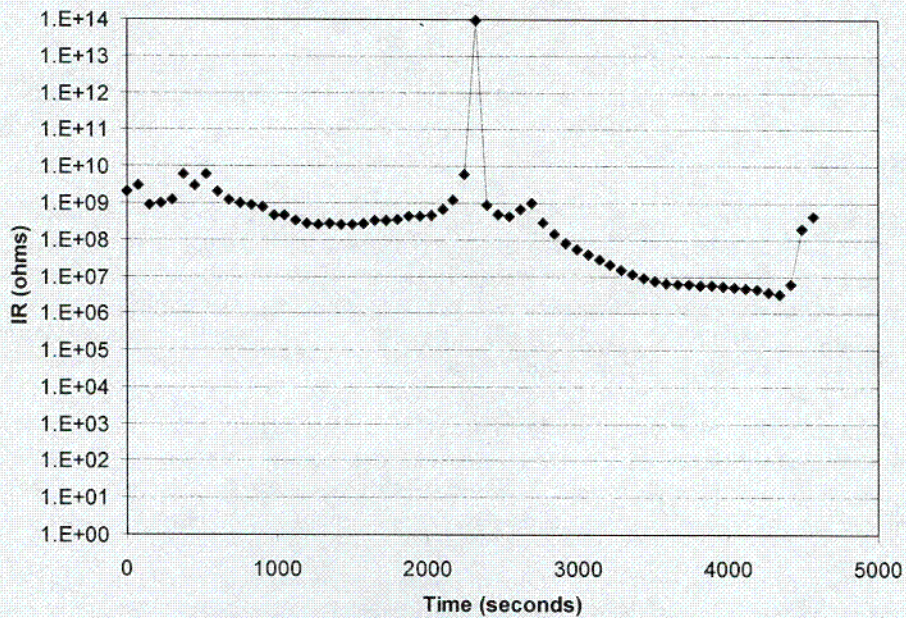
Figure 5-43. IR between Conductor 1 and 2 obtained during Test 11.

As shown in the figure, the IR between Conductors 1 and 2 remains fairly constant with very small variations until ~2700 seconds into the test run. Then the conductor IR gradually decreases from  $\sim 10^9$  to  $\sim 3 \times 10^6 \Omega$  at ~4400 seconds; it then seems to be recovering over the remaining time of the test.

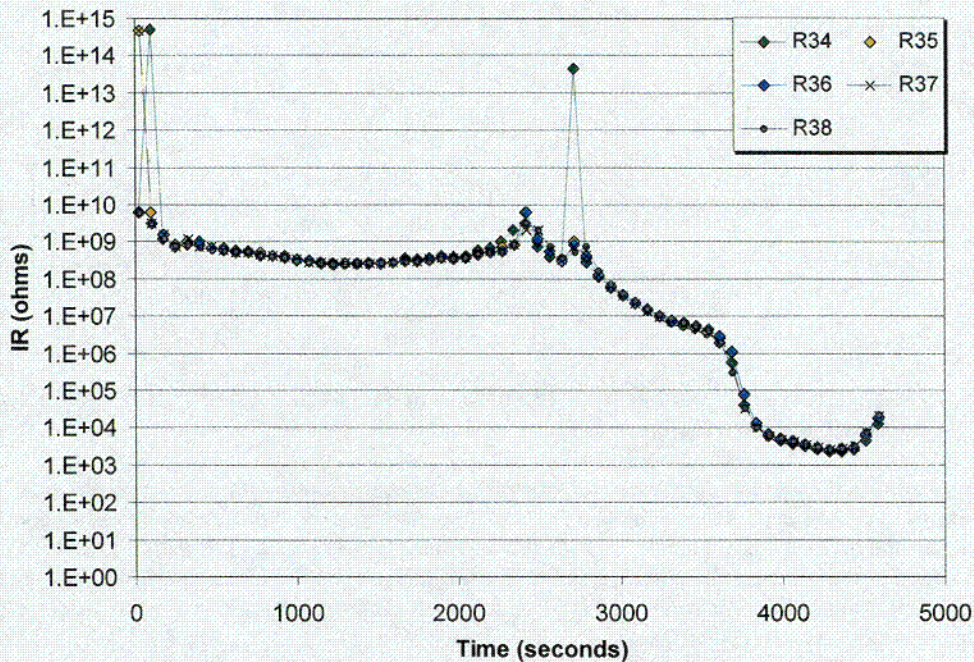
Figure 5-44 shows the IR change between Conductor 3 and the other conductors in IR3 cable during the test. In general, the behavior is the same as shown above for Conductors 1 and 2; however, a definite change in the conductor-to-conductor IRs occurs at ~3600 seconds, when the cable IR3 conductor IRs decrease smoothly from  $3 \times 10^9 \Omega$  down to  $3 \times 10^3 \Omega$  near the end of the test run.

Figure 5-44. IRs between Conductor 3 and Conductors 4 through 8 obtained during Test 11.

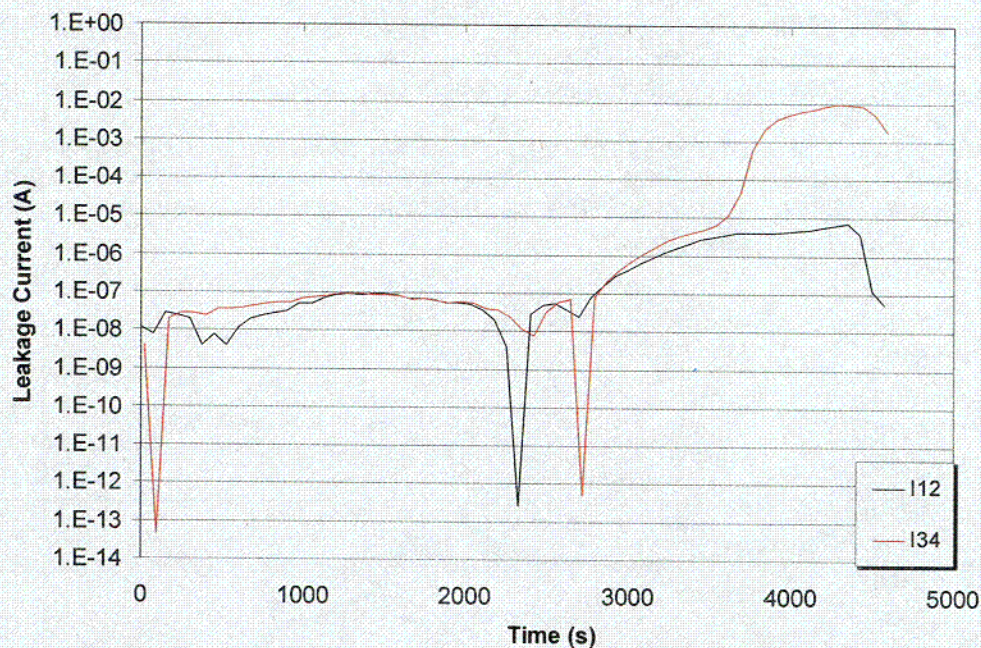
Figure 5-45 plots how the leakage currents between Conductors 1 and 2, and 3 and 4 (a shielded pair within IR3), changed as the test progressed. The peak leakage current appears to be  $\sim 7 \mu\text{A}$  between Conductors 1 and 2, which is not enough to pose a serious problem, even to a typical instrument circuit. However, the peak leakage current between Conductors 3 and 4 is  $\sim 10 \text{ mA}$ , which could cause a substantial instrument reading error in, for example, a 4-20 mA instrument circuit.

Based on the results of the IR measurements made during Test 11, it appears that the IR3 cable experienced substantial fire-induced degradation. While the IR did remain above  $1000 \Omega$  for the test duration, depending on the specific instrument circuit considered, this degradation might have been sufficient to cause incorrect instrument readings. The IR1 cable did not experience any substantial IR degradation.

Figure 5-45. Leakage currents resulting from IR changes between Conductors 1 and 2 and between Conductors 3 and 4 during Test 11.

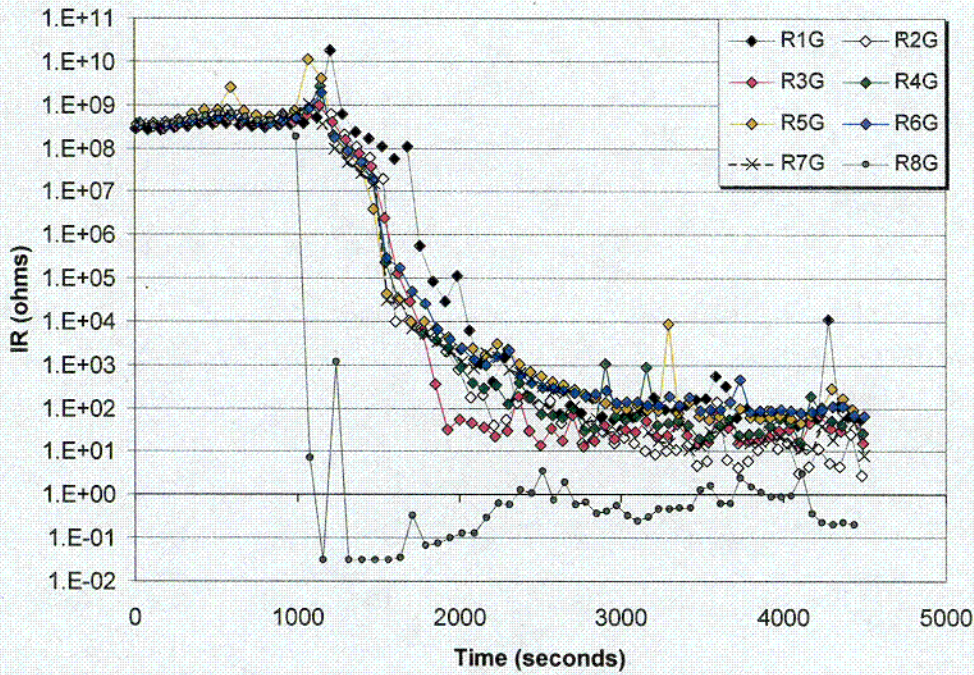
Table 5-6 summarizes the conductor failure modes and times for Test 12. All of the initial failures observed involved the conductors shorting to ground. Initially, at about 1000 seconds, Conductor 8 (the three external conductors as a gang) shorts to ground. This short-to-ground failure is also manifested by the apparent reduction in IR between Conductor 8 and the other conductors in the cable bundle. A second ground short involving Conductor 3 is observed at about 1900 seconds. Over the period of 2200 to 3500 seconds, the rest of the conductors short to ground.

Figure 5-48. Conductor-to-ground IRs obtained during Test 12.

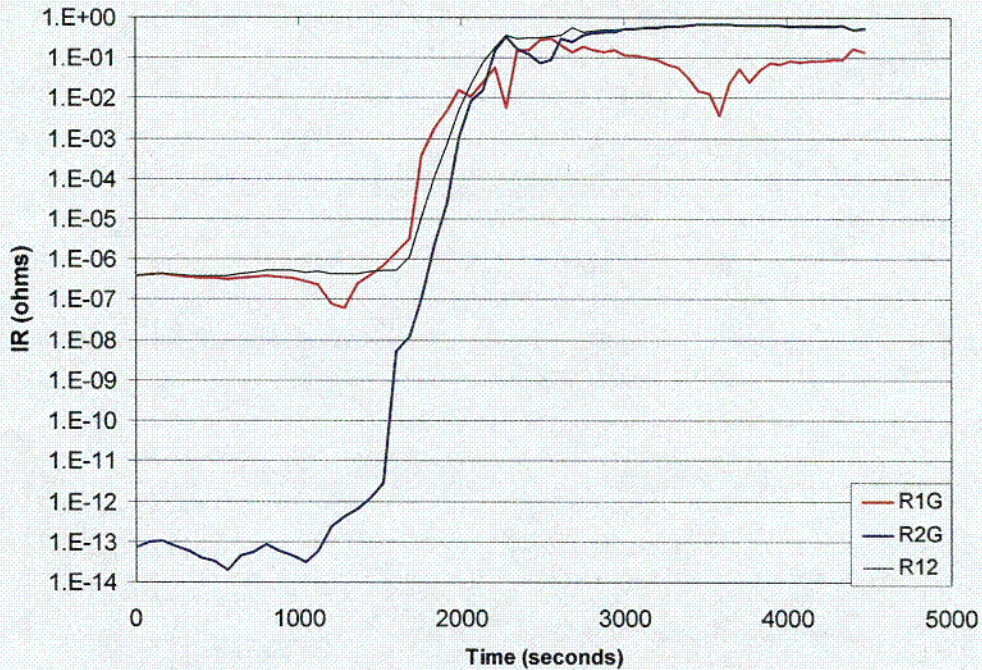
Figure 5-49 plots how the leakage currents for Conductors 1 and 2 changed in their relationship to one another and to ground as the test progressed.

Based solely on the results of the IR measurements made during Test 12, it appears that the IR cable experienced fire-induced damage that allowed leakage currents high enough to cause device actuation or blown fuses.

Figure 5-49. Leakage currents resulting from IR changes between Conductors 1 and 2 during Test 12.

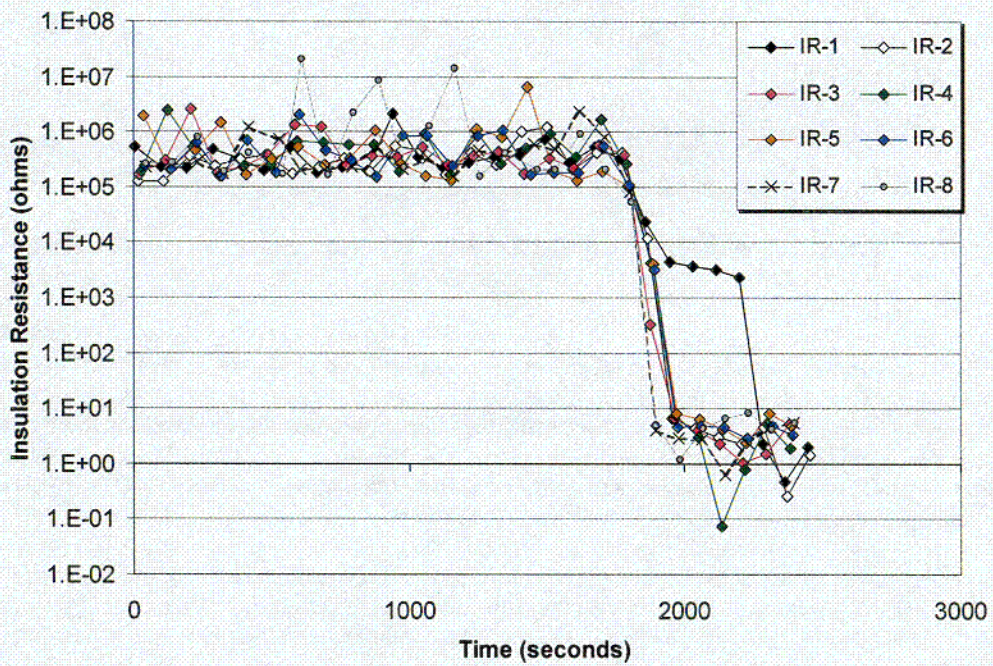
As noted previously, the IR measurement system was only capable of determining total IR to ground due to a wiring problem during Test 13. Figure 5-51 shows the time-dependent change in the total IR for each of the eight conductors in the IR cable measured during this test. The fact that the IR values fall to very low levels (<100 Ω) beginning at about 1900 seconds indicates that conductor failures have occurred. Figure 5-52 shows the associated leakage currents.

Figure 5-51. Total IR of each conductor recorded during Test 13.

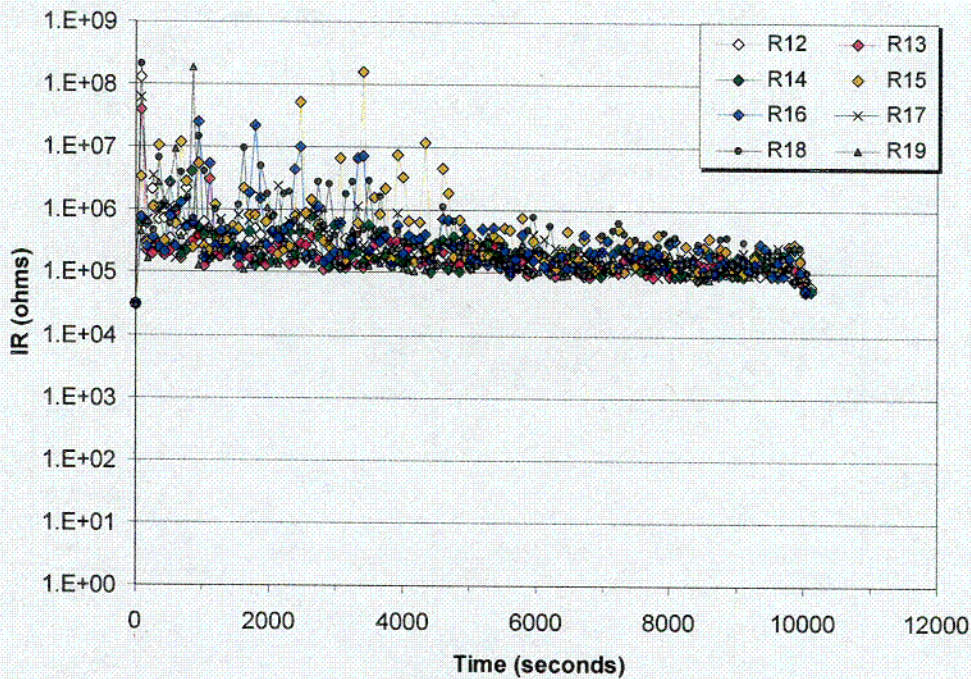
No thermocouple-instrumented cable was routed in the conduit during this test; hence, there is no cable temperature data available. In addition, no direct measure of conduit temperature was made either. However, no failures of the IR cable bundle were identified based on the results of this test. Figure 5-53 shows a plot of the IRs between Conductor 1 and the other conductors in the IR bundle. Conductors 1 through 3 were enclosed in one of the three-conductor cables of the IR bundle, Conductors 4 through 6 were in a second cable, and Conductors 7 through 9 formed the third cable. As shown in the figure, the IRs declined very little over the course of the test run.

Figure 5-53. Representative conductor-to-conductor IRs obtained during Test 14.

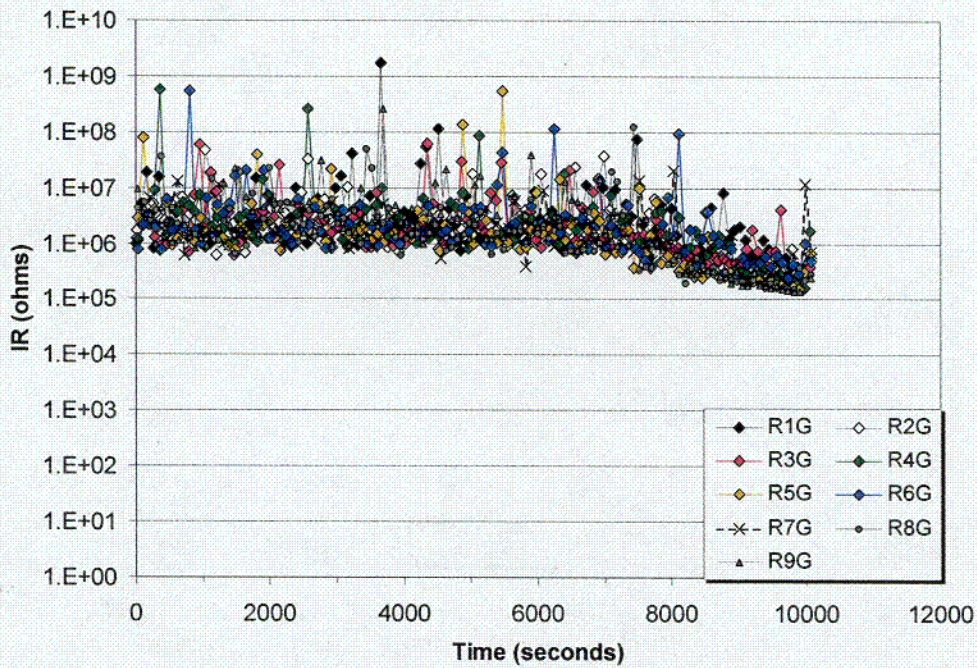
Figure 5-54 shows the values of IR between each of the IR cable conductors to ground recorded during Test 14. This figure also shows that the IRs to ground decreased very slightly during the test. Figure 5-55 presents the change in leakage current for Conductors 1 and 2 occurring during Test 14.

Based solely on the results of the IR measurements made during Test 14, it appears that the IR cable experienced virtually no damage and would not have caused any device actuation or blown fuses.

Figure 5-54. Conductor-to-ground IRs obtained during Test 14.

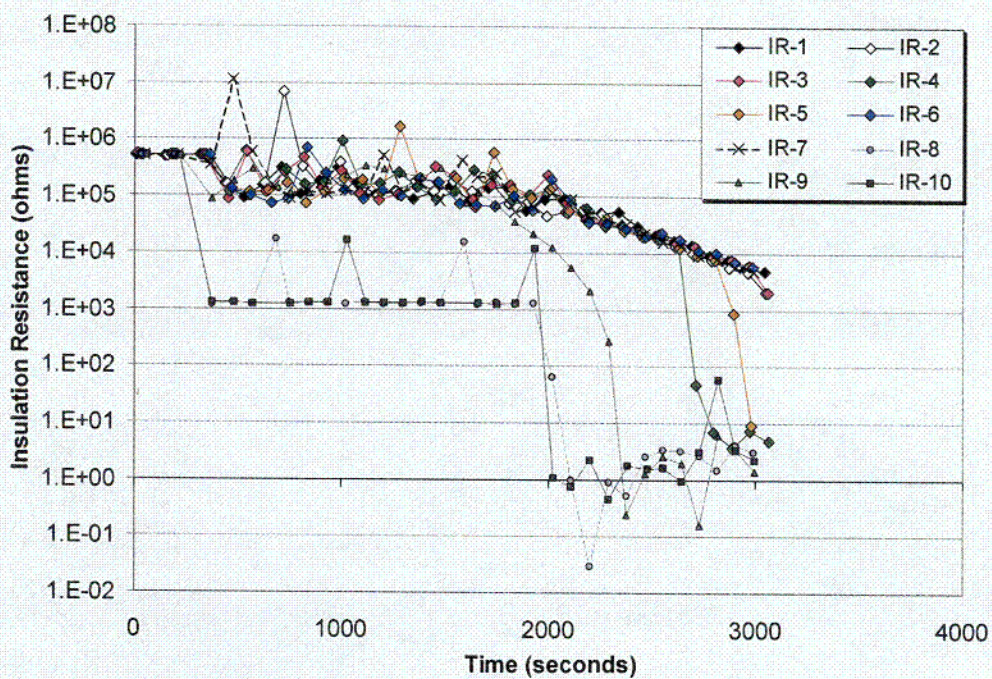
As noted previously, the IR measurement system was only capable of determining total IR due to a wiring problem during Test 15. Figure 5-57 shows the time-dependent change in the total IR for each of the 10 conductors in the IR cable measured during this test. Table 5-7 summarizes the behavior of the cable in the test. Only five of the 10 conductors appear to have total IRs <100 Ω at the end of the test. The other conductors, while experiencing decreasing total IRs, did not reach the point of failure.

Figure 5-57. Total IR of each conductor recorded during Test 15.

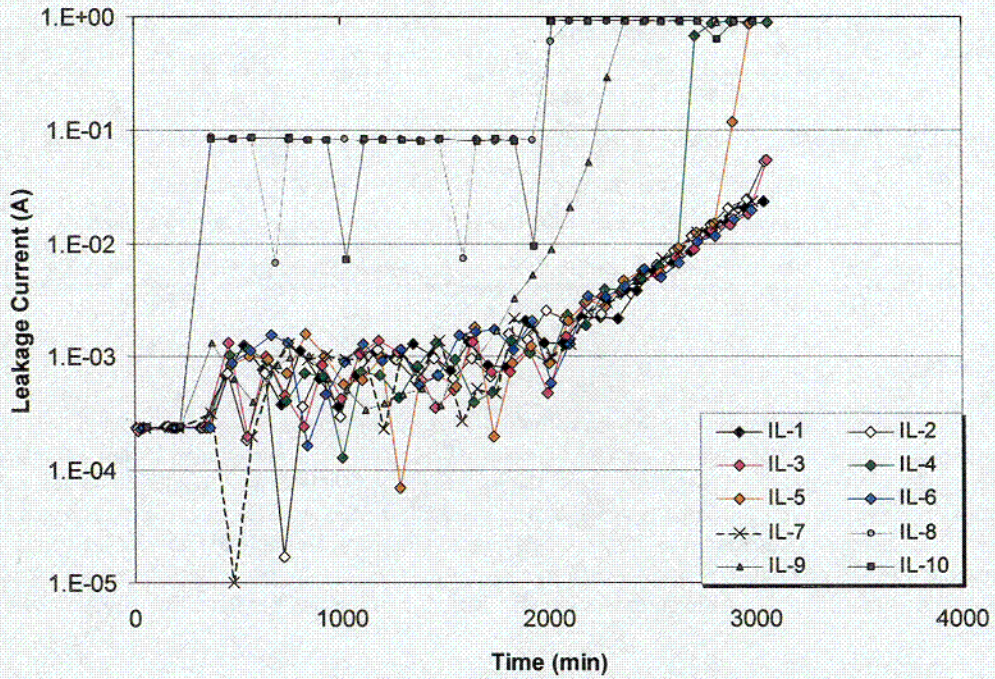
Figure 5-58 shows the resulting leakage currents allowed by the change in IR for each conductor. Although there is no direct evidence, the two external Conductors 8 and 10 may have been shorted together without ground interaction during the period of time their IRs decreased to and held at ~1000 Ω. This supposition is largely based on previous experience with conductors shorting together and the resulting voltage responses recorded on the IR system.

Figure 5-58. Total leakage currents resulting from IR changes for each Conductor during Test 15.

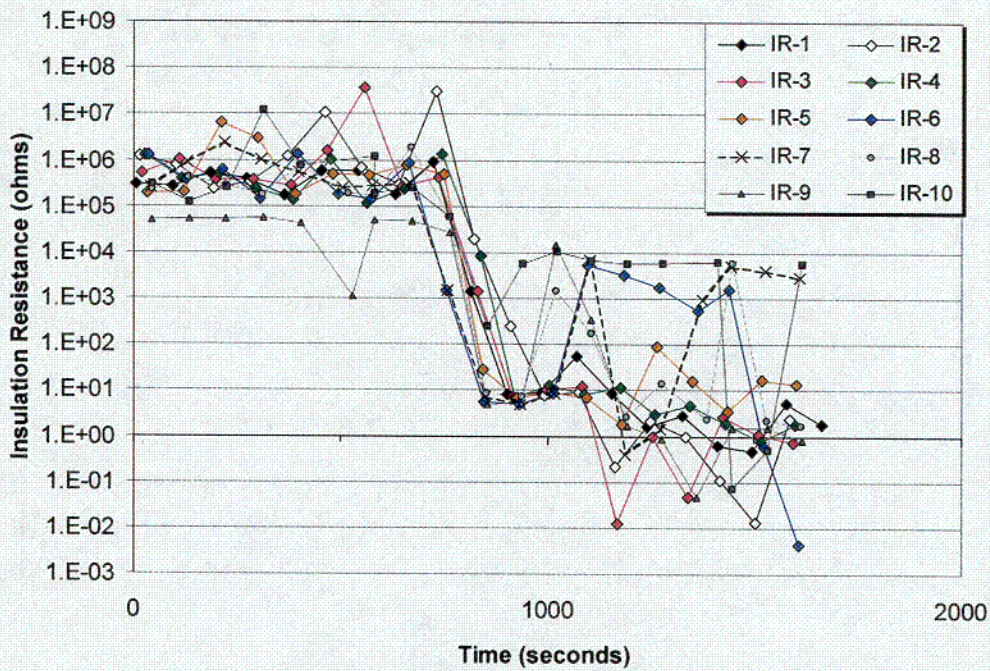
As previously mentioned, the IR measurement system was only capable of determining total IR due to a wiring problem during Test 16. Figure 5-60 shows the time-dependent change in the total IR for each of the 10 conductors in the IR cable measured during this test. Table 5-8 summarizes the behavior of the cable in the test. While some of the conductor IRs increase again (~1000  $\Omega$ ) near the end of the test, it is believed that all experienced failure and the apparent recovery was due more to noise than to real healing. Figure 5-61 shows the resulting leakage currents allowed by the change in IR for each conductor.

Figure 5-60. Total IR of each conductor recorded during Test 16.

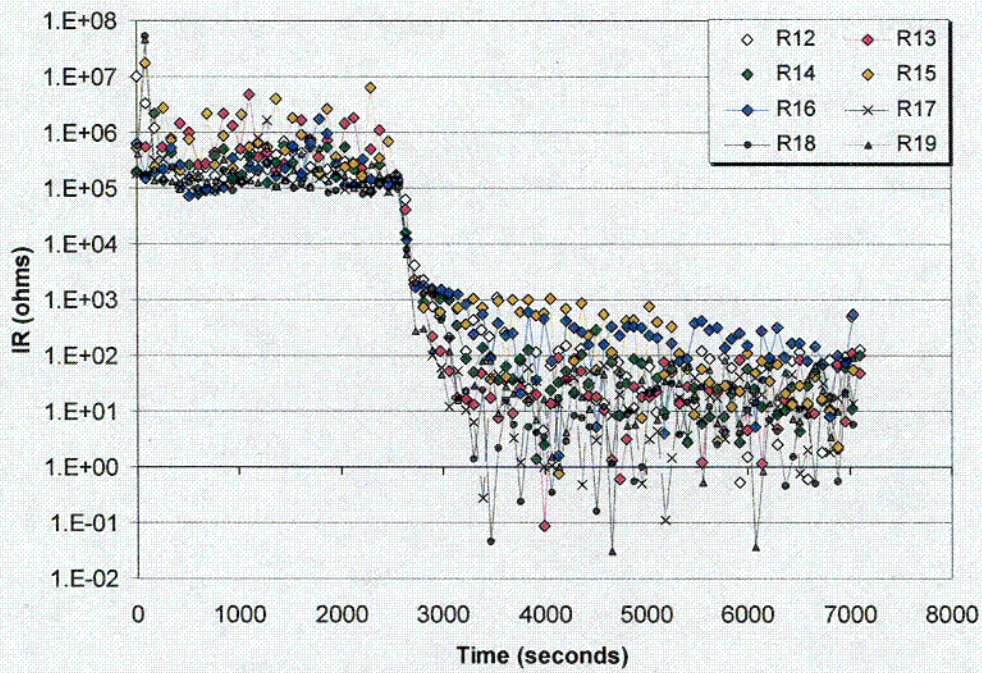
No thermocouple-instrumented cable was routed in the conduit during this test; hence, there is no cable temperature data available. In addition, no direct measure of conduit temperature was made either. Failures of the IR cable bundle were identified based on the results of this test. Figure 5-65 shows a plot of the IRs between Conductor 1 and the other conductors in the IR bundle. Conductors 1 through 3 made up one of the three-conductor cables of the IR bundle, Conductors 4 through 6 were in a second cable, and Conductors 7 through 9 formed the third cable. As shown in the figure, most of the IR values drop to < 100  $\Omega$  at ~3000 seconds.

Figure 5-65. Representative conductor-to-conductor IRs obtained during Test 18. This plot shows the IR between Conductor 1 and the other eight conductors in the IR cable bundle.

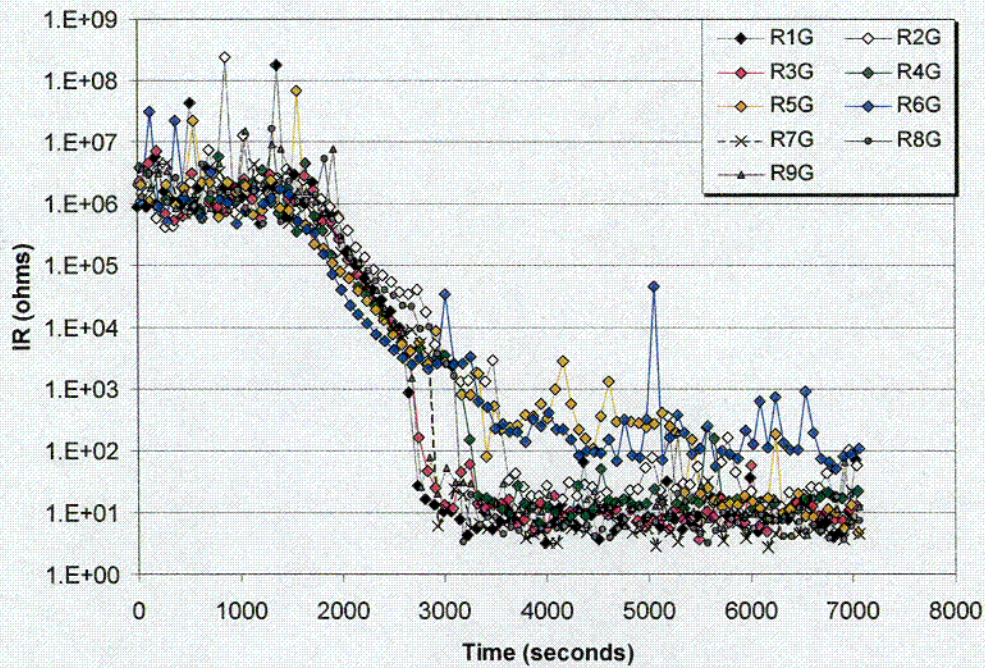
Figure 5-66 shows the IR values between each of the IR cable conductors and ground recorded during Test 18. This figure shows a relatively gradual decline in IRs to ground from ~ $10^6$  down to ~3000  $\Omega$  over the period 1500 to 2500 seconds. The almost simultaneous failure of Conductors 1, 3, and 9 followed this. The next conductor to fail was Conductor 7 at ~ 2900 seconds, then Conductors 8 and 4 failed. Conductors 5, 2, and 6 eventually failed during the course of the test. All conductors shorted to ground before interacting with any other conductor. Table 5-10 provides a summary of the conductor failures. Figure 5-67 presents the change in leakage current for Conductors 1 and 2 occurring during Test 18.

Based solely on the results of the IR measurements made during Test 18, it appears that the IR cable experienced significant damage and could have caused blown fuses.

Figure 5-66. Conductor-to-ground IRs obtained during Test 18.

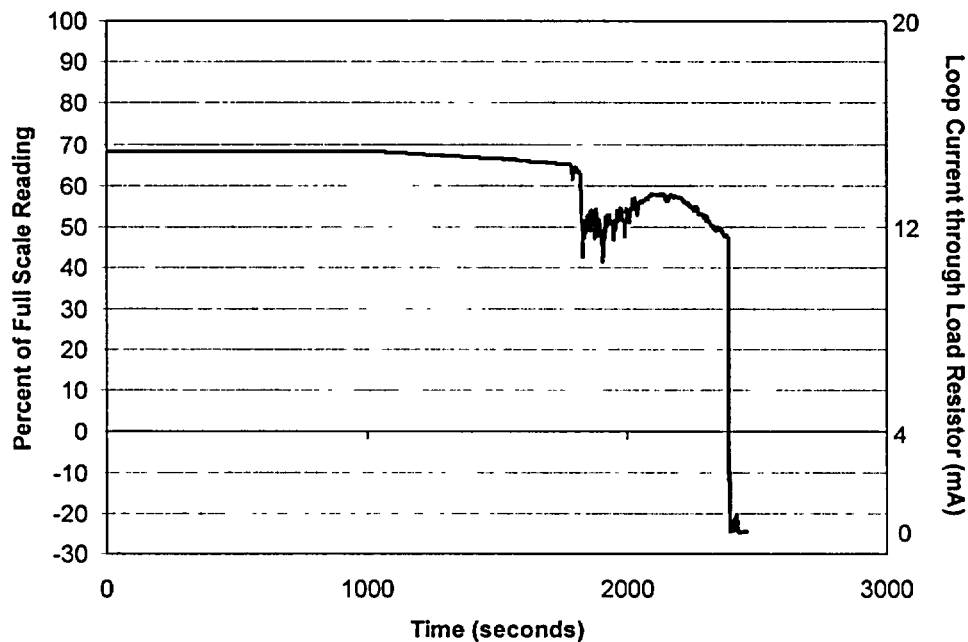
Figure 6-2 presents the current loop data obtained during Test 13. The cable used was a shielded two-conductor thermoset instrumentation cable exposed to the hot gas layer of a 350-kW flame. As shown in the figure, the output

Figure 6-2. Current loop data obtained during Test 13.

signal of the circuit holds at a steady 68% (corresponding correctly to the 15 mA input signal) until ~1100 seconds. At that time, the signal begins to degrade to about 64% at ~1800 seconds. The signal then drops to ~50% and experiences several fluctuations between ~40% to ~53%. After some time, the signal climbs back up to ~57% and holds for a short time. The signal then decays to about 47% and is lost at ~2390 seconds.

This sort of behavior in an instrument circuit could provide an operator with misleading information. The operator would not be able to readily determine if the readout was an accurate indication of plant status or if it was the result of a fire. This is particularly true in this case, since the change in signal output varies rather slowly, and depending on the filtering on the input side of the readout device, the fluctuations occurring from 1800 to 2200 seconds may be damped so that the readout would remain stable. As noted below, a prolonged transition from “good signal” to obviously failed proved to be typical of the thermoset cables tested.

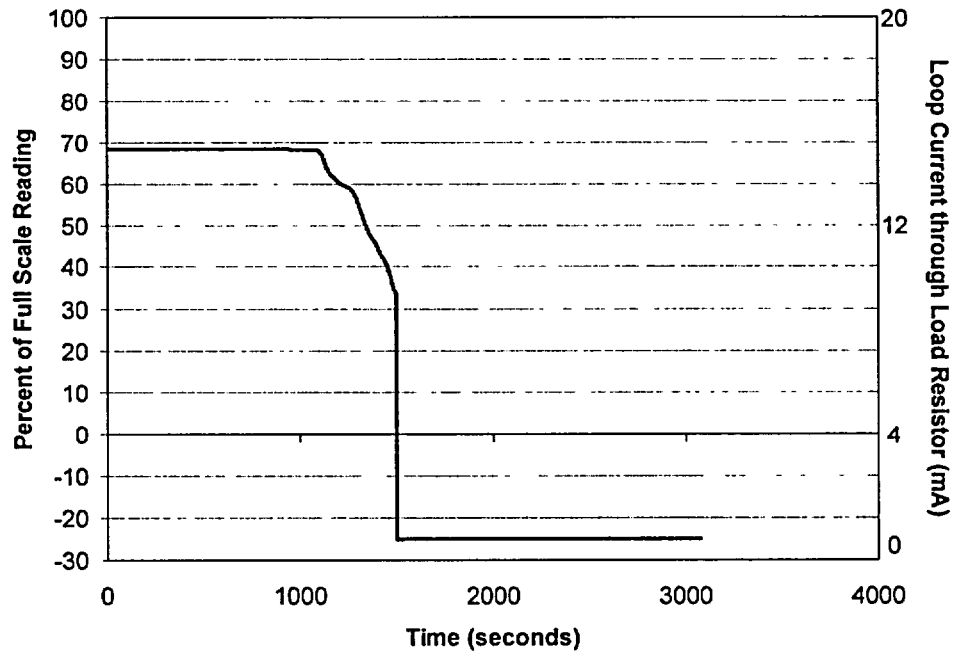
Figure 6-4 presents the current loop data obtained during Test 15. The cable used was a shielded two-conductor thermoset instrumentation cable with a drain wire included. The cable was routed in a horizontal cable tray and exposed to a variable intensity flame (350/200/450 kW) during the test. As shown in the figure, the 68% output signal remains constant until ~1100 seconds. It then begins a slow decline to ~36% over the next 400 seconds. At this time, the signal is lost completely and remains so for the duration of the test.

Figure 6-4. Current loop data obtained during Test 15.

Here again, as discussed above for Test 13, because of the rather slow, monotonic decay of the output signal, an operator may be misled into thinking that plant conditions are changing rather than that the instrument is being adversely affected by the fire.

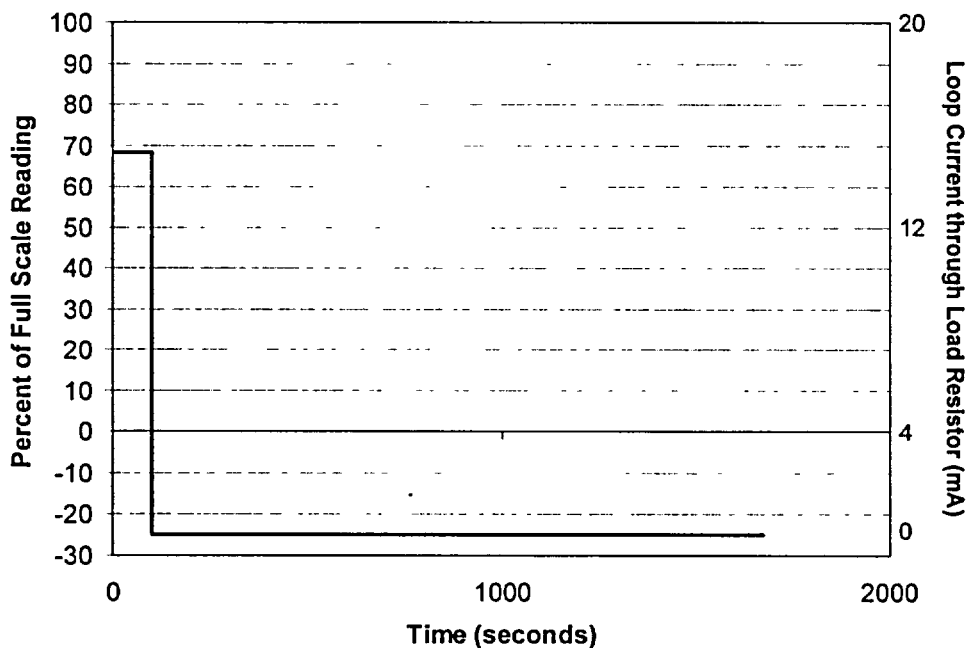
Figure 6-5 presents the current loop data obtained during Test 16. The cable used was a three-pair thermoplastic instrumentation cable with shield and drain wire. Only one pair of conductors was employed during this test. The instrument loop cable was routed in the cable tray and exposed to the plume of a 145 kW fire. As shown in the figure, this cable only lasted ~100 seconds before succumbing to damage and losing the signal for the rest of the run.

As was the case for Test 14, above, this sort of extremely rapid loss of signal would make the operator realize that the instrument had been affected by the fire and was an unreliable source of plant information.

Figure 6-5. Current loop data obtained during Test 16.

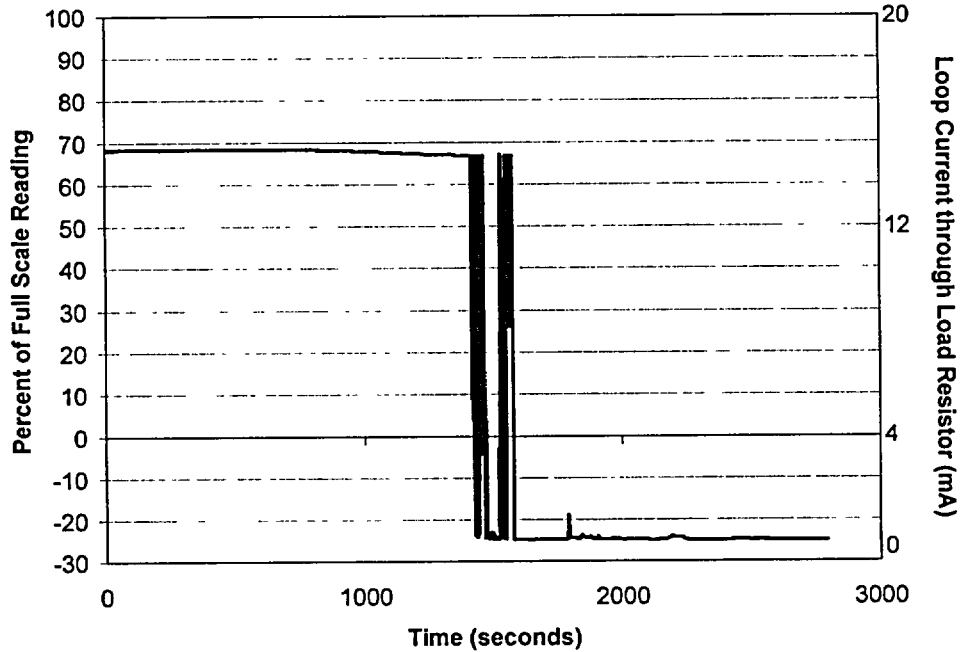
Figure 6-6 presents the current loop data obtained during Test 17. A two-conductor thermoset instrumentation cable was routed in a vertical cable tray and exposed to the hot gas layer and radiant heat from a 200-kW flame. As shown in the figure, the signal remains at a constant 68% until ~930 seconds when it degrades slightly to 67% at ~1420 seconds. The signal fluctuates very wildly over the period of 1420 to 1500 seconds, and then fluctuates again during the period of 1530 to 1600 seconds. The signal is then lost for the rest of the test.

This sort of extreme fluctuation and rapid loss of signal would make the operator realize that the instrument had been affected by the fire and was an unreliable source of plant information.

Figure 6-6. Current loop data obtained during Test 17.

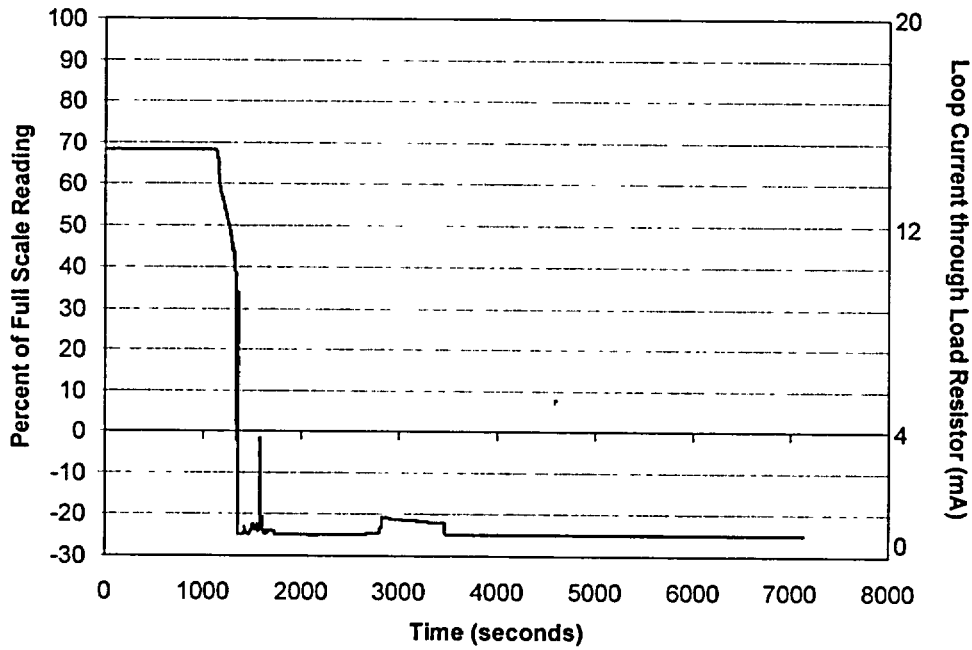
Figure 6-7 presents the current loop data obtained during Test 18. A two-conductor thermoset instrumentation cable was routed in the conduit. A 250-kW hot gas layer exposure fire was employed during this test. As shown in the figure, the current loop circuit output signal remains relatively constant at 68% until ~1140 seconds. The signal then decays down to ~40% at 1325 seconds. Afterwards, the signal fluctuates briefly and is ultimately lost for the duration of the test.

In this case, the signal degradation has some of the same “gentle” sloping characteristics of the other thermoset cables tested, giving rise to the concern about whether or not the operator would interpret the change as a change in plant status or as the effect of the fire.

Figure 6-7. Current loop data obtained during Test 18.
