Insulation Resistance Measurement Results

5.3.2 Test 10

6. CURRENT LOOP DATA AND RESULTS

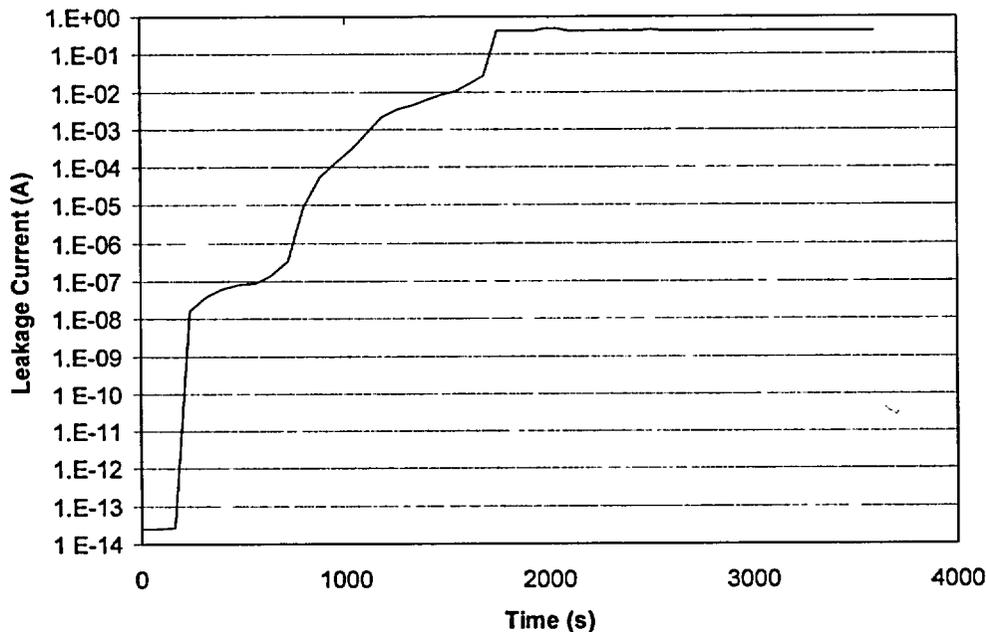
Figure 5-38. Leakage current resulting from IR changes between Conductors 1 and 2 during Test 9.

Based solely on the results of the IR measurements made during Test 9, it appears that the IR cable experienced fire-induced damage that allowed leakage currents high enough to cause device actuation in a DC control circuit. The modes of failure cannot, however, be determined with confidence.

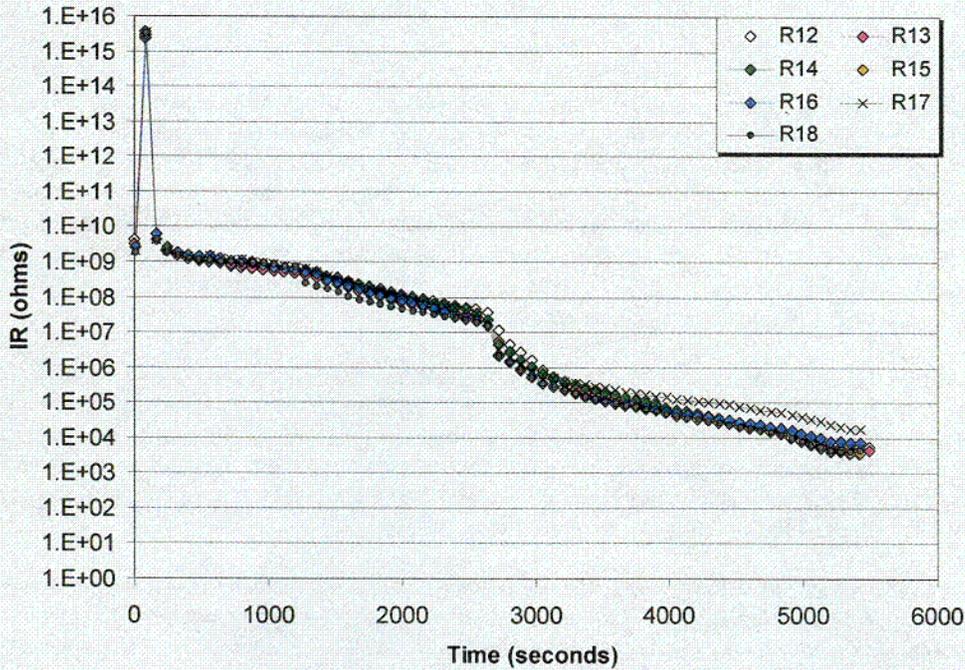
Figure 5-40 shows the IR changes occurring between Conductor 1 and each of the other conductors during the test. Conductor 1 was the center conductor in the seven-conductor cable and the other six conductors surrounded Conductor 1 and were immediately adjacent to it. Conductor 8 is a single conductor cable bundled with the seven-conductor cable to make up the IR bundle for this test.

Figure 5-40. Representative conductor-to-conductor IRs obtained during Test 10. This plot shows the IR between Conductor 1 and the other seven conductors in the IR cable bundle.

As shown in the figure, there was a very gradual decrease in IRs between the conductors from start to end of the test run (3×10^9 down to $1 \times 10^4 \Omega$).

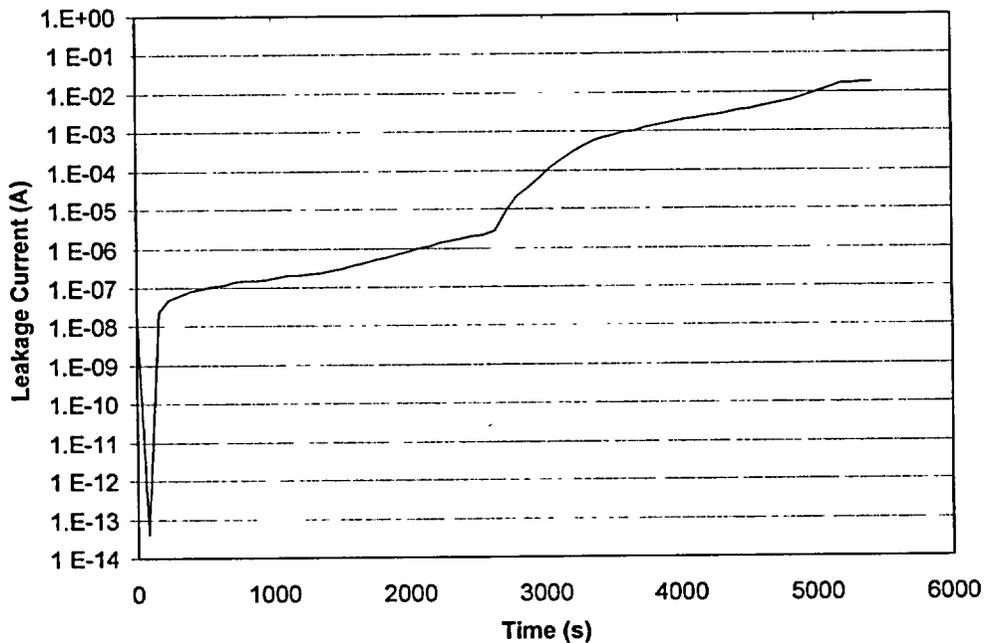
Figure 5-41 plots how the leakage current between Conductors 1 and 2 changed as the test progressed. The peak leakage current appears to be ~ 20 mA between the conductors.

Based solely on the results of the IR measurements made during Test 10, while the cable did show substantial IR degradation, the test appears to have stopped short of actual failure. That is, it does not appear that the IR cable experienced fire-induced damage that would allow leakage current high enough to cause device actuation in a DC control circuit.

Figure 5-41. Leakage current resulting from IR changes between Conductors 1 and 2 during Test 10.

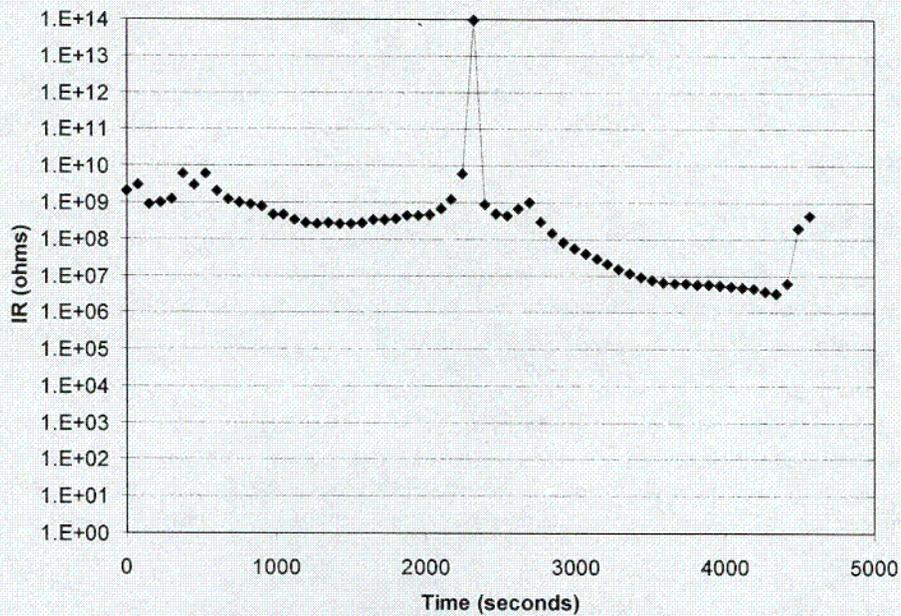
Figure 5-43 shows the changes in IR occurring between Conductors 1 and 2 in the IR1 cable during the test. (Conductors 1 and 2 were the conductor pair within the IR1 cable.)

Figure 5-43. IR between Conductor 1 and 2 obtained during Test 11.

As shown in the figure, the IR between Conductors 1 and 2 remains fairly constant with very small variations until ~2700 seconds into the test run. Then the conductor IR gradually decreases from $\sim 10^9$ to $\sim 3 \times 10^6 \Omega$ at ~4400 seconds; it then seems to be recovering over the remaining time of the test.

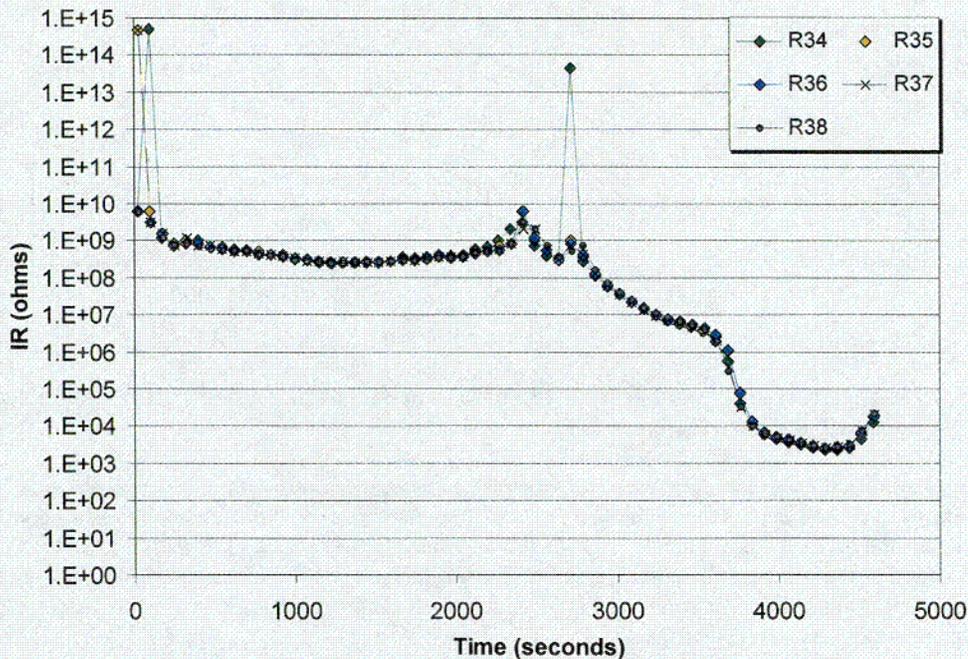
Figure 5-44 shows the IR change between Conductor 3 and the other conductors in IR3 cable during the test. In general, the behavior is the same as shown above for Conductors 1 and 2; however, a definite change in the conductor-to-conductor IRs occurs at ~3600 seconds, when the cable IR3 conductor IRs decrease smoothly from 3×10^6 down to $3 \times 10^3 \Omega$ near the end of the test run.

Figure 5-44. IRs between Conductor 3 and Conductors 4 through 8 obtained during Test 11.

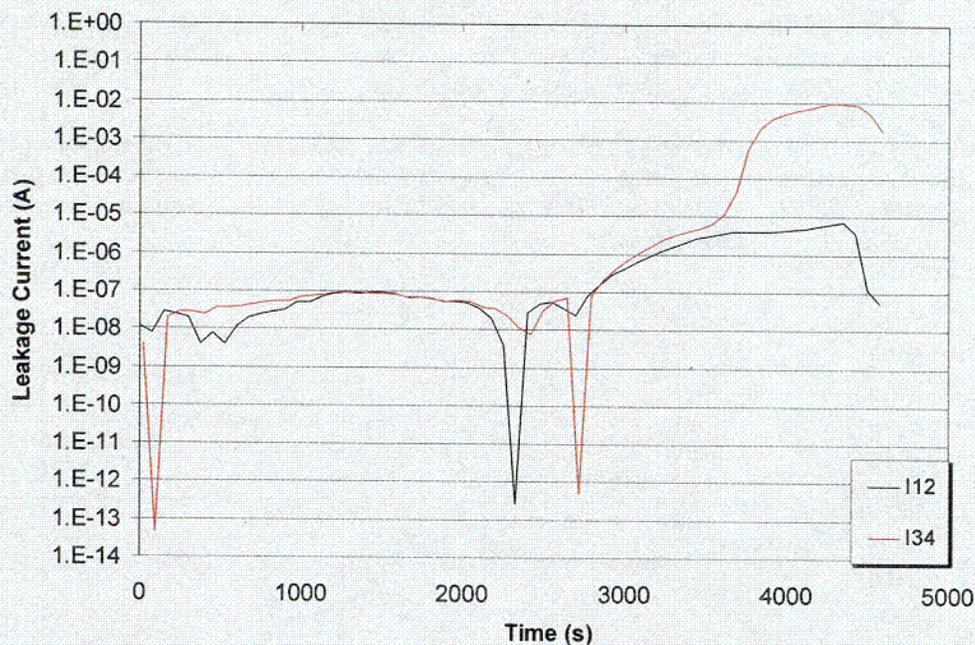
Figure 5-45 plots how the leakage currents between Conductors 1 and 2, and 3 and 4 (a shielded pair within IR3), changed as the test progressed. The peak leakage current appears to be $\sim 7 \mu\text{A}$ between Conductors 1 and 2, which is not enough to pose a serious problem, even to a typical instrument circuit. However, the peak leakage current between Conductors 3 and 4 is $\sim 10 \text{ mA}$, which could cause a substantial instrument reading error in, for example, a 4-20 mA instrument circuit.

Based on the results of the IR measurements made during Test 11, it appears that the IR3 cable experienced substantial fire-induced degradation. While the IR did remain above 1000Ω for the test duration, depending on the specific instrument circuit considered, this degradation might have been sufficient to cause incorrect instrument readings. The IR1 cable did not experience any substantial IR degradation.

Figure 5-45. Leakage currents resulting from IR changes between Conductors 1 and 2 and between Conductors 3 and 4 during Test 11.

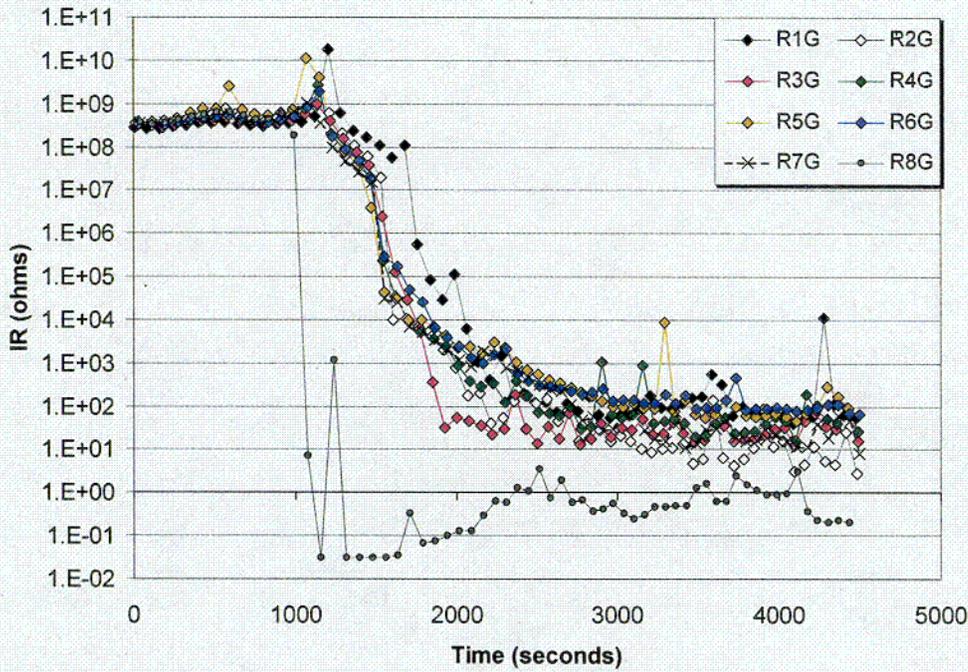
Table 5-6 summarizes the conductor failure modes and times for Test 12. All of the initial failures observed involved the conductors shorting to ground. Initially, at about 1000 seconds, Conductor 8 (the three external conductors as a gang) shorts to ground. This short-to-ground failure is also manifested by the apparent reduction in IR between Conductor 8 and the other conductors in the cable bundle. A second ground short involving Conductor 3 is observed at about 1900 seconds. Over the period of 2200 to 3500 seconds, the rest of the conductors short to ground.

Figure 5-48. Conductor-to-ground IRs obtained during Test 12.

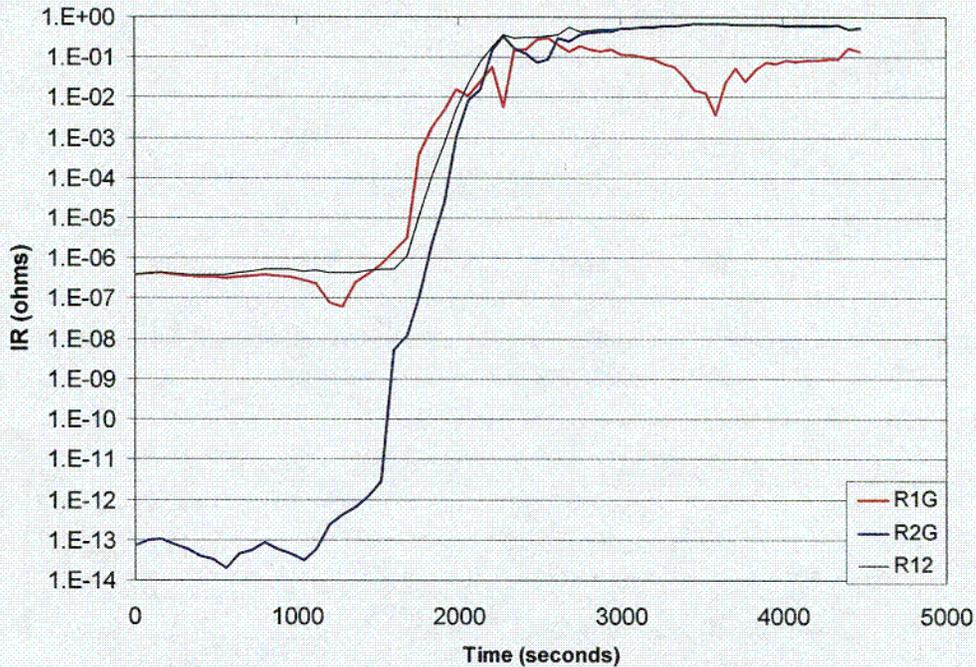
Figure 5-49 plots how the leakage currents for Conductors 1 and 2 changed in their relationship to one another and to ground as the test progressed.

Based solely on the results of the IR measurements made during Test 12, it appears that the IR cable experienced fire-induced damage that allowed leakage currents high enough to cause device actuation or blown fuses.

Figure 5-49. Leakage currents resulting from IR changes between Conductors 1 and 2 during Test 12.

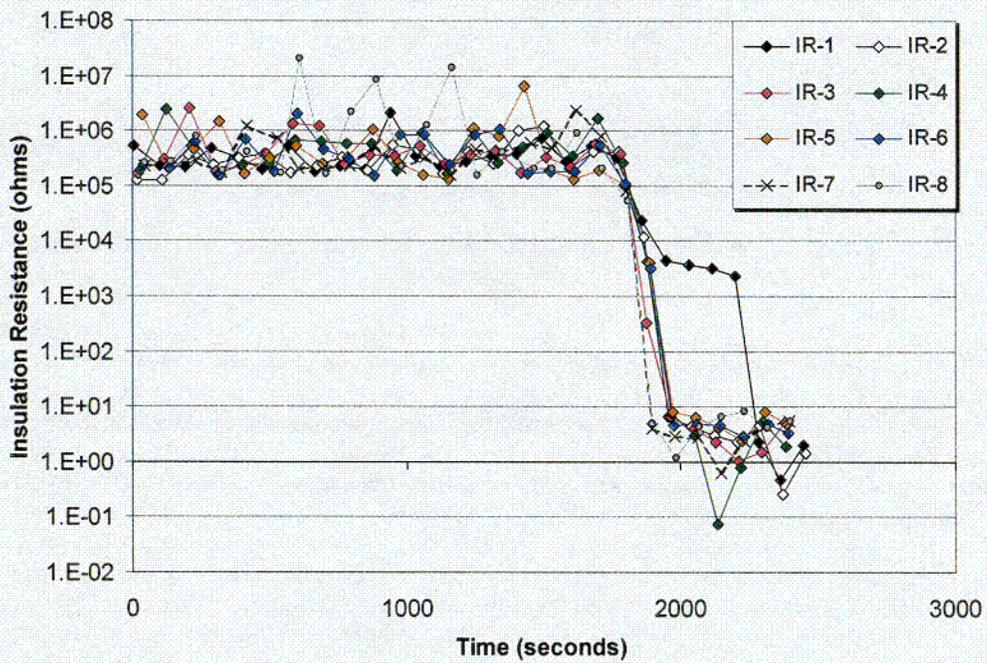
As noted previously, the IR measurement system was only capable of determining total IR to ground due to a wiring problem during Test 13. Figure 5-51 shows the time-dependent change in the total IR for each of the eight conductors in the IR cable measured during this test. The fact that the IR values fall to very low levels (<100 Ω) beginning at about 1900 seconds indicates that conductor failures have occurred. Figure 5-52 shows the associated leakage currents.

Figure 5-51. Total IR of each conductor recorded during Test 13.

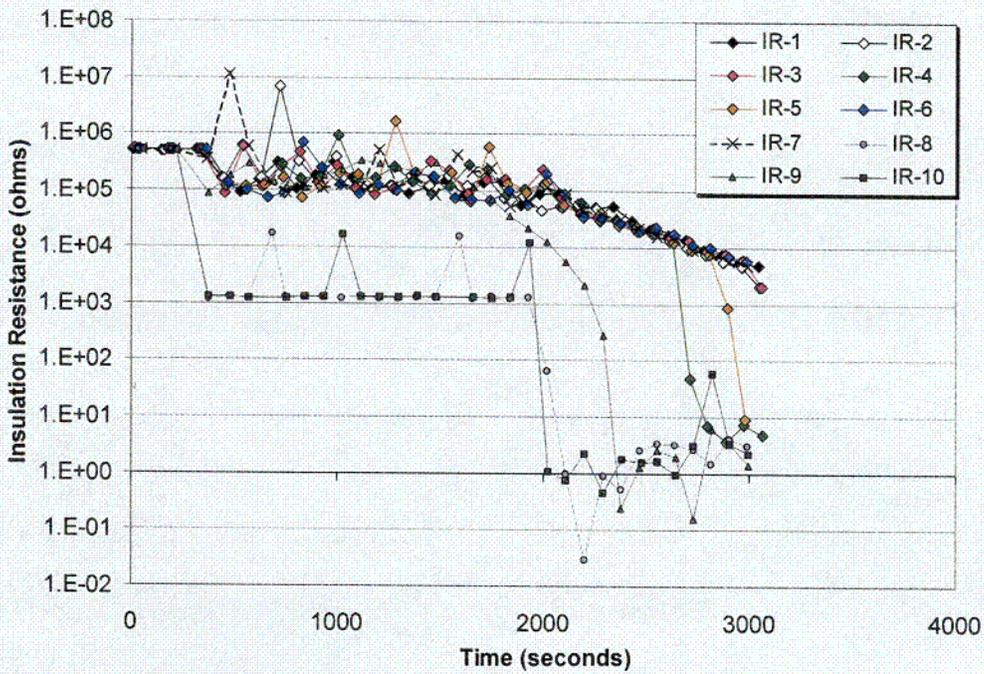
As noted previously, the IR measurement system was only capable of determining total IR due to a wiring problem during Test 15. Figure 5-57 shows the time-dependent change in the total IR for each of the 10 conductors in the IR cable measured during this test. Table 5-7 summarizes the behavior of the cable in the test. Only five of the 10 conductors appear to have total IRs <100 Ω at the end of the test. The other conductors, while experiencing decreasing total IRs, did not reach the point of failure.

Figure 5-57. Total IR of each conductor recorded during Test 15.

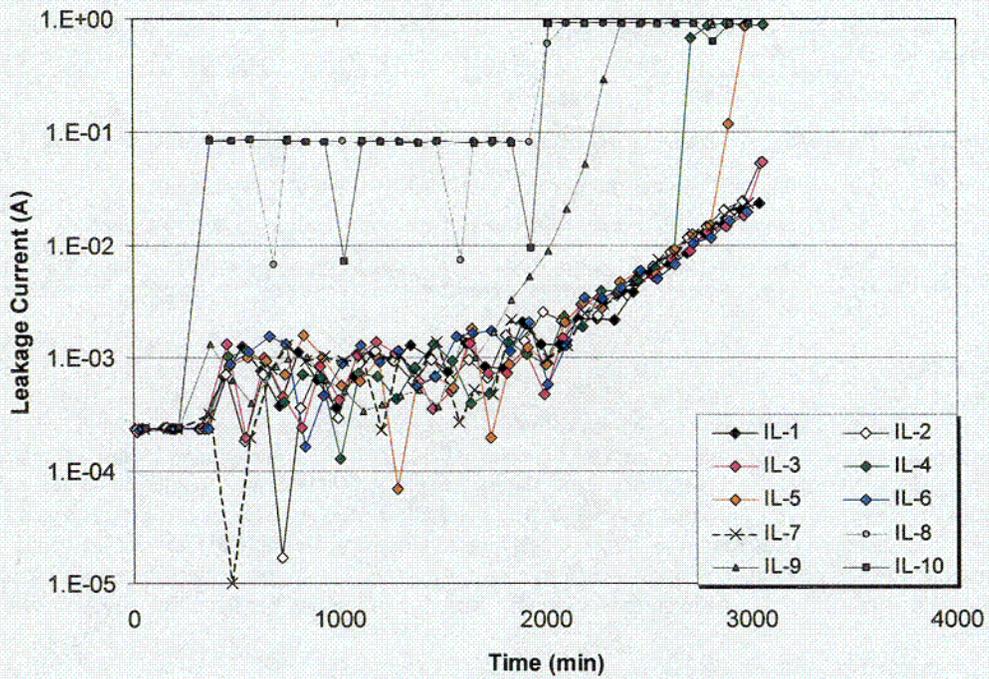
Figure 5-58 shows the resulting leakage currents allowed by the change in IR for each conductor. Although there is no direct evidence, the two external Conductors 8 and 10 may have been shorted together without ground interaction during the period of time their IRs decreased to and held at ~1000 Ω. This supposition is largely based on previous experience with conductors shorting together and the resulting voltage responses recorded on the IR system.

Figure 5-58. Total leakage currents resulting from IR changes for each Conductor during Test 15.

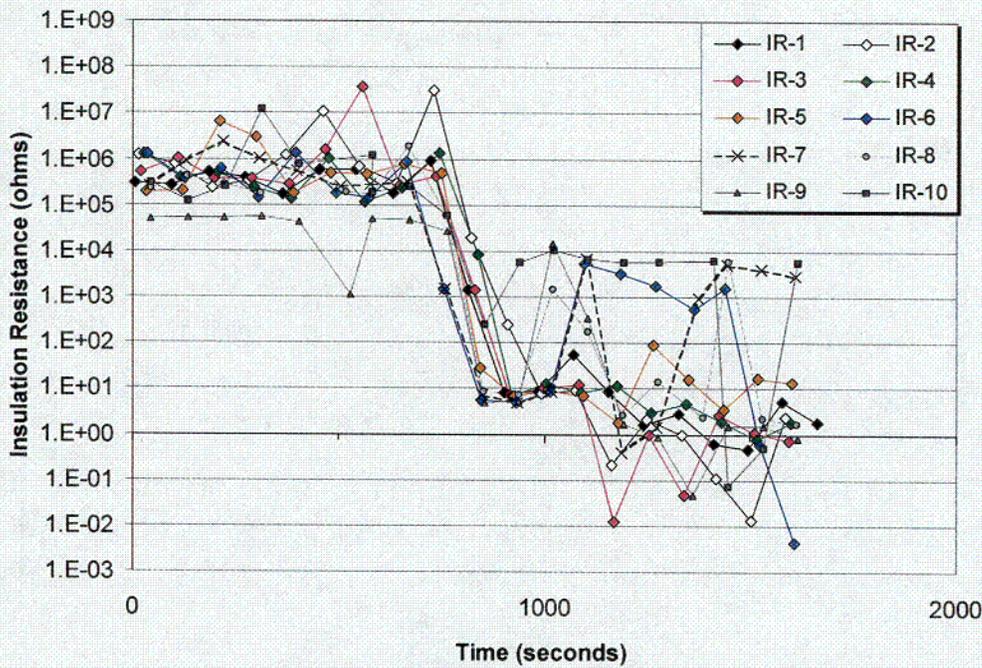
As previously mentioned, the IR measurement system was only capable of determining total IR due to a wiring problem during Test 16. Figure 5-60 shows the time-dependent change in the total IR for each of the 10 conductors in the IR cable measured during this test. Table 5-8 summarizes the behavior of the cable in the test. While some of the conductor IRs increase again (~1000 Ω) near the end of the test, it is believed that all experienced failure and the apparent recovery was due more to noise than to real healing. Figure 5-61 shows the resulting leakage currents allowed by the change in IR for each conductor.

Figure 5-60. Total IR of each conductor recorded during Test 16.

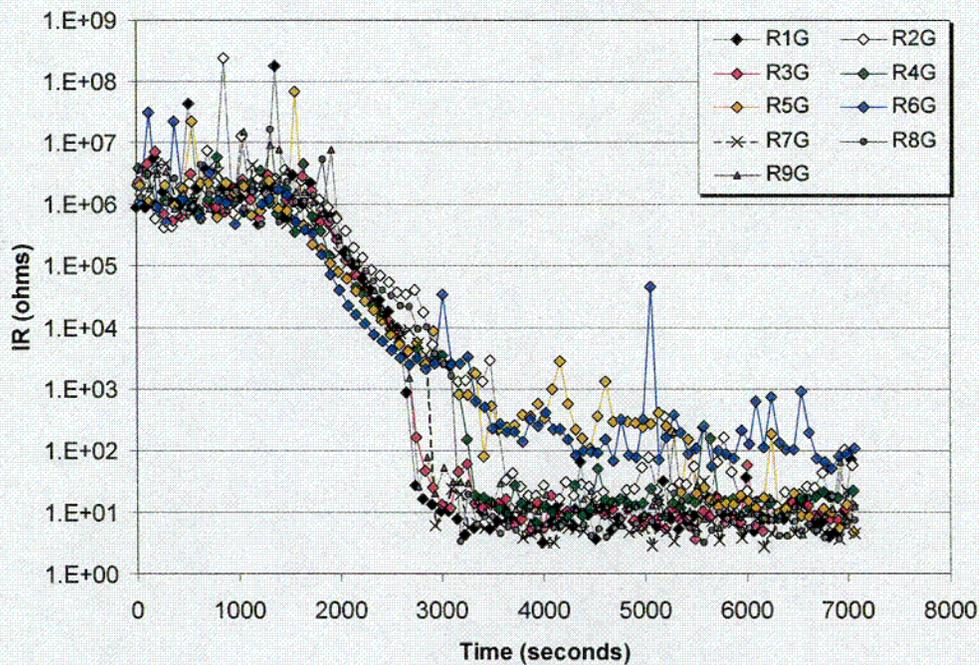
Figure 5-66 shows the IR values between each of the IR cable conductors and ground recorded during Test 18. This figure shows a relatively gradual decline in IRs to ground from ~ 10^6 down to ~3000 Ω over the period 1500 to 2500 seconds. The almost simultaneous failure of Conductors 1, 3, and 9 followed this. The next conductor to fail was Conductor 7 at ~ 2900 seconds, then Conductors 8 and 4 failed. Conductors 5, 2, and 6 eventually failed during the course of the test. All conductors shorted to ground before interacting with any other conductor. Table 5-10 provides a summary of the conductor failures. Figure 5-67 presents the change in leakage current for Conductors 1 and 2 occurring during Test 18.

Based solely on the results of the IR measurements made during Test 18, it appears that the IR cable experienced significant damage and could have caused blown fuses.

Figure 5-66. Conductor-to-ground IRs obtained during Test 18.

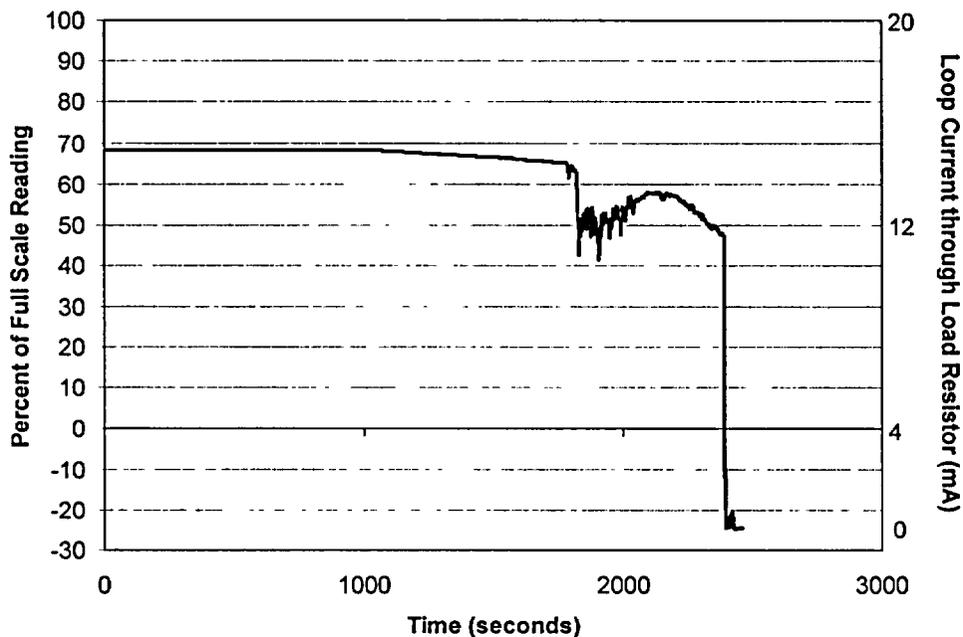
Figure 6-2 presents the current loop data obtained during Test 13. The cable used was a shielded two-conductor thermoset instrumentation cable exposed to the hot gas layer of a 350-kW flame. As shown in the figure, the output

Figure 6-2. Current loop data obtained during Test 13.

signal of the circuit holds at a steady 68% (corresponding correctly to the 15 mA input signal) until ~1100 seconds. At that time, the signal begins to degrade to about 64% at ~1800 seconds. The signal then drops to ~50% and experiences several fluctuations between ~40% to ~53%. After some time, the signal climbs back up to ~57% and holds for a short time. The signal then decays to about 47% and is lost at ~2390 seconds.

This sort of behavior in an instrument circuit could provide an operator with misleading information. The operator would not be able to readily determine if the readout was an accurate indication of plant status or if it was the result of a fire. This is particularly true in this case, since the change in signal output varies rather slowly, and depending on the filtering on the input side of the readout device, the fluctuations occurring from 1800 to 2200 seconds may be damped so that the readout would remain stable. As noted below, a prolonged transition from “good signal” to obviously failed proved to be typical of the thermoset cables tested.

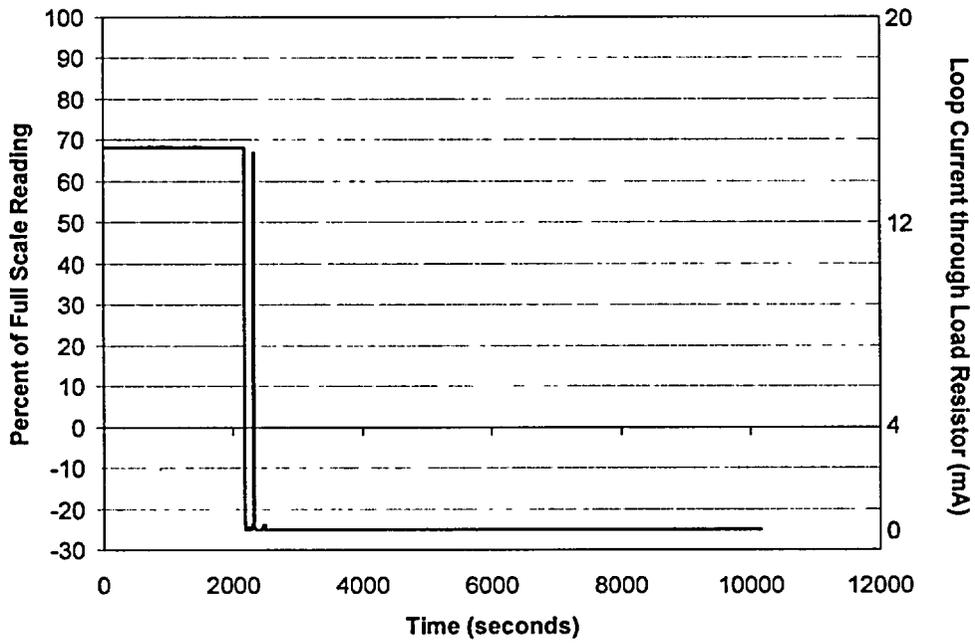
Unlike the previous case, this sort of extremely rapid loss of signal would be an obvious indication that the instrument circuit had failed and was an unreliable source of plant information. As noted below, this abrupt failure behavior proved to be typical of the thermoplastic cables tested.

Figure 6-3. Current loop data obtained during Test 14.

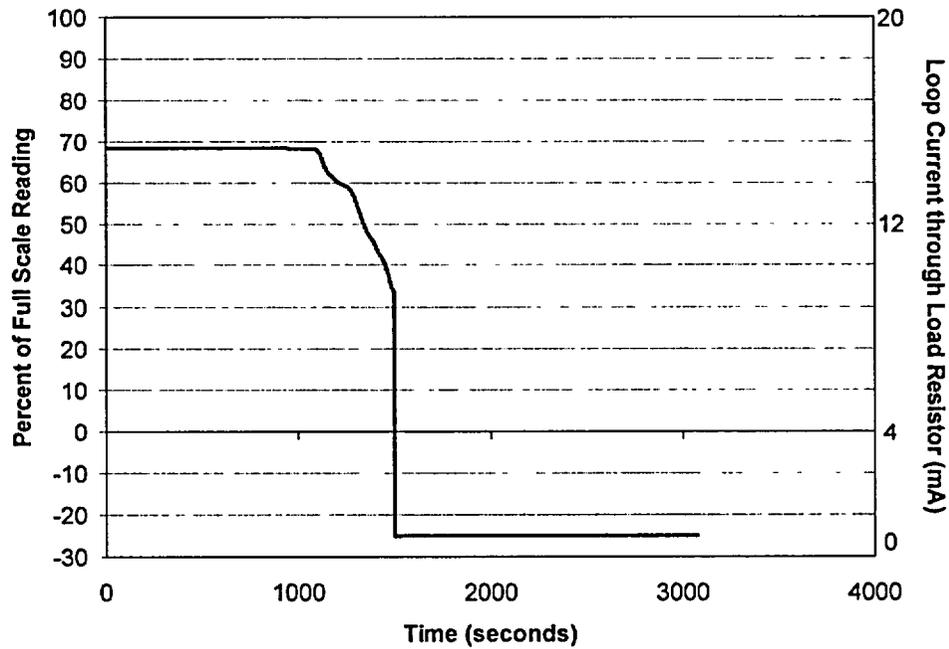
Figure 6-4 presents the current loop data obtained during Test 15. The cable used was a shielded two-conductor thermoset instrumentation cable with a drain wire included. The cable was routed in a horizontal cable tray and exposed to a variable intensity flame (350/200/450 kW) during the test. As shown in the figure, the 68% output signal remains constant until ~1100 seconds. It then begins a slow decline to ~36% over the next 400 seconds. At this time, the signal is lost completely and remains so for the duration of the test.

Figure 6-4. Current loop data obtained during Test 15.

Here again, as discussed above for Test 13, because of the rather slow, monotonic decay of the output signal, an operator may be misled into thinking that plant conditions are changing rather than that the instrument is being adversely affected by the fire.

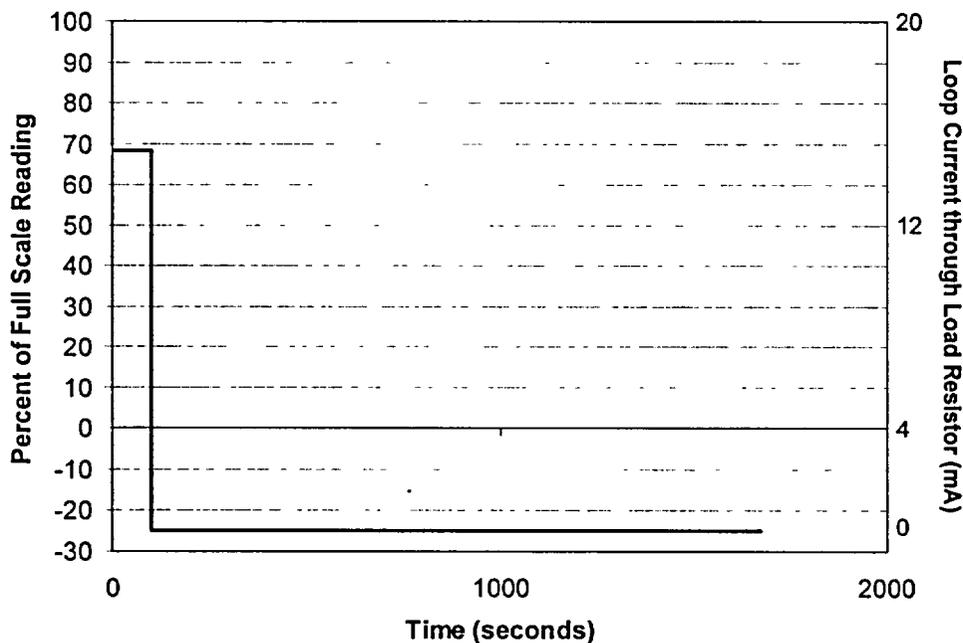
Figure 6-5 presents the current loop data obtained during Test 16. The cable used was a three-pair thermoplastic instrumentation cable with shield and drain wire. Only one pair of conductors was employed during this test. The instrument loop cable was routed in the cable tray and exposed to the plume of a 145 kW fire. As shown in the figure, this cable only lasted ~100 seconds before succumbing to damage and losing the signal for the rest of the run.

As was the case for Test 14, above, this sort of extremely rapid loss of signal would make the operator realize that the instrument had been affected by the fire and was an unreliable source of plant information.

Figure 6-5. Current loop data obtained during Test 16.

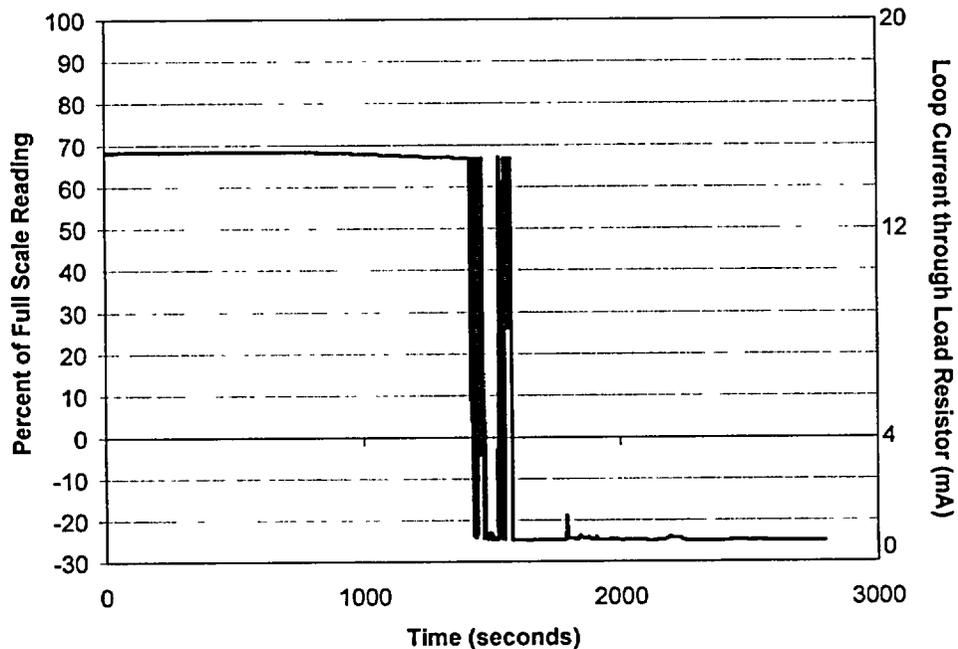
Figure 6-6 presents the current loop data obtained during Test 17. A two-conductor thermoset instrumentation cable was routed in a vertical cable tray and exposed to the hot gas layer and radiant heat from a 200-kW flame. As shown in the figure, the signal remains at a constant 68% until ~930 seconds when it degrades slightly to 67% at ~1420 seconds. The signal fluctuates very wildly over the period of 1420 to 1500 seconds, and then fluctuates again during the period of 1530 to 1600 seconds. The signal is then lost for the rest of the test.

This sort of extreme fluctuation and rapid loss of signal would make the operator realize that the instrument had been affected by the fire and was an unreliable source of plant information.

Figure 6-6. Current loop data obtained during Test 17.

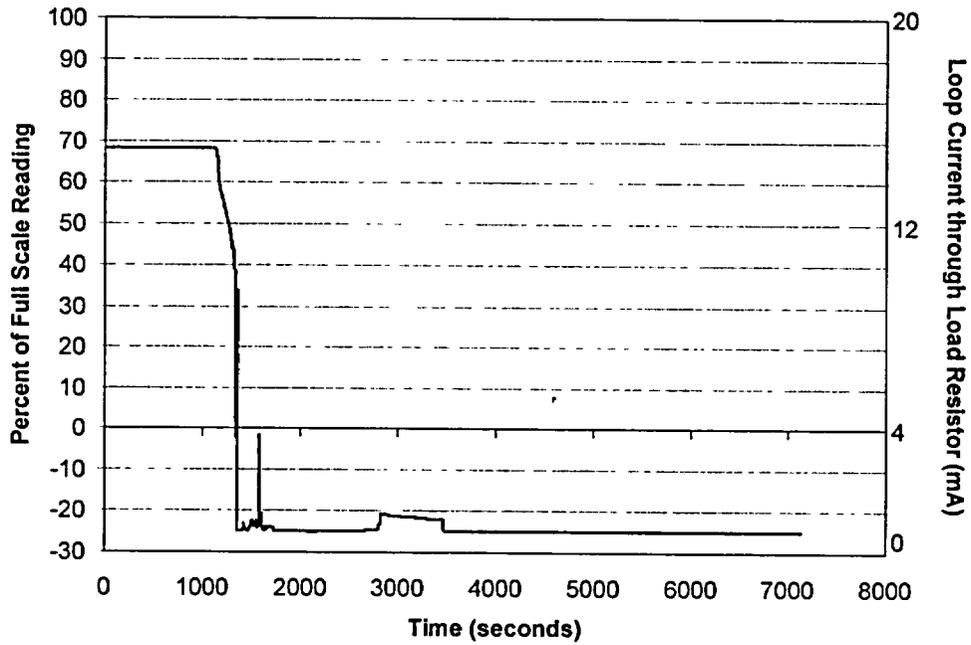
Figure 6-7 presents the current loop data obtained during Test 18. A two-conductor thermoset instrumentation cable was routed in the conduit. A 250-kW hot gas layer exposure fire was employed during this test. As shown in the figure, the current loop circuit output signal remains relatively constant at 68% until ~1140 seconds. The signal then decays down to ~40% at 1325 seconds. Afterwards, the signal fluctuates briefly and is ultimately lost for the duration of the test.

In this case, the signal degradation has some of the same “gentle” sloping characteristics of the other thermoset cables tested, giving rise to the concern about whether or not the operator would interpret the change as a change in plant status or as the effect of the fire.

Figure 6-7. Current loop data obtained during Test 18.
