**Commissioners' Technical Assistants Brief**  
Wednesday, November 14, 2001  
1:00 P.M. - 2:00 P.M.  
Room: 18<sup>th</sup> Floor Commissioners, Conference Room

**Purpose:** 1) To discuss updated results of the staff's review of responses to Bulletin 2001-01, "Circumferential Cracking of Reactor Pressure Vessel Head Penetration Nozzles."  
2) To discuss the basis for proposed Order(s).

## DAVIS BESSE

# *RPV Head 11 & 12 RFO Inspection Results*

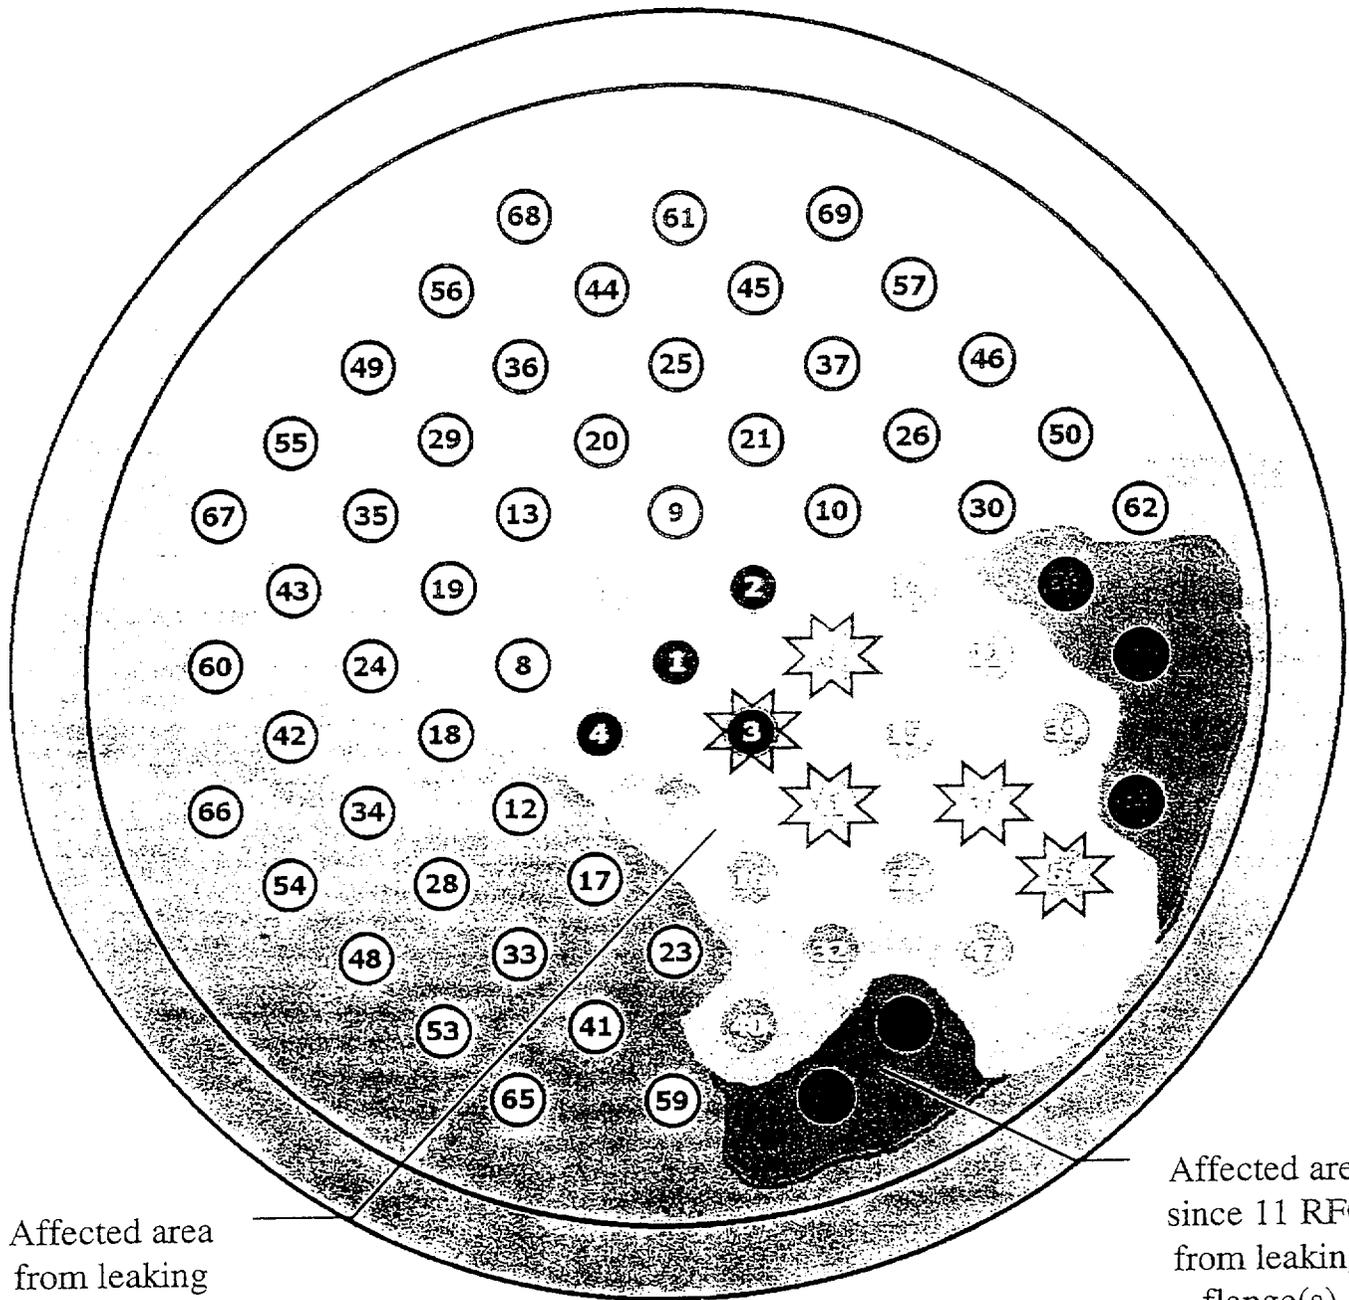
Affected area from leaking flange(s)

Affected area since 11 RFO from leaking flange(s)

- ⑥① - No leakage identified
- ④ - Evaluated not to have sufficient gap to exhibit leakage
- ★③ - Insufficient gap with leaking flange
- ⑤ - Nozzle obscured by boron
- ★⑥ - Nozzle obscured by boron with leaking flange
- ② - Newly affected, since 11 RFO, by leaking flange(s)

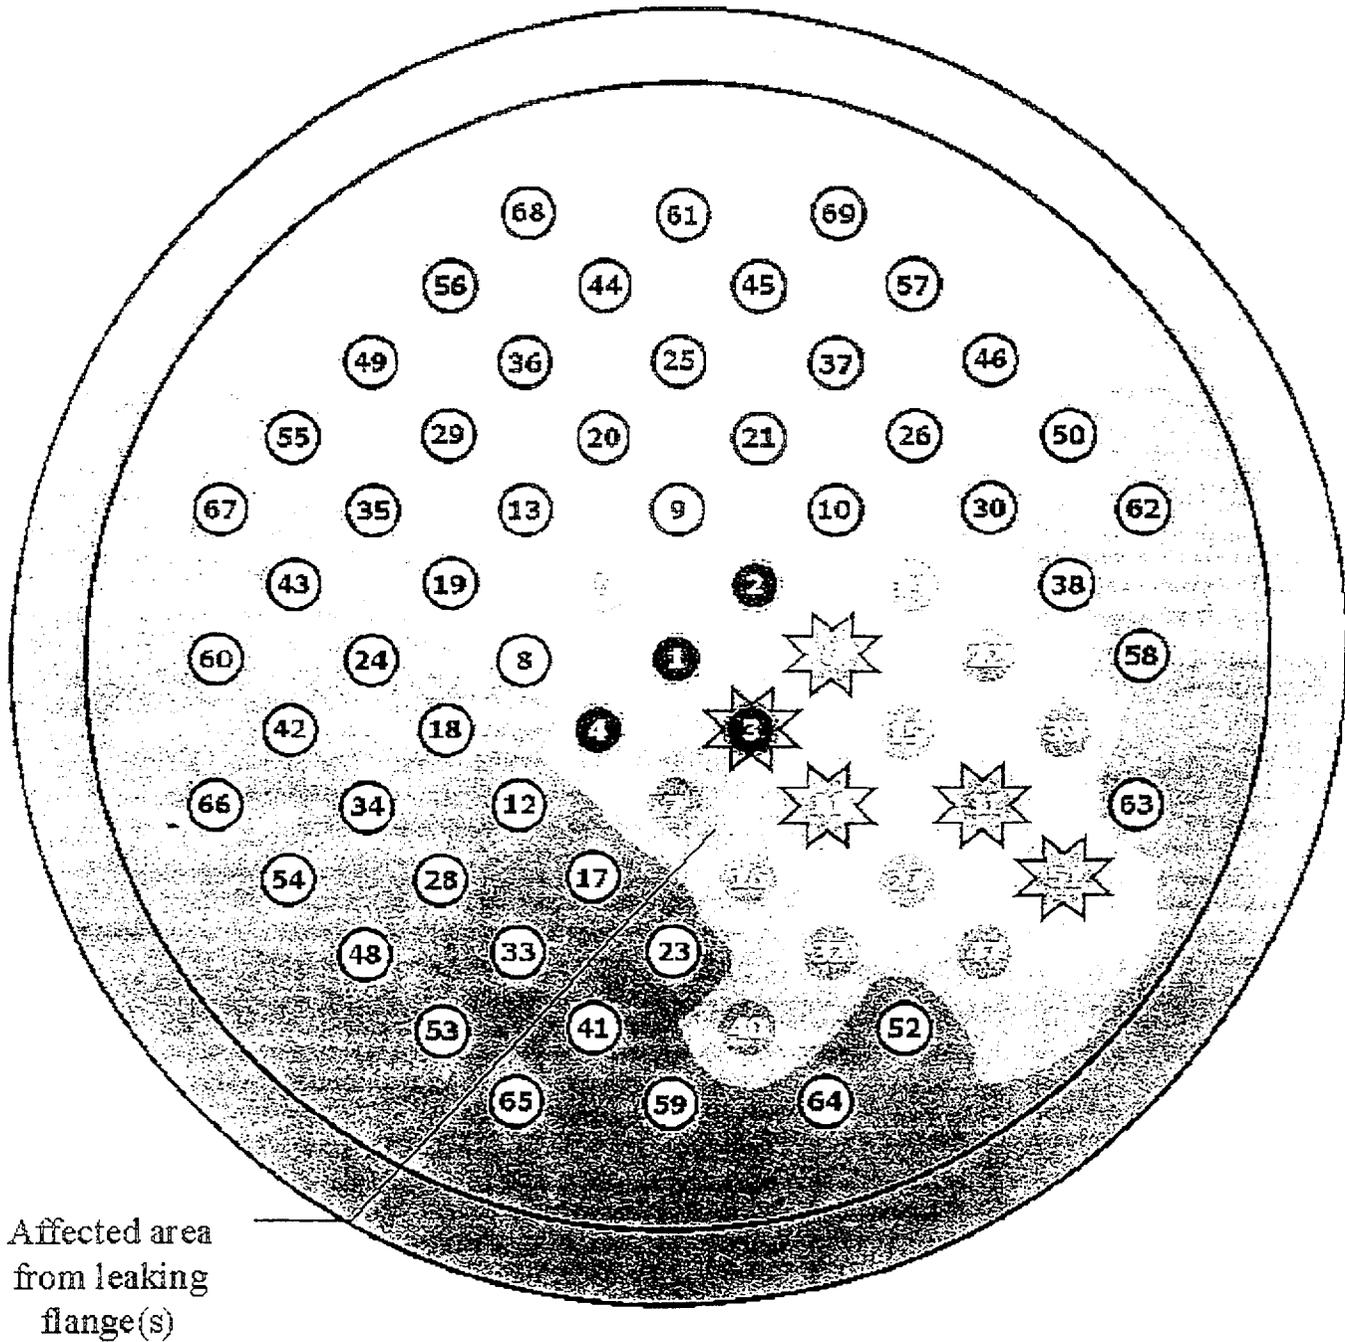
# *RPV Head 11 RFO Inspection Results*

- ⊙ - No leakage identified
- - Evaluated not to have sufficient gap to exhibit leakage
- ★ - Insufficient gap with leaking flange
- ⊙ - Nozzle obscured by boron
- ★ - Nozzle obscured by boron with leaking flange

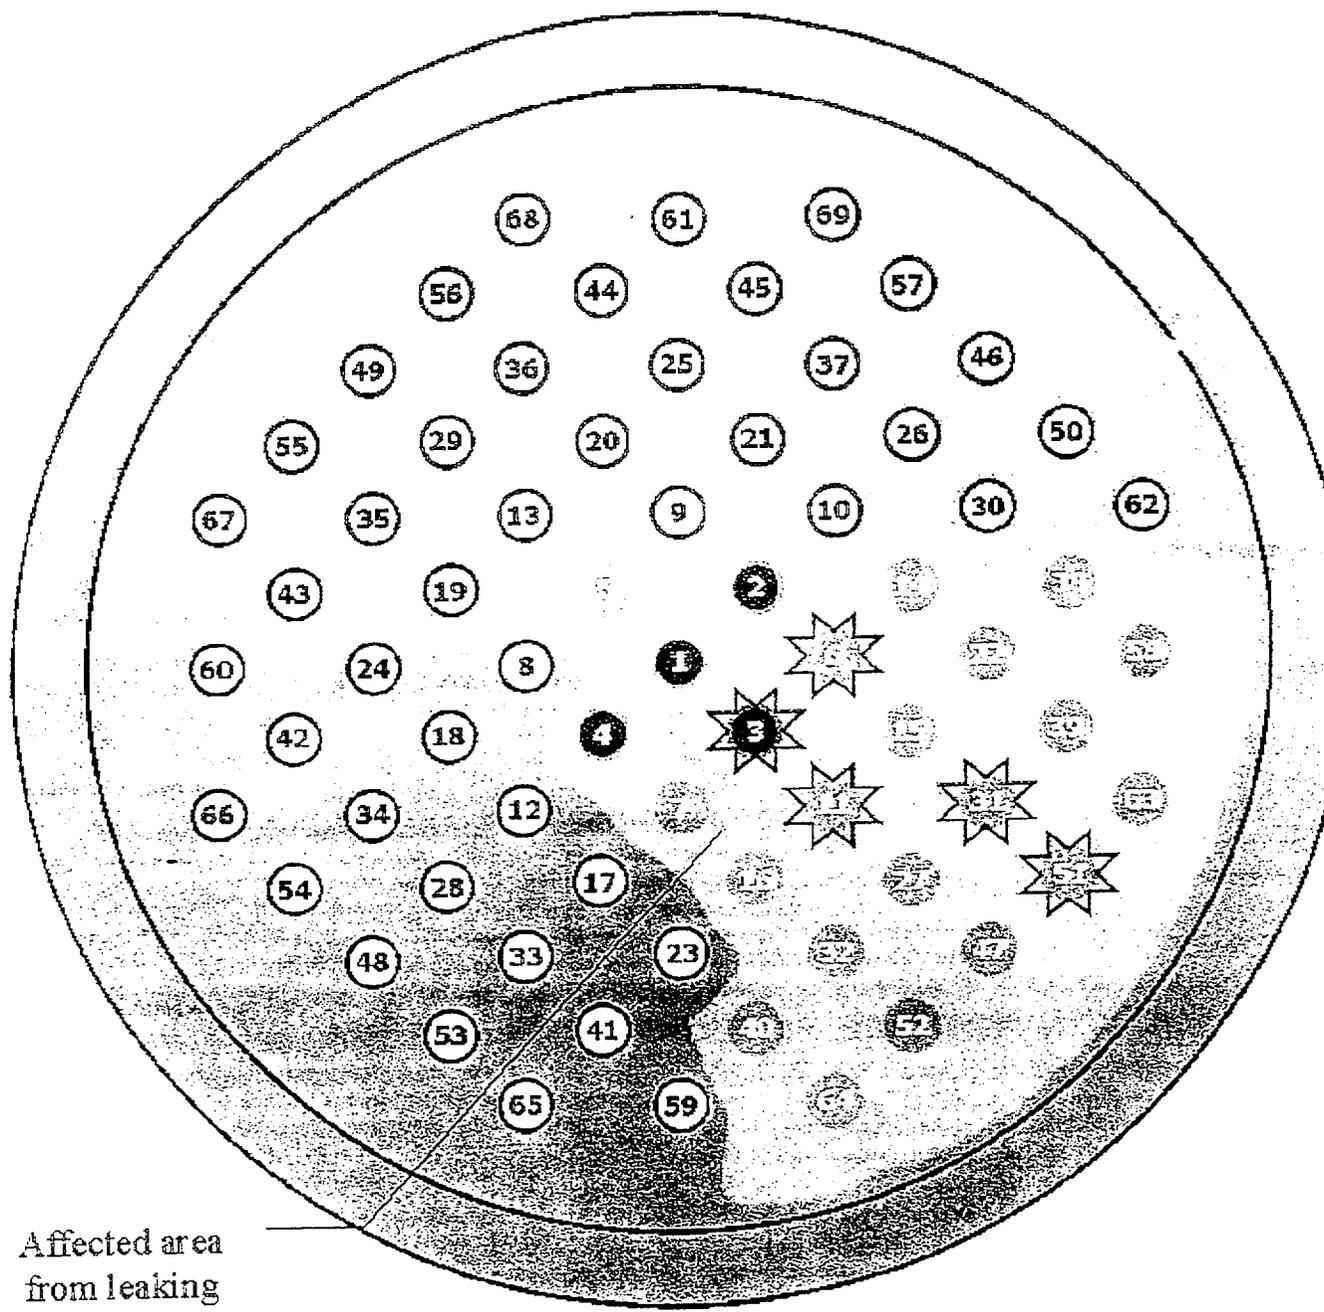
# *RPV Head 12 RFO Inspection Results*

Affected area from leaking flange(s)

- ⊙ - No leakage identified
- - Evaluated not to have sufficient gap to exhibit leakage
- ★ - Insufficient gap with leaking flange
- ⊙ - Nozzle obscured by boron
- ★ - Nozzle obscured by boron with leaking flange
