Subject: Transmittal of Annual Facility Operating Report for 1996.

**Idaho State University  
AGN-201M Reactor Facility  
License R-110, Docket No. 50-284  
Annual Operating Report for 1996**

### Final Results of the AGN-201 Reactor Shield Water Tank Assessment

## **Modification of the AGN-201 Reactor Glory Hole and Gamma Shielding**

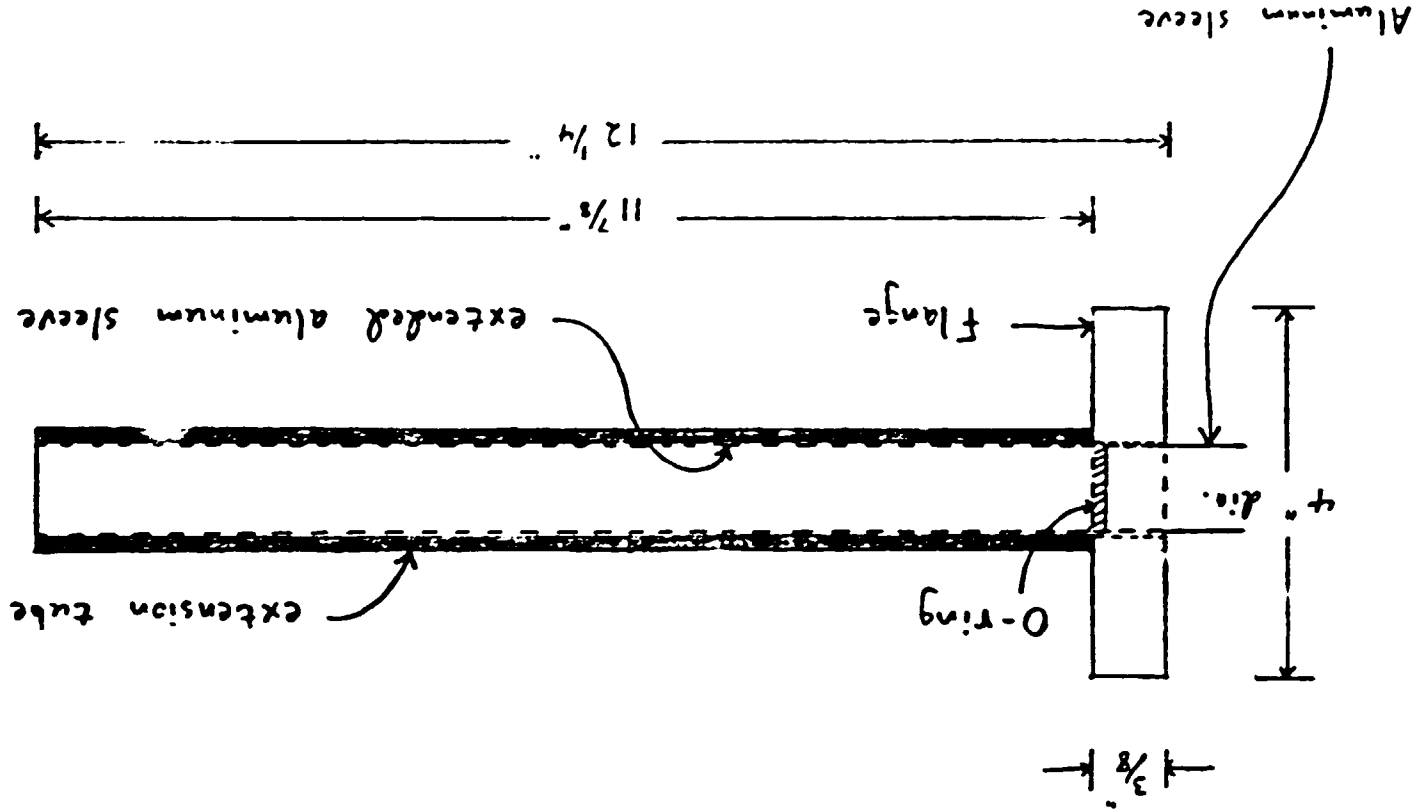
Figure 1 - Extension Tube Assembly

The east end of the glory hole will be extended to the outer edge of the concrete block shielding by means of an extension tube assembly (Figure 1). The extension tube is welded to a flange which will be bolted to the existing glory hole flange. The entire assembly is constructed from carbon steel, and is sized to accommodate the aluminum glory hole sleeve. To eliminate abrupt internal edges at the glory hole/extender interface, the sleeve will be replaced by one which reaches the end of the extension tube.

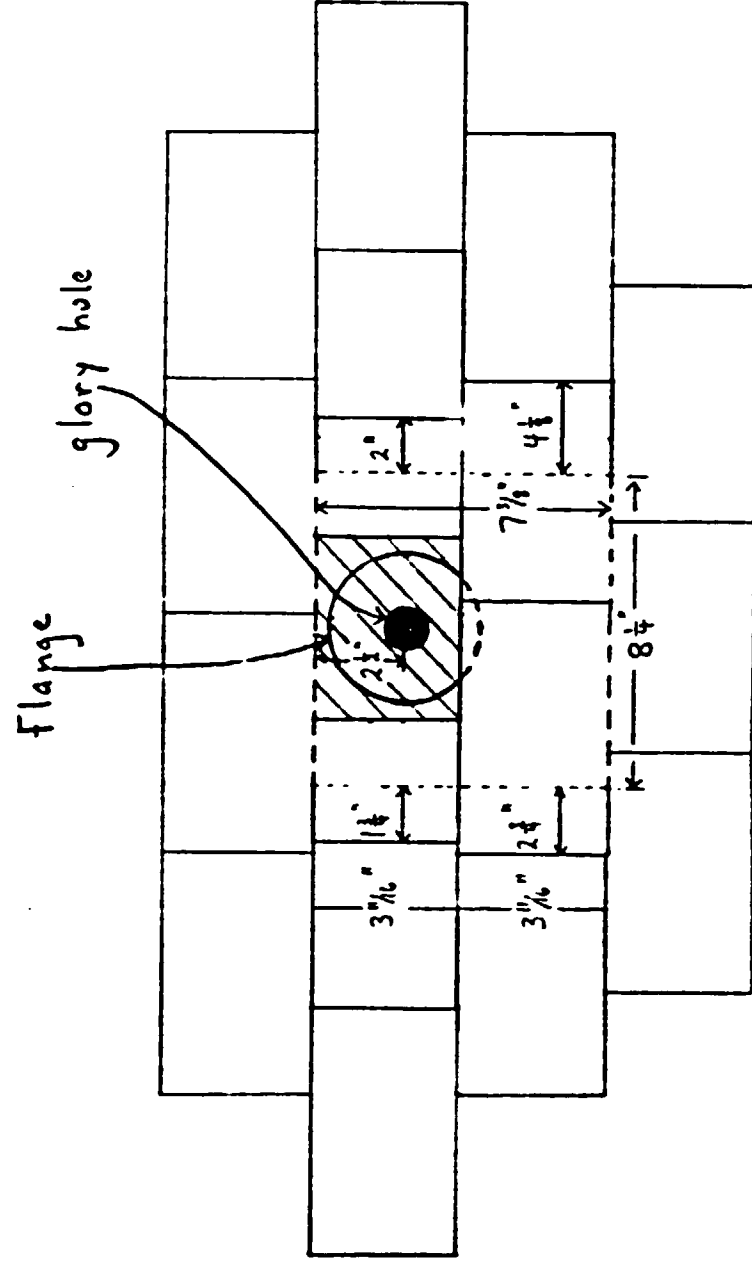
Figure 12 - Current Glory Hole Access Opening

During reactor operation, the glory hole of the AGN-201 reactor is accessible only through a 5-inch wide by 4 $\frac{1}{2}$ -inch high opening in the concrete shielding surrounding the reactor. The opening is large enough to allow insertion of objects into the glory hole. However, the lower portion of the glory hole flange is nestled behind the concrete shielding. Removal of the flange requires that several bricks be removed from the shield wall to allow access to the lower retaining screw. This is a very laborious process. In addition, the glory hole entrance is situated over a foot behind the front of the shield wall, making it difficult to see and access the glory hole. To facilitate work on and access to the glory hole, a modification to the glory hole and shielding is proposed.

The shielding in front of the glory hole region will be modified to include frames which will accommodate lead shield plugs (Figure 2). The lead plugs are solid except for a 1 $\frac{1}{4}$ -inch diameter hole through which the extension tube will pass. Since the outside diameter of the extension tube is 1 $\frac{1}{4}$  inches, a  $\frac{1}{8}$ -inch clearance between the tube and shield plug is provided. This design eliminates the large opening which now exists in front of the glory hole, thereby reducing radiation levels in this region. Handles on the plugs will allow easy installation and removal. The frames are constructed of  $\frac{1}{4}$ -inch plate carbon steel (Figure 3). Two assemblies are used to facilitate initial installation of the frames into the shielding wall (Figure 4). Figure 5 shows a front view of a shield and frame assembly. The regions on either side of the shield frames will be filled in with lead brick (Figure 2).
