October 3, 2002  
NG-02-0909

Subject: Duane Arnold Energy Center  
Docket No: 50-331  
Op. License No: DPR-49  
Licensee Event Report #2002-002-00  
File: A-120

TITLE (4)  
**Technical Specification Required Shutdown Due to Residual Heat Removal Service Water (RHRSW) Strainer Plugging Caused by Algae Intrusion from the Cedar River**

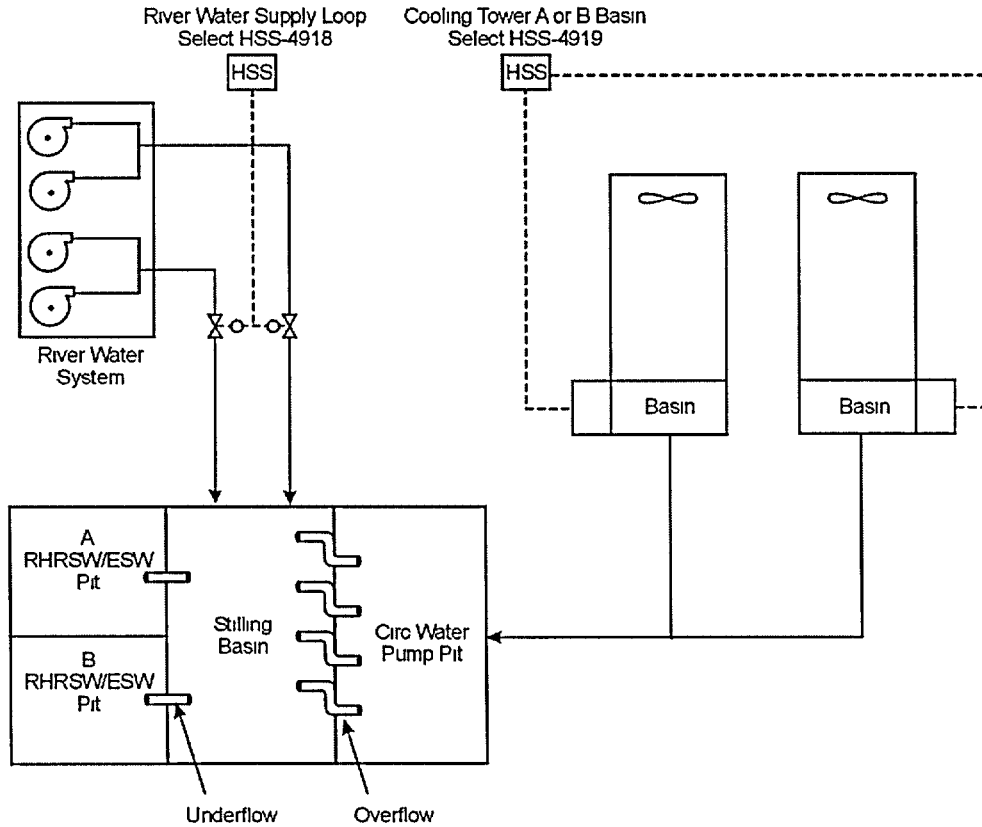
## Attachment 1, River Water Flow to RHRSW Pits

On Sunday, August 4, 2002, at 1056 hours while operating at 94% licensed thermal power, operators commenced "B" RHRSW loop operation in preparation for planned maintenance on the "A" loop of RHRSW (refer to Attachments 1 and 2 for one-line diagrams). There were other systems inoperable at the time, none of which impacted this event. During the test, a strainer high differential pressure alarm was received on the "B" RHRSW loop. Investigation indicated that the differential pressure instrument was pegged upscale high (greater than 15 psid). The procedural limit was 12 psid (Operating Instruction 416, Revision 25). As a result, at 1105 hours, "B" RHRSW subsystem was declared inoperable and Technical Specification (TS) Limiting Condition for Operation (LCO) 3.7.1 Condition C, one RHRSW subsystem inoperable for reasons other than an inoperable pump, was entered. The applicable TS Required Action for Condition C is to restore the RHRSW subsystem to an operable status within 7 days.
